THE BIRDCAGE TAVERN/ROB ROY HOTEL (R11/2499), FREEMANS BAY, AUCKLAND: FINAL ARCHAEOLOGICAL REPORT

In fulfilment of NZHPT Authority No. 2010/206

Prepared for the Victoria Park Alliance

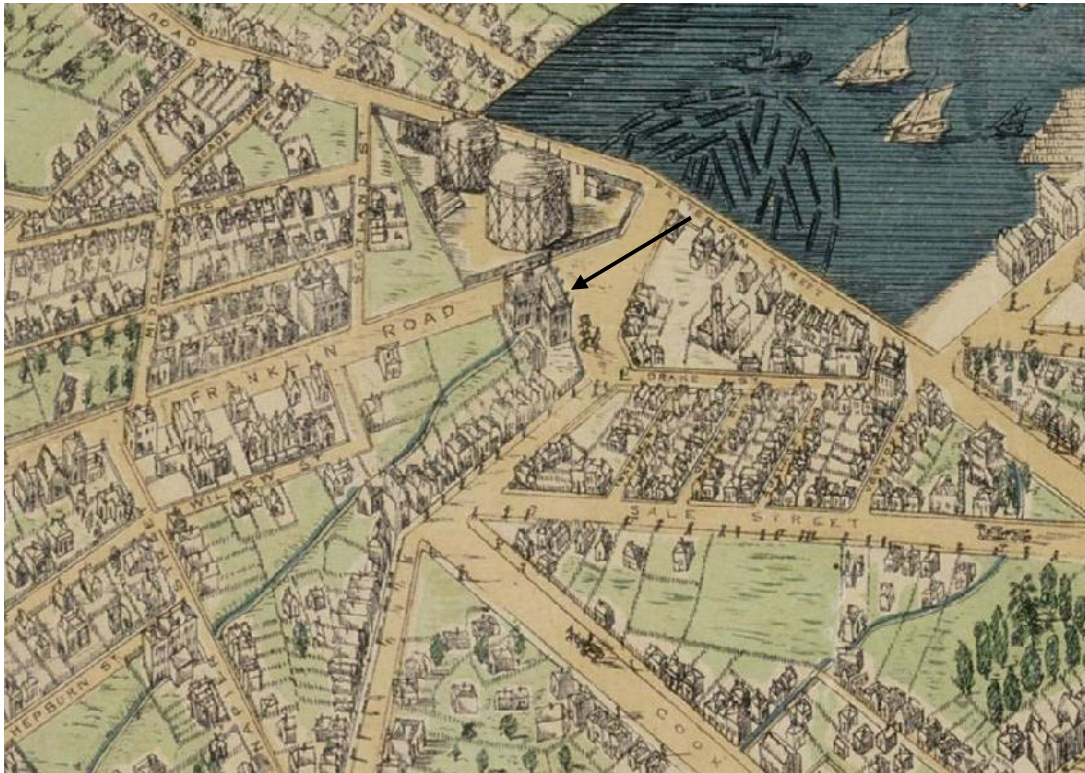
Figure 13. Stevens' 1886 Birdseye view of Freemans Bay. Note the line of the stream/culvert and the presence of the Rob Roy Hotel (arrow) (Sir George Grey Special Collections, Auckland Libraries, NZ Map 4641)

Brick culverts were built within the various reclamations to assist in the drainage of the surrounding watershed (Figure 10). It is likely that the Freemans Bay stormwater culvert that was located beneath the Rob Roy Hotel (extending down from Wellington Street and draining into the bay) was constructed in the 1870s, as other culverts in the area were being installed. In the *Daily Southern Cross* it was noted during the formation of Napier Street in 1876 that “a substantial stone culvert is being constructed at the bottom of the gully between Napier-street and its continuation on the western side of Hepburn-street”.⁶ Certainly, in an undated photograph the Freemans Bay stormwater culvert is visible draining into the bay along with a sea wall and the empty site of the later Rob Roy Hotel (Figure 11). This was the seawall along Patterson Street which would have been built at the time of the Drake Street to Patterson Street reclamation (sometime between 1873 and 1880, as discussed above), and this photo must therefore have been taken after 1873 but before construction of the hotel in late 1885. The stream/culvert can be seen in Hickson’s 1882 plan (Figure 12) as well as Stevens’ 1886 Birdseye view of the area up to Patterson Street (Figure 13), and this latter plan also illustrates the recently constructed brick Rob Roy Hotel.

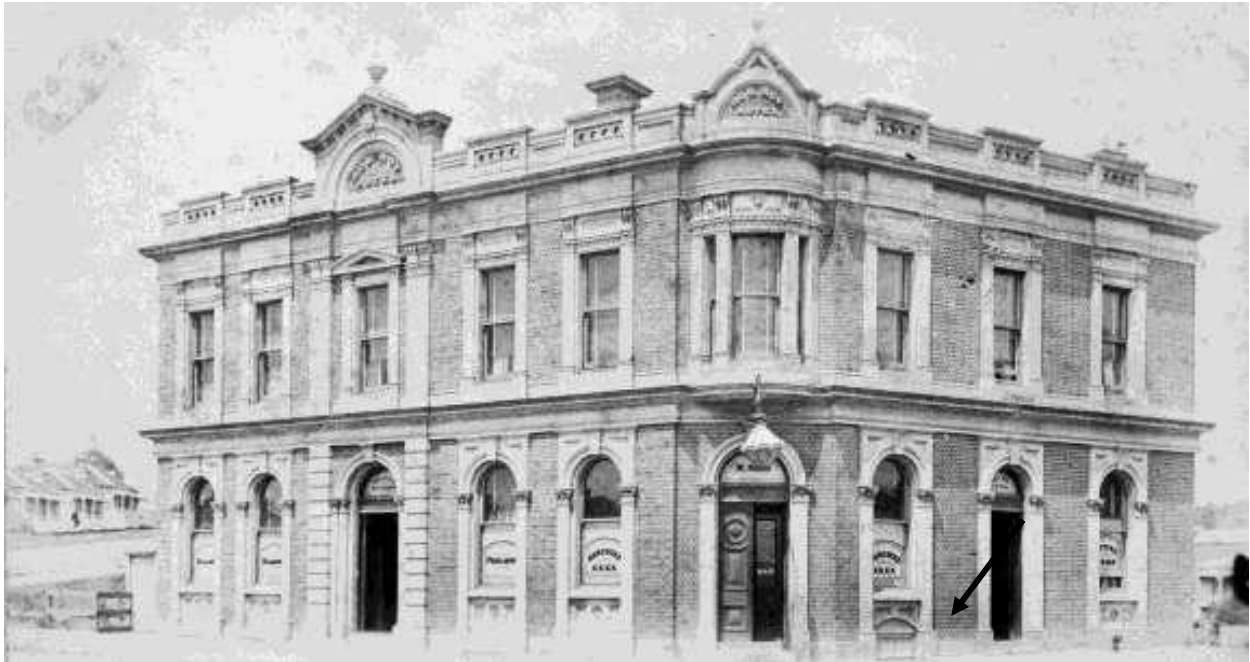
Figure 16. The Rob Roy Hotel in the 1890s. The three wooden houses extending up Union St (at left) are also visible in Figure 15. Note the original private entrance on the northern frontage, the corner entrance to the public bar, the cellar door (arrow), and an additional side entrance next to the cellar door. The entrances underwent various changes through the 20th century (Sir George Grey Special Collections, Auckland Libraries, 7-A4942)

By the end of January 1886 it had nearly been completed, occupying the prominent corner site fronting Franklin Road and Drake Street (Figure 16–Figure 17).¹⁷ Interestingly, the Rob Roy Hotel stood in contrast to the squalor around it, with its ornate facades and detailed interior (Mathews & Mathews 2003: 20). The hotel included a Billiard Room which was located to the east end of the ground floor. The private entrance was on the north façade, with the Parlour adjacent, and the entrance to the public bar was on the corner. The cellar door and an additional side entrance were located on the western frontage (Figure 16).

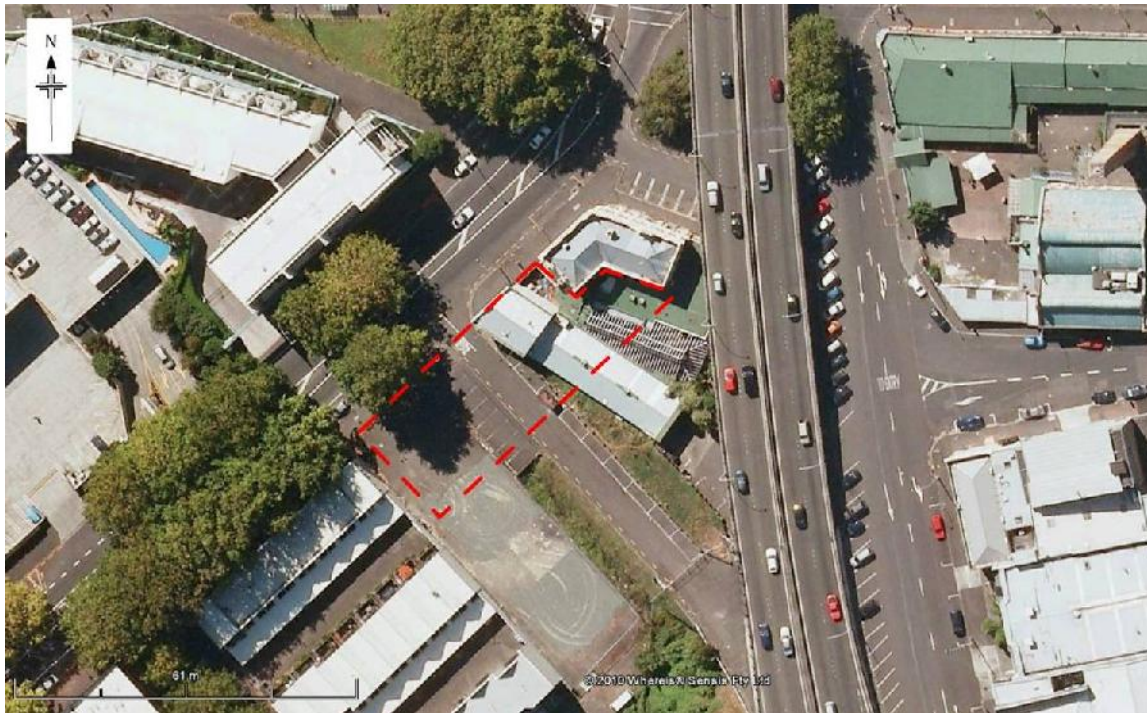
Figure 20. The area of the relocation trench outlined in red at the rear of the Birdcage Tavern

As part of works to move the Birdcage Tavern, a large area crossing several allotments (Allotment 32 SECT 43 SBRS of Auckland, Pt Lot 1 DP 34567 and Lot 1 DP 35525) to the southwest of the Birdcage was excavated to approximately 2m below the ground surface (Figure 20). The works were monitored over a few weeks from 5 July until 16 July 2010. This trench was excavated by Fletchers Construction to enable the top two stories of the building to slide off the basement walls, and then be shifted across runway beams to its new (temporary) location (Figure 21, Figure 22). Initially an area of around 20m² was opened to a depth of 1.5m below the level of the ground surface. A toothed bucket was used to remove the bulk of the modern material, then the base of the excavation was scraped carefully using a toothless bucket. This gave a clean and level surface to see features and deposits in plan view. The area was then extended to the southern boundary of the allotment, and widened by a further 10m. Finally the base of the trench was excavated a further 0.5m, again using a toothless bucket, taking the final depth to 2m.

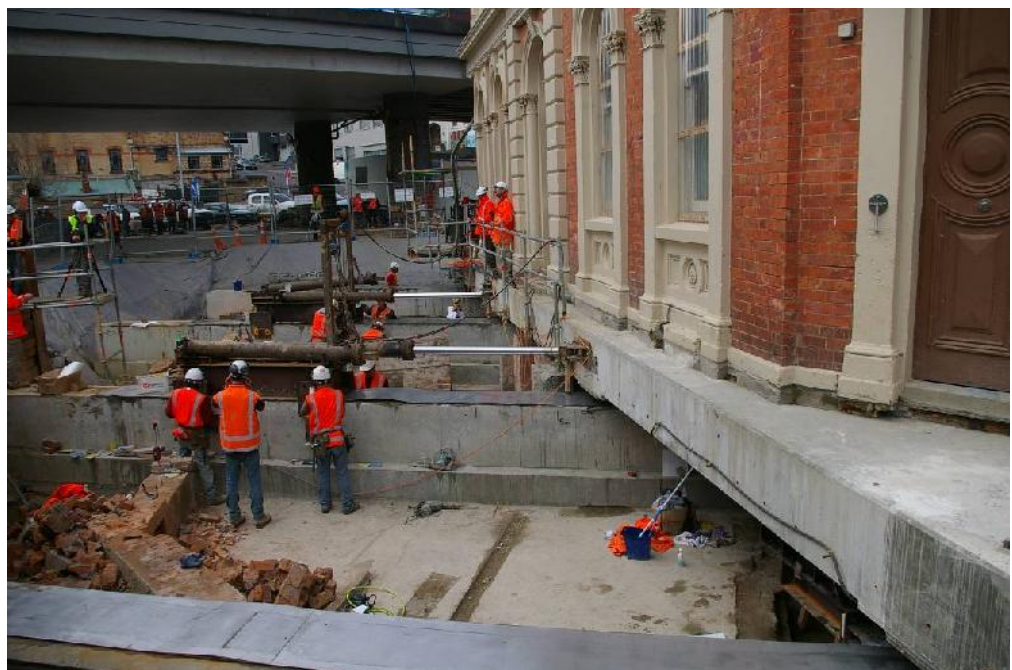
Figure 21. The Birdcage Tavern at the start of its journey in August 2010, showing the concrete tracks with greased Teflon surface that were constructed to move the building

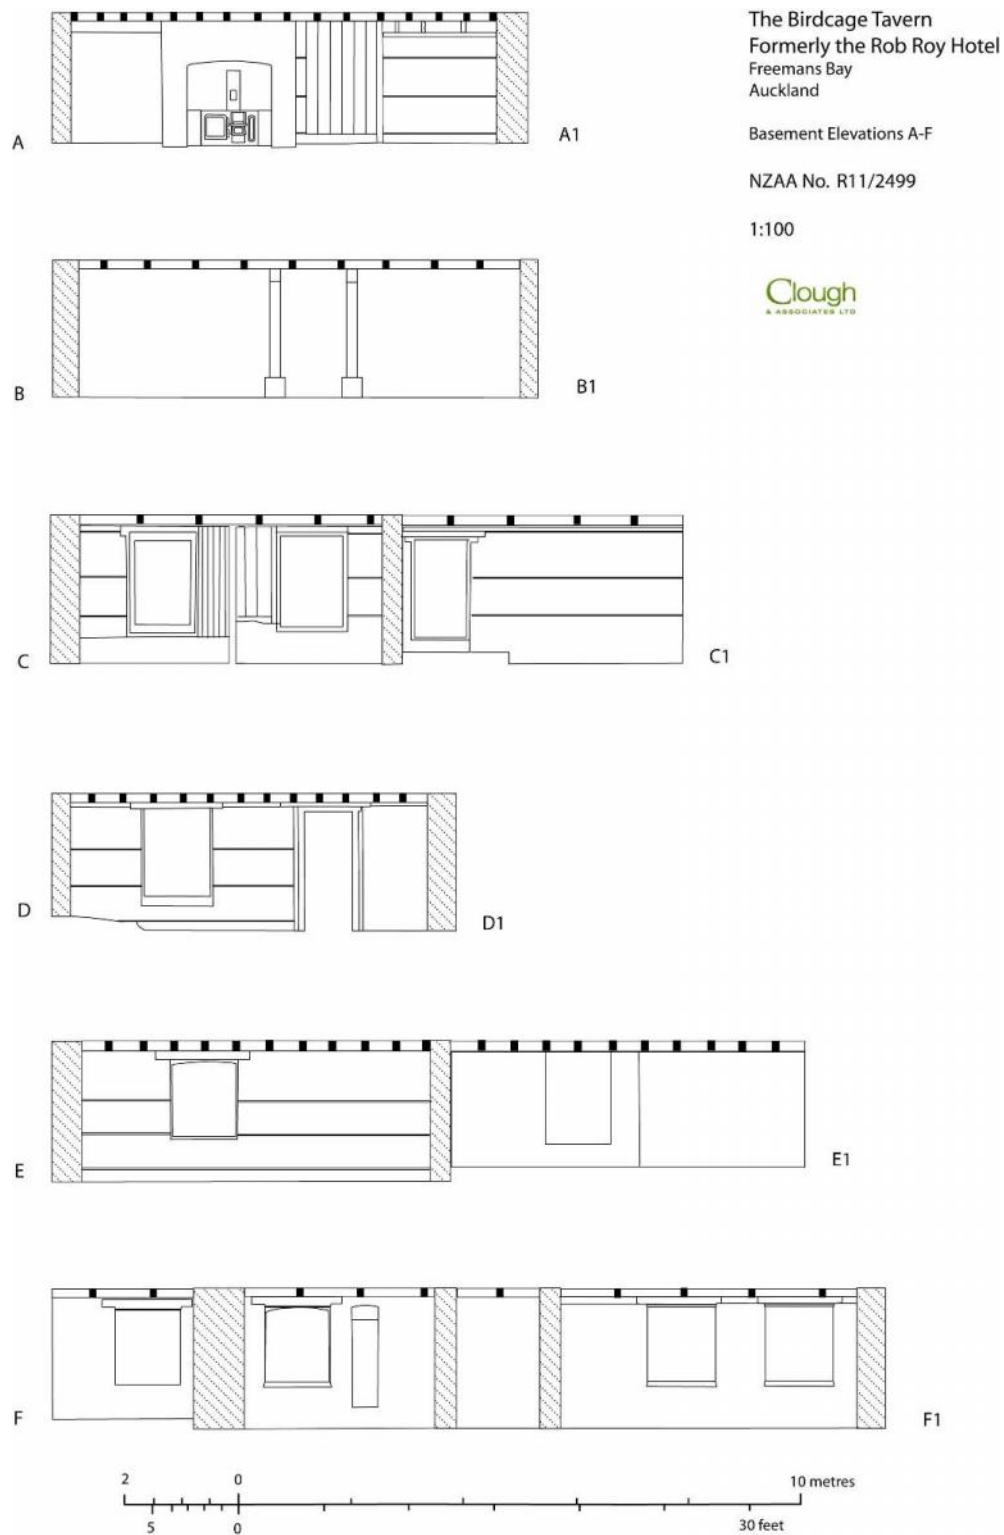
Figure 25. Rob Roy Hotel basement elevation drawings, walls A-F. (NB. Scale is 1:100 at A4 scaled only)

Elevations and descriptions of the Rob Roy Hotel basement are presented in this section. The basement plan is presented as Figure 24, and the elevation drawings as Figure 25 and Figure 26. The room allocations have been made based on features observed and historical descriptions.

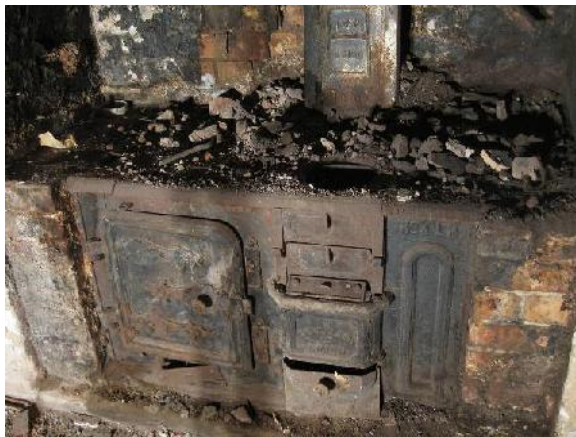
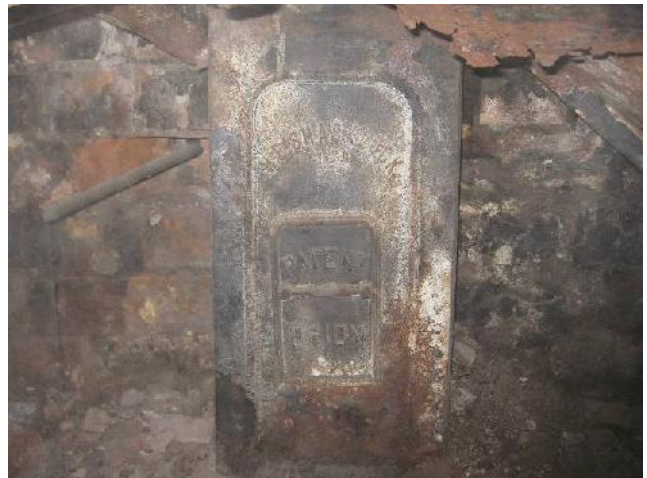
Figure 27. The Shacklock Orion coal range located in the kitchen/scullery, prior to removal. The name on the right hand photo says: Shacklock Ltd. Patent Orion

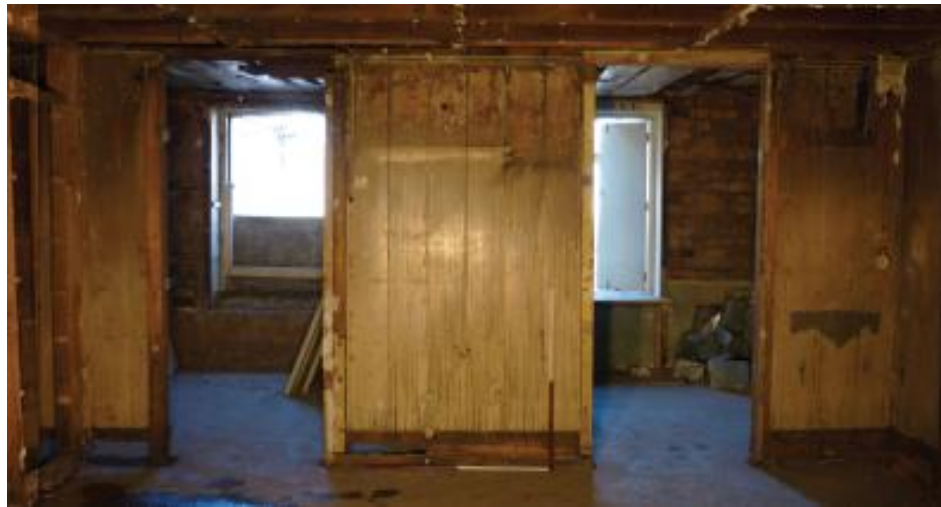
Figure 30. Kauri panelled wall with four pane window separating the coal cellar from the storeroom. The view from the coal cellar (left) and storeroom (right) (red and white scales measure 1m)

- One brick box window which extended to the ground surface and would have let light into the cellar
- Brick coal shute alongside the window, the top of the shute being at ground level
- Kauri panelled wall with a four paned window forming the southern limit of the room (Figure 30)
- Timber entrance to the antechamber which probably also had a door
- Brick and plaster walls, partially whitewashed. Some coal dust staining evident
- Arched entrance-way
- Concrete floor

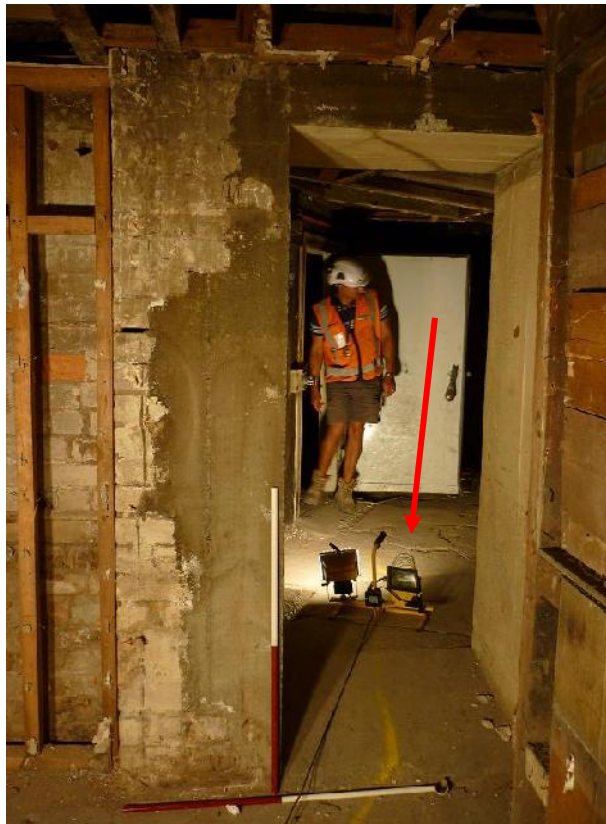
Figure 31. The raised floor in the beer cellar can be seen here (arrow), looking through the doorway from the storeroom, facing west. (1m scales shown)

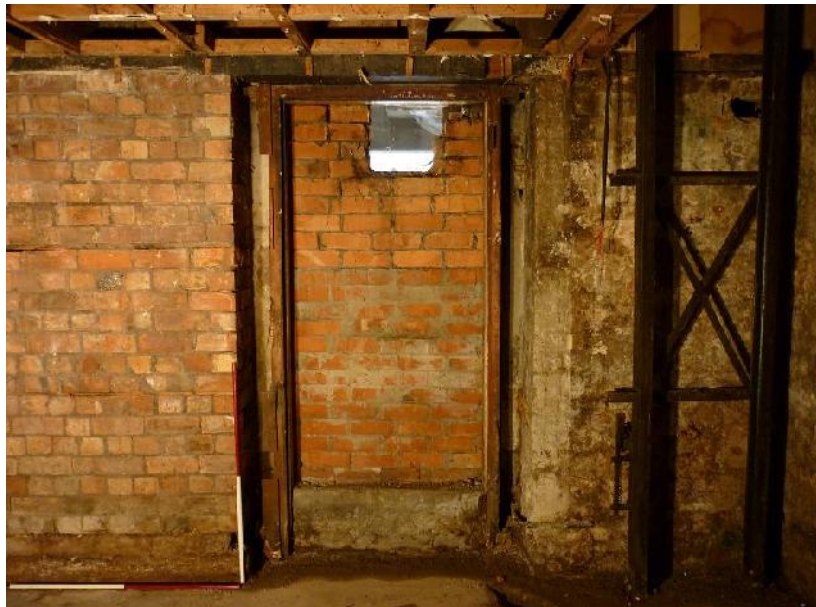
Figure 32. Doorway from the storeroom (here blocked off) which would have accessed the yard. The steel frame to the right is the modern hydraulic lift. Facing east. (1m scales shown)

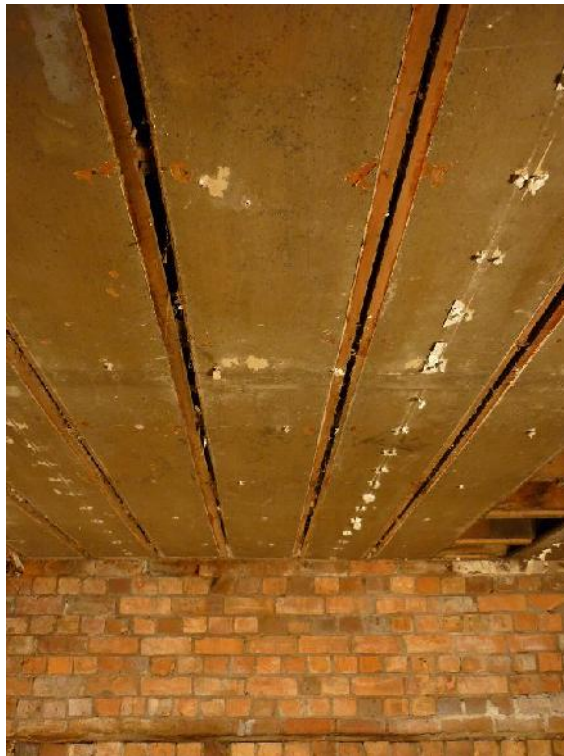
Figure 33.
Remnant kauri
ceiling panels in
the scullery/
storeroom.
Facing south

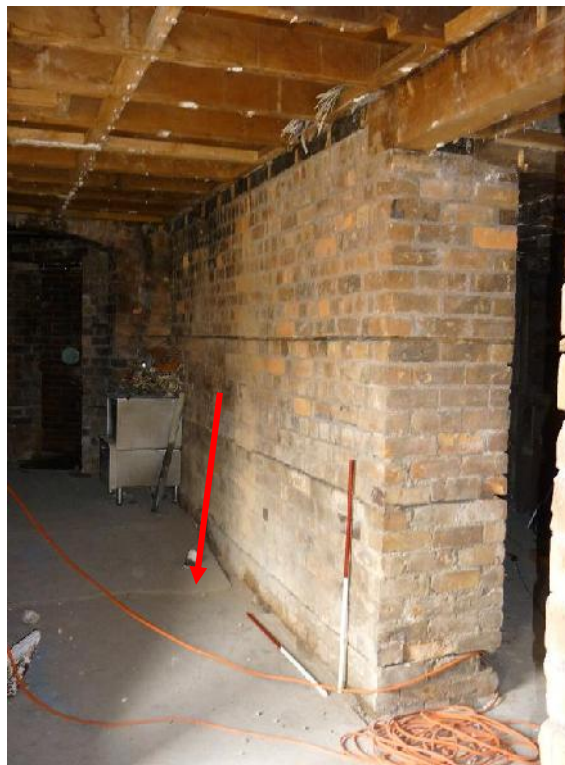
Figure 34. Ramp
in hallway above
the stormwater
trench (arrow).
Facing west. (1m
scales shown)

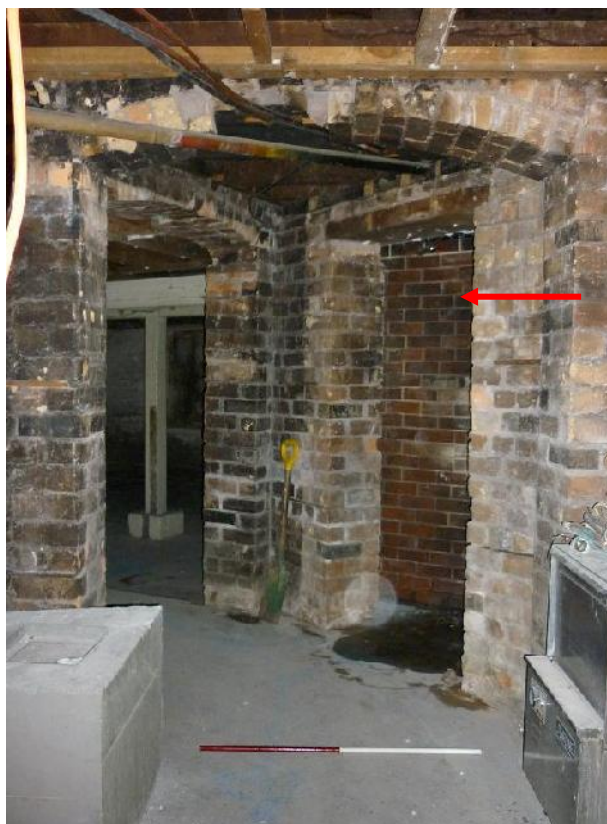
Figure 35.
Arched doorway in the hall and in the scullery/store room on the left. The bricked in doorway (arrow) is the beer cellar entrance. Facing west. (1m scale shown)

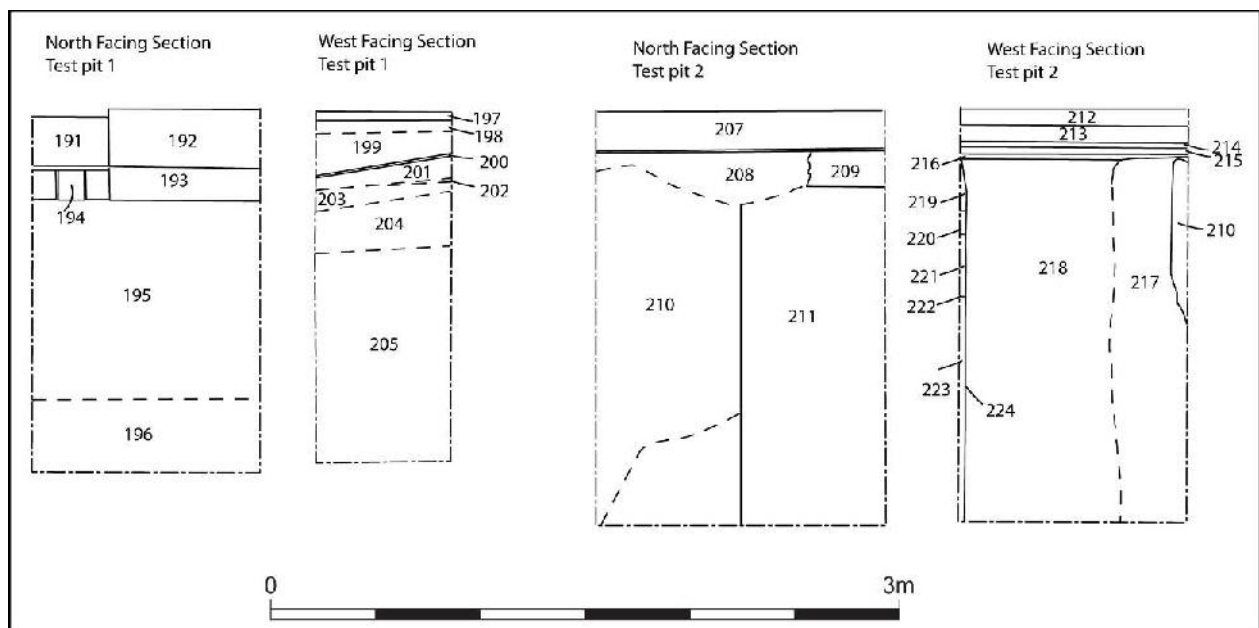
Figure 38. Section drawings, Test Pits 1 and 2 (see Appendix 2 for context descriptions)

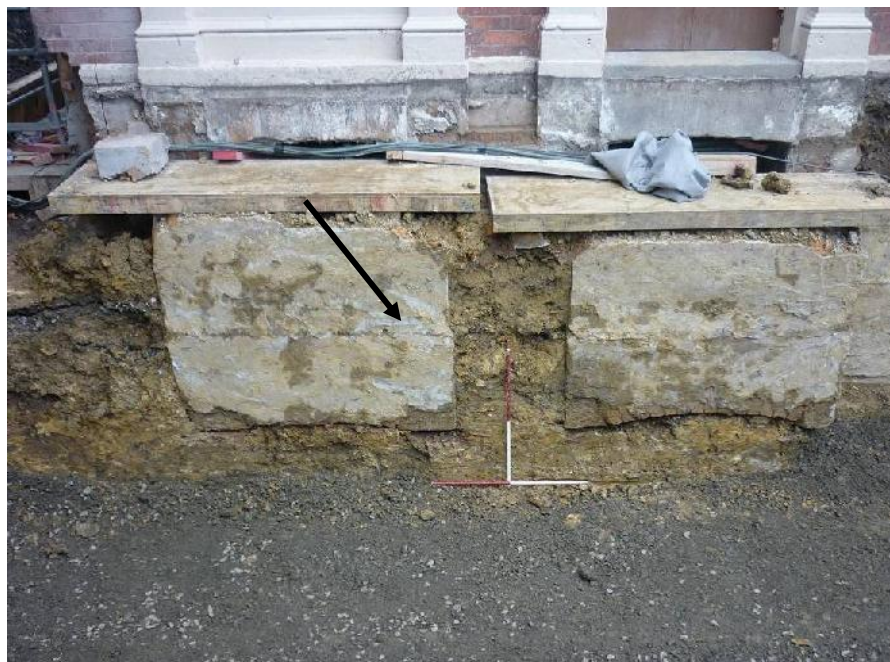
Figure 39. Layers dating to the period of construction of the Rob Roy Hotel, with the rendering lines on window boxes C and D and surface level (context 554) indicated by the arrow. Facing south (1m scales)

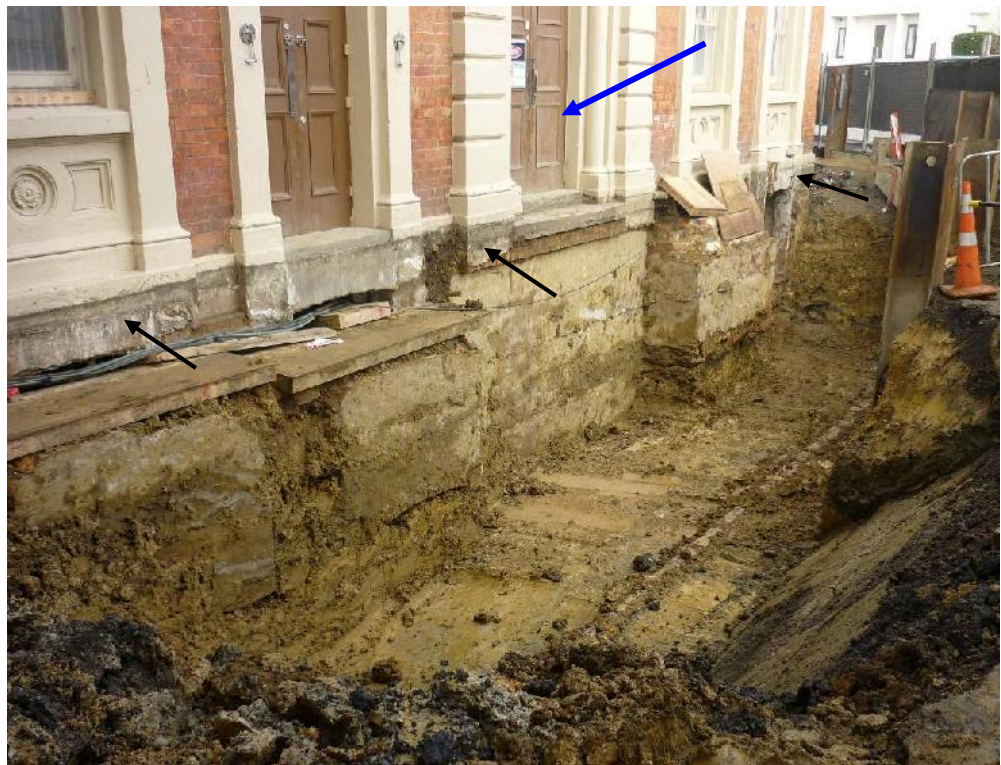
Figure 40. The dark band (arrows) indicates the original ground surface level once the Rob Roy Hotel was completed. The original private entrance is indicated by the blue arrow, with the door to its left being a later alteration of a window to a door. Facing southwest

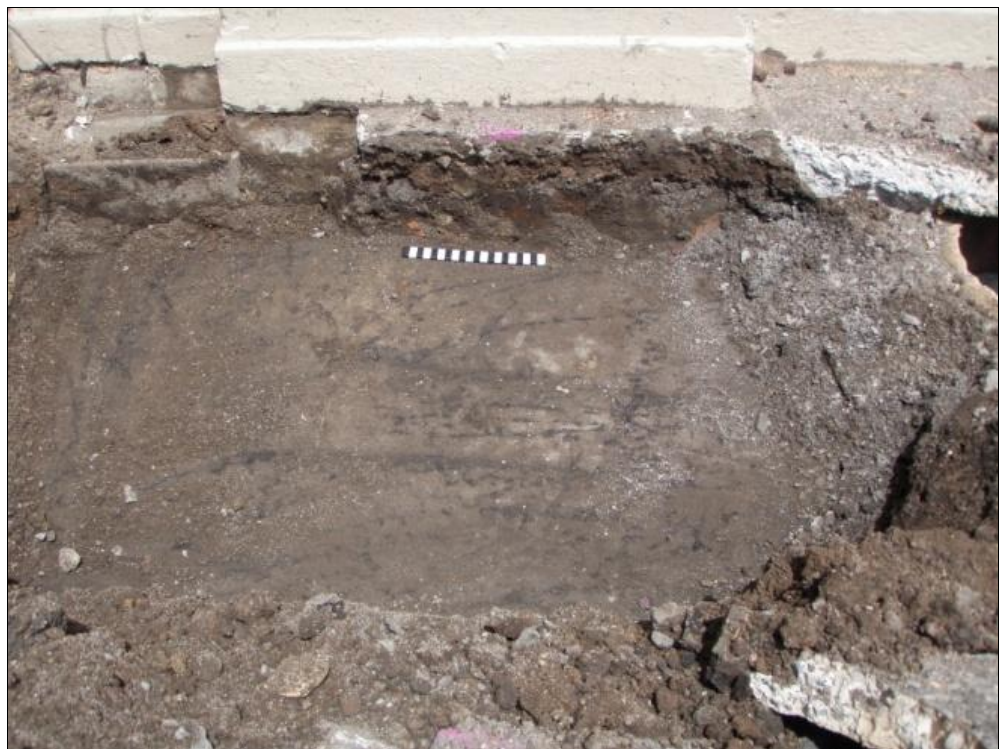
Figure 41. The original ground surface tarseal layer present in plan as exposed in Test Pit 1. Facing south

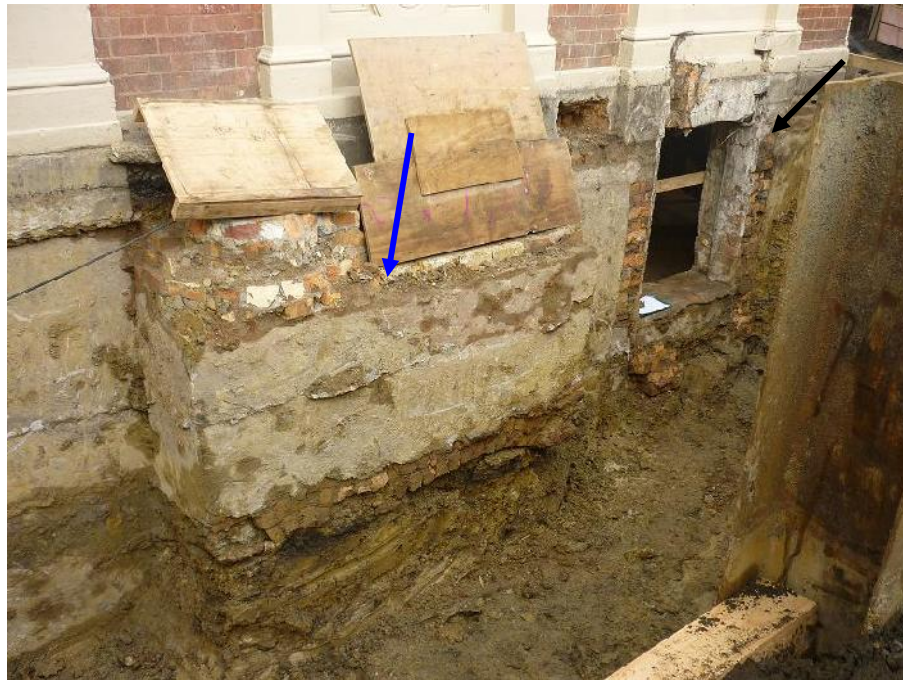
Figure 42.
Window Box A
after demolition
(black arrow);
Window Box B
and the coal
shute (blue
arrow). Facing
southwest

Window Box A: the window box was not observed before it was removed (Figure 42).

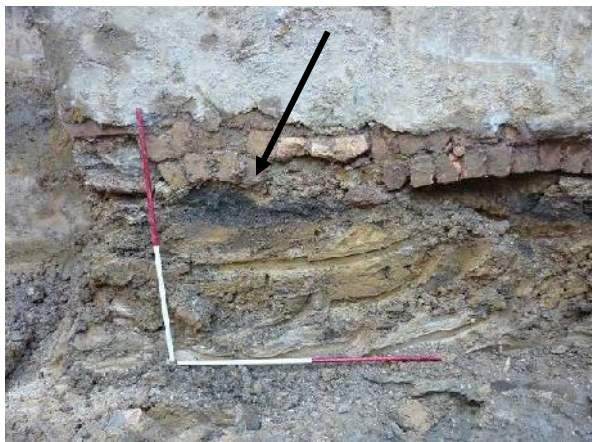
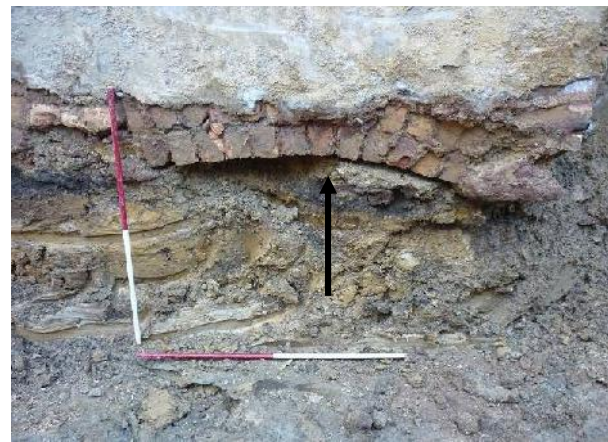
Figure 43. The arch at the base of the coal shute (left), and the arch at the base of Window Box B (right). Facing south (1m scales)

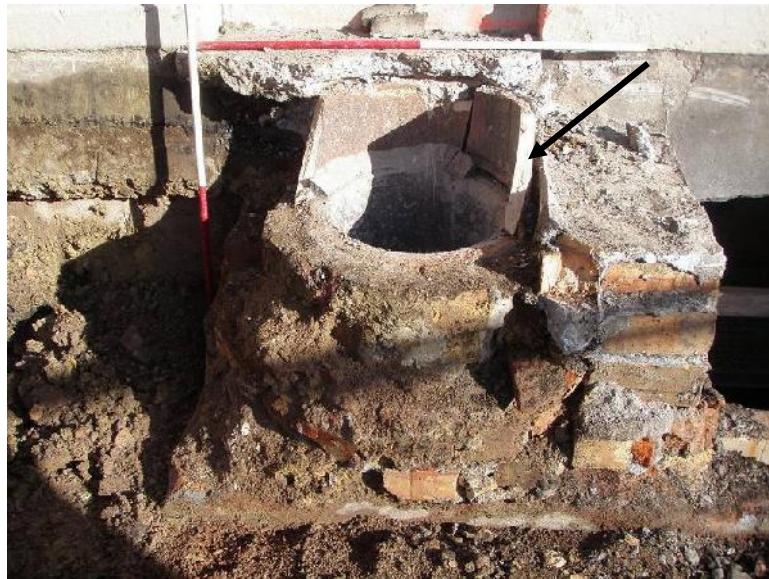
Figure 44. Top of the coal shute, with modern ceramic pipe insert (arrow). Facing south (1m scales)

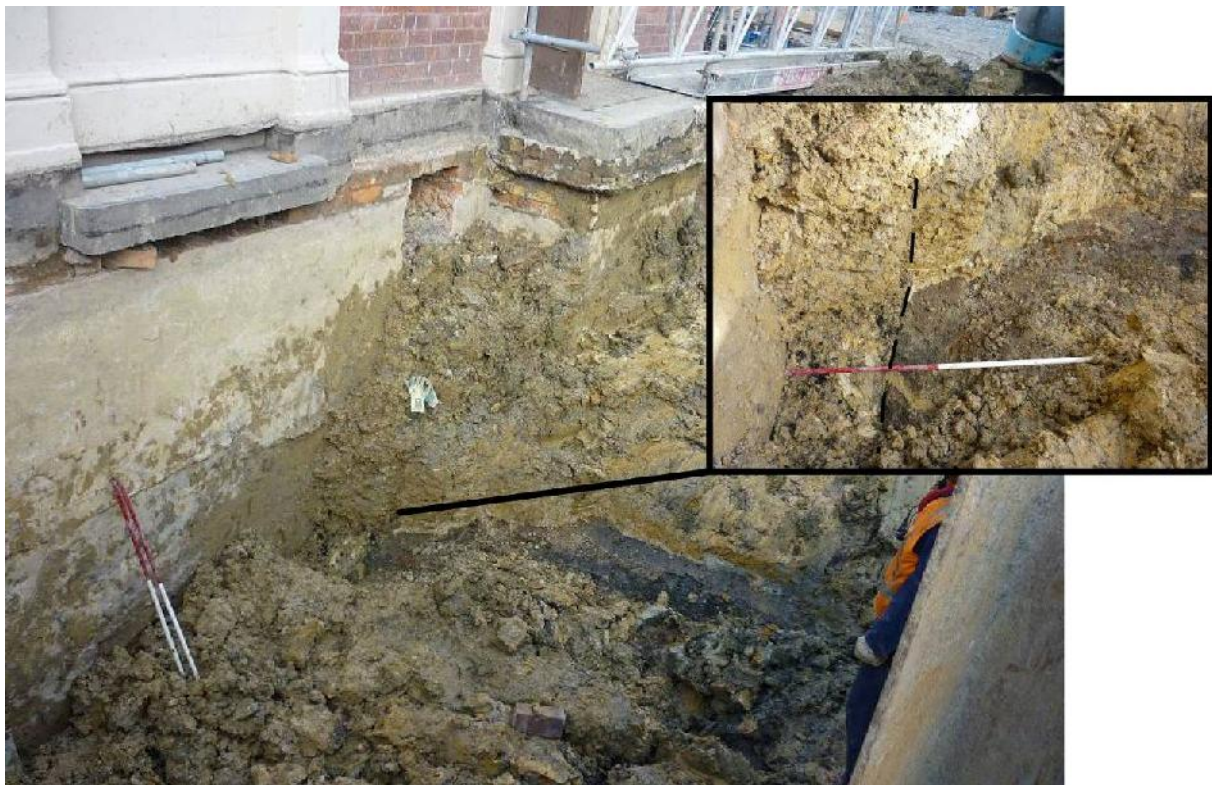
Figure 45. The cut (573) for the basement is visible, with a close-up view (inset). The window box visible in the background is Box F. Facing southeast

A cut for the basement was observed in this trench, context 573, filled by 572, a yellow mottled sticky clay (Figure 45). A cut (566) for the lower section of the cellar door was also recorded, filled by 567, with the lower section recorded as context 568 (Figure 46). The cellar door is shown as E on the plan (Figure 36 and Figure 37). A thick yellowish-brown mottled clay layer (563) formed the bulk of the stratigraphy above the older surface (564).

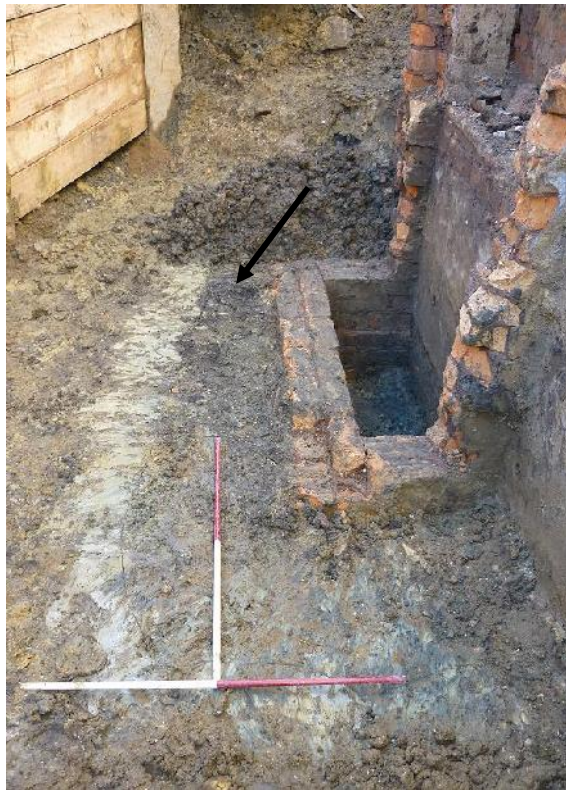
Figure 46. Lower structure (context 658) of the cellar door (E), with the construction cut indicated by the arrow. Facing north (1m scales)

Cellar Door E: two brick foundations were identified for the cellar door. The lower foundations (also recorded as context 568) consisted of 9 brick courses and formed a mortar lined structure (Figure 47 and Figure 48). This lower structure was only partially internally rendered. On top of this, and slightly offset, were the remains of the timber cellar door foundations. The top of the cellar door, which opened at ground level, was timber, and has been recorded by Salmond Reed Architects, November 2011). The door would have also had a trap-door on the footpath which would have opened upwards, while the timber door opened inwards, allowing the barrels to be rolled into the cellar.

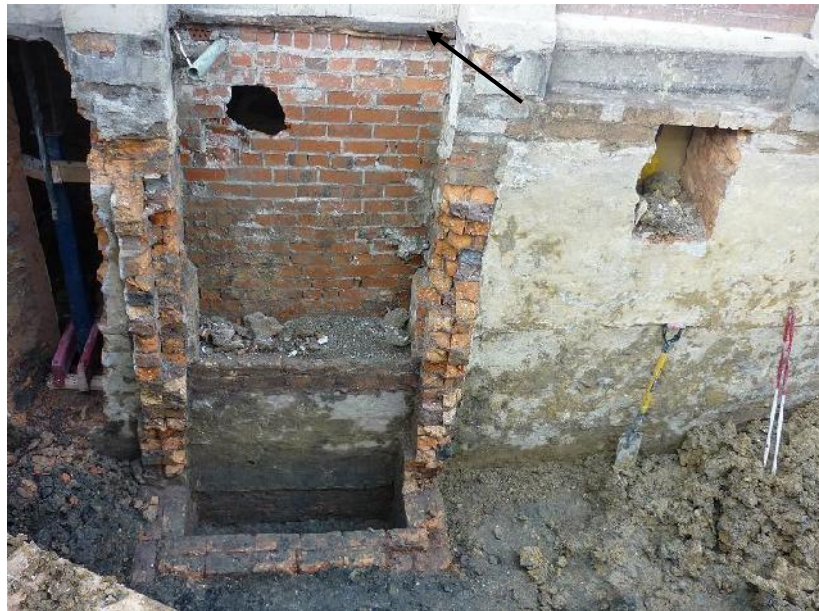
Figure 47. Cellar Door E, which had been bricked over in the late 20th century from the inside. The arrow points to the base of the wooden cellar door at ground level. Facing east

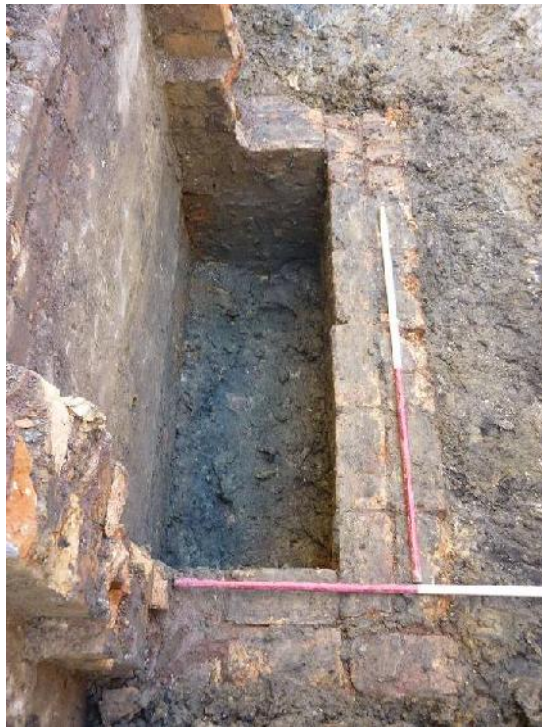
Figure 48. The mortar lined base of the cellar door, recorded as context 568. Facing south (1m scales)

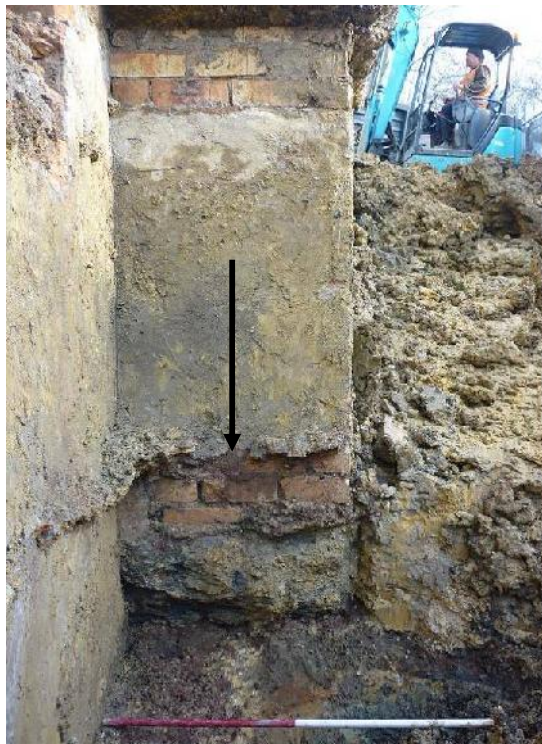
Figure 49. Window Box F, illustrating the rendered bricks, and one bluestone block at the base (arrow). Facing south (1m scale)

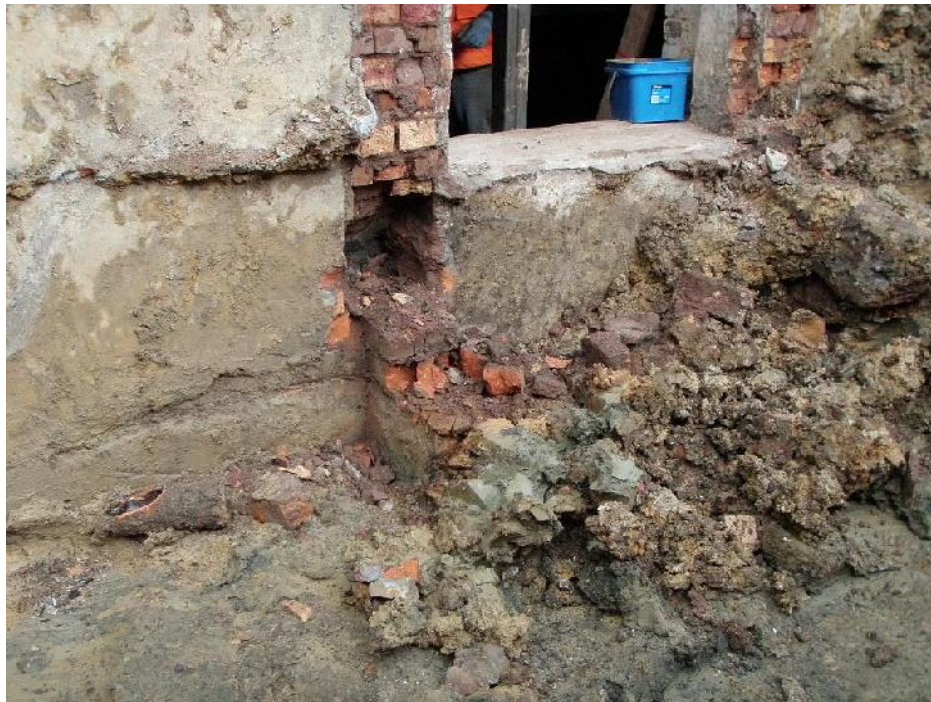
Figure 50.
Window Box F
during
demolition, down
to the bluestone
block. Facing
southeast

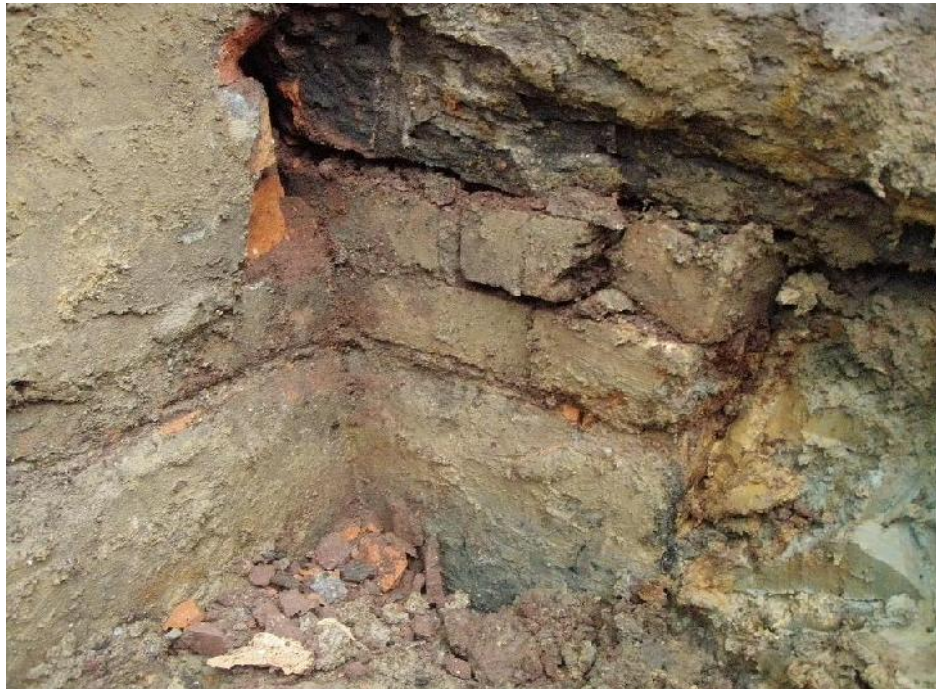
Figure 51. Closer
view of the bricks
and bluestone
block near the
base of Window
Box F. Facing
southeast

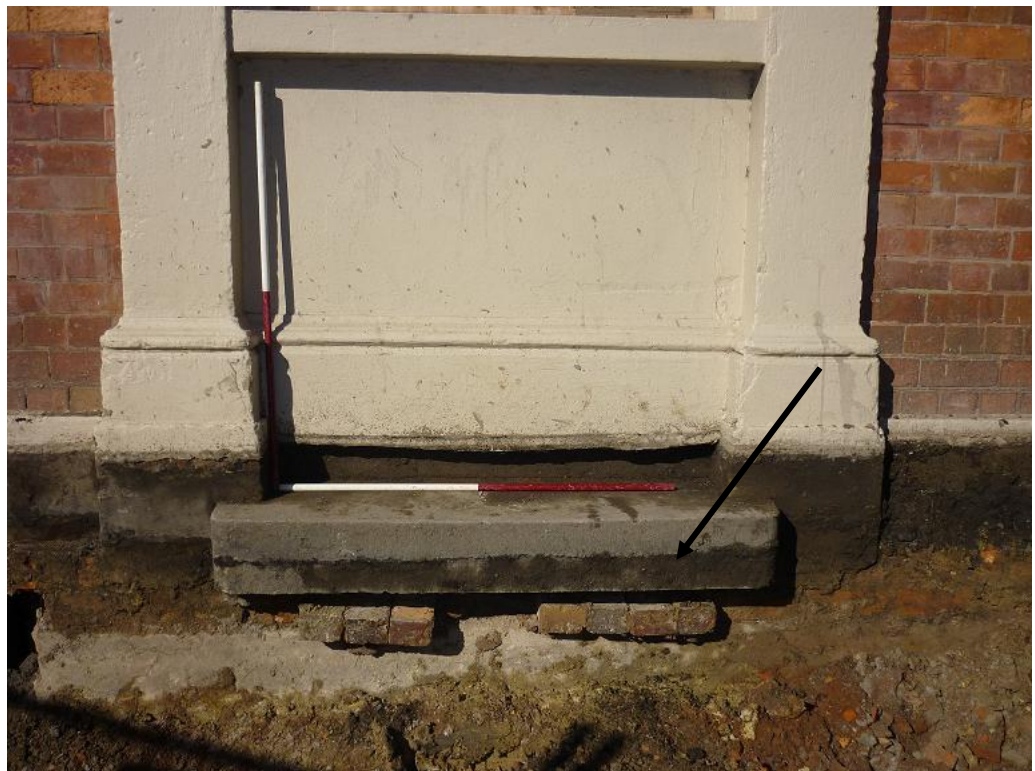
Figure 52. The original ground surface was at the base of the step. This is the original step of the west door that was later converted to a window. Facing east (1m scale)

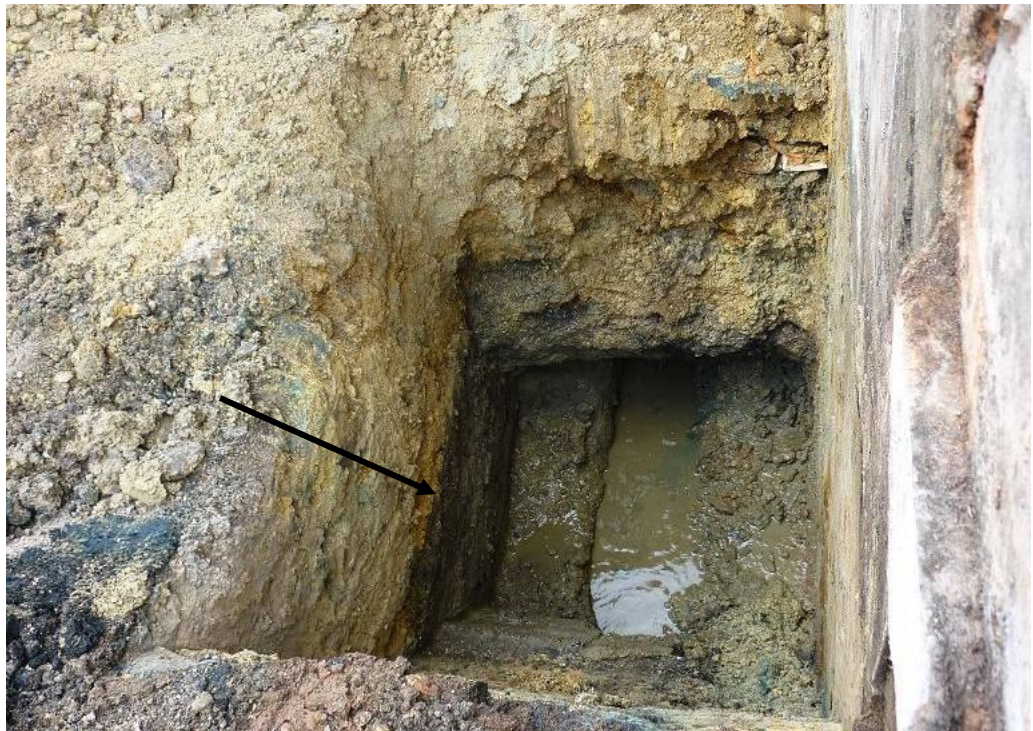
Figure 53. The bucket trench which abutted the southwest wall of the Rob Roy Hotel. The dark layers are 268 and 269 (arrow). Note the water table had been reached. Facing west

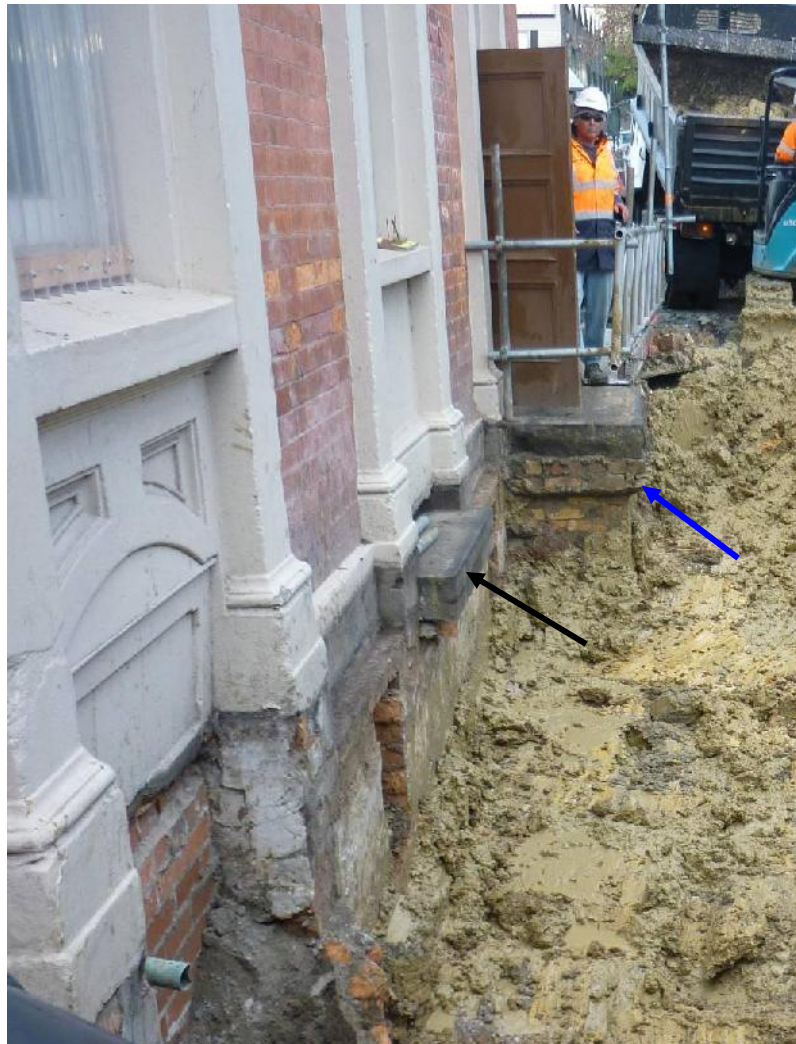
Figure 54. The original west door (centre, arrow) which was later modified into a window, and the new door step above Window Box F exposed during excavation of the trench (blue arrow). Facing south

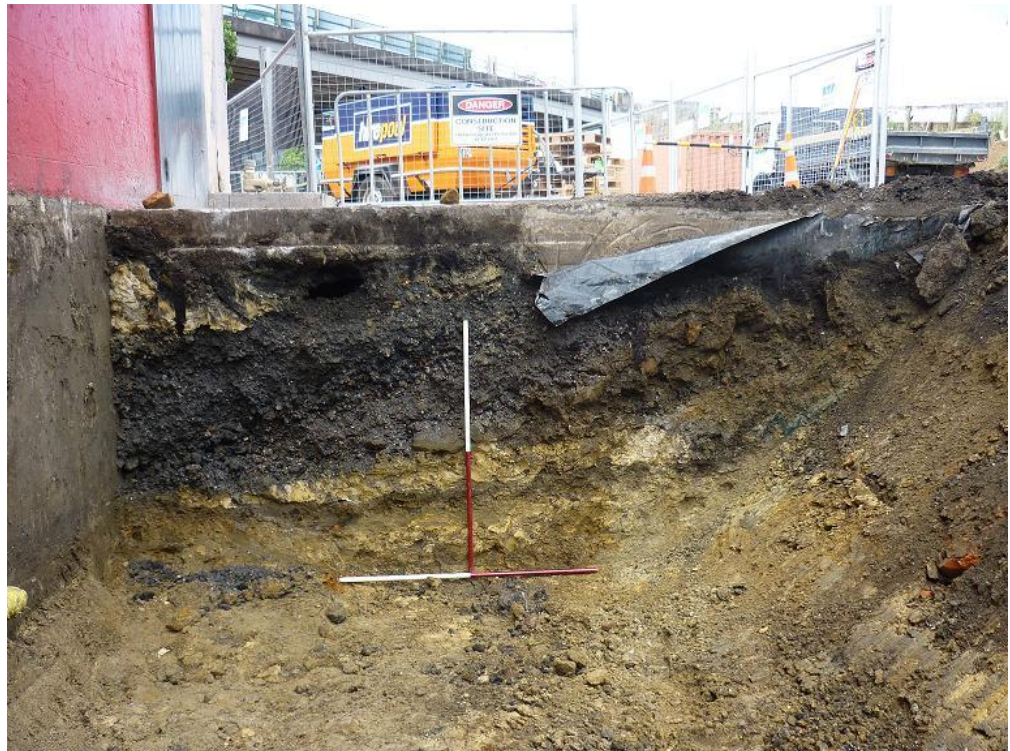
Figure 56.
Trench 1, west
facing section.
The cinder/ash
layer is clearly
visible. (1m
scales)
