THE BIRDCAGE TAVERN/ROB ROY HOTEL (R11/2499), FREEMANS BAY, AUCKLAND: FINAL ARCHAEOLOGICAL REPORT

In fulfilment of NZHPT Authority No. 2010/206

Prepared for the Victoria Park Alliance

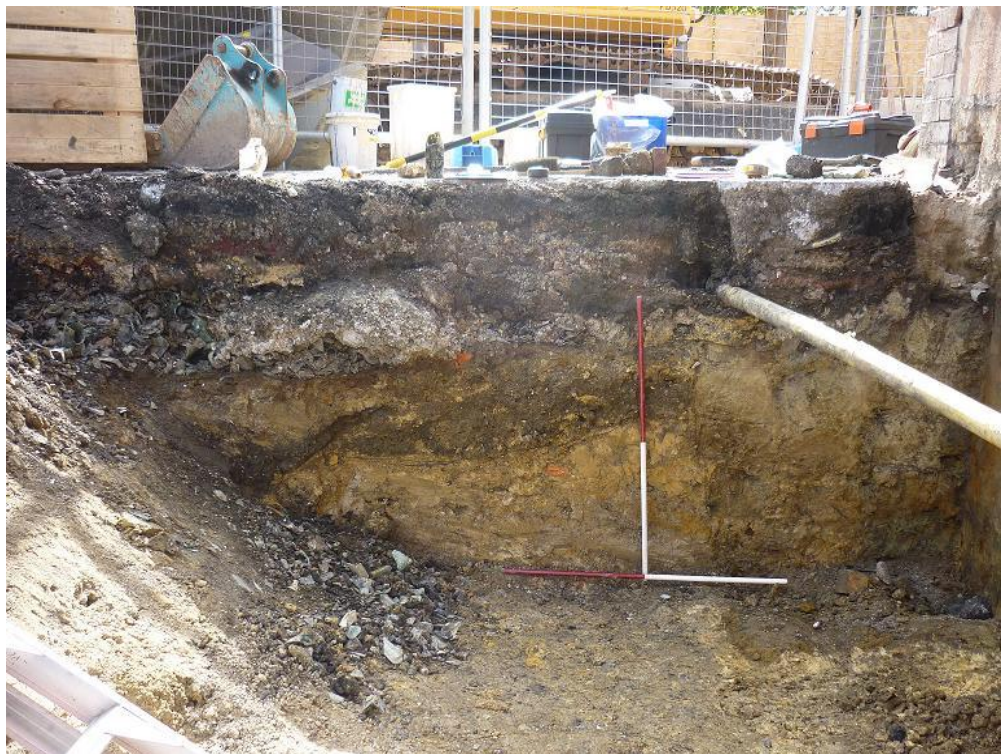
Figure 57.
Trench 1, east
facing section,
with the bottle
dump located on
the left side of the
section (1m
scales)

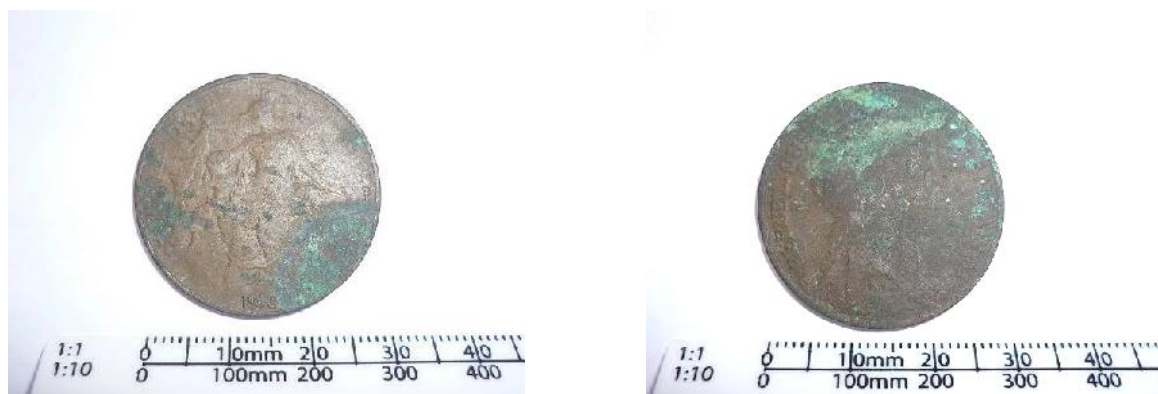
Figure 70. Face of the coin showing Liberty, the date 1910 and the number 10 (left), and reverse side of coin with the bust and the words 'Francaise Republique' (right)

Two artefacts were recovered from within the basement of the Rob Roy Hotel. However, the date they were placed in the basement is unknown. The first, a French 10 centime bronze coin with the date 1910, was recovered from the floor in the coal cellar (Figure 70). Text on the face of the coin reads: 'Liberte, Egalite, Fraternite'. The depiction is of Liberty seated on the left and Cupid or Eros seated to her right. On the reverse of the coin is a bust of Liberty facing right and the words: 'Francaise Republique'.

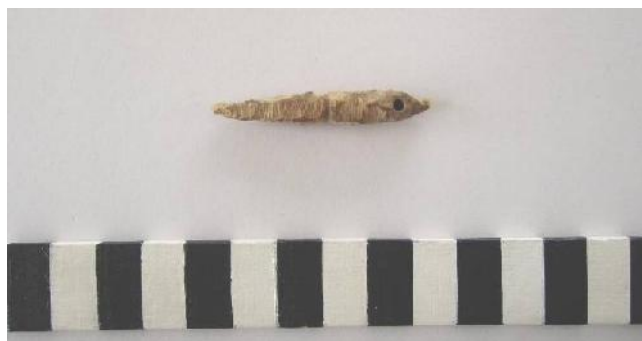
Figure 71.
Remnant bone
pendant, severely
damaged by rat
gnawing. 1cm
scale

The second artefact is the partial remains of a bone pendant recovered after it fell from the basement ceiling during basement stripping in the former pantry adjacent to the stairwell (Figure 71). The pendant was 49mm long and had been severely damaged by rat gnawing, making its original form unrecognisable. However, two indents were still present, the first located below a hole for the string, and the second approximately half way down the pendant. Remnant yellow twine was also threaded through the pendant.

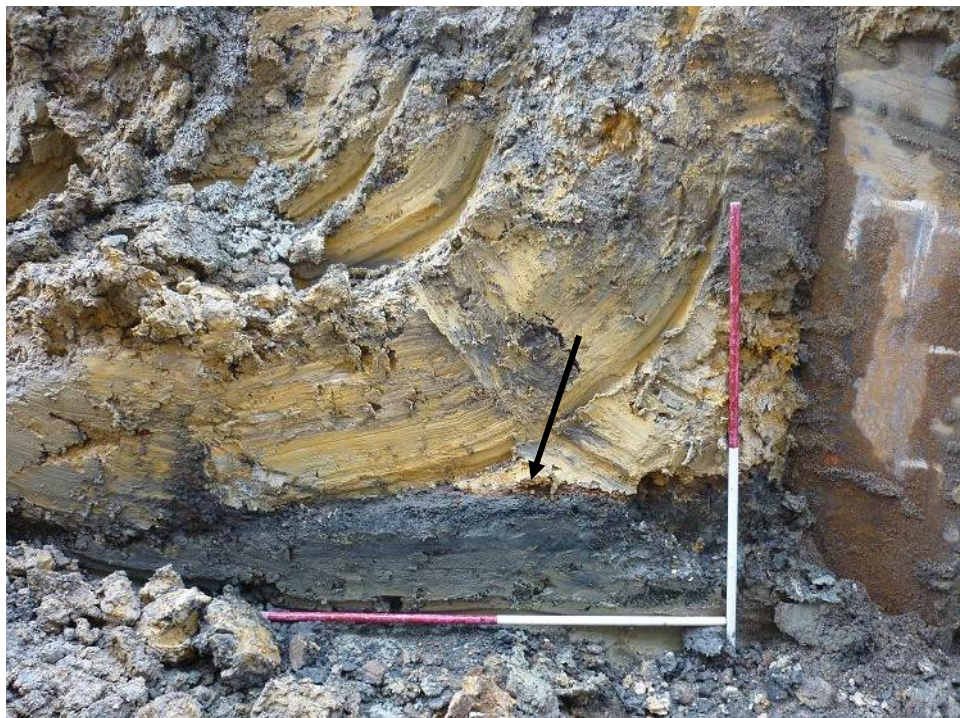
Figure 72. The former road surface, context 564 (arrow). The grey clay layer 565 is visible beneath the surface. Facing west (1m scales)

A former surface, context 564, is likely to date to this period. This surface, a compacted mix of gravels, bitumen and a sandstone-like material, was present in the northwest trench only (Figure 37 (no. 2); Figure 72 and Figure 73). It sloped to the north, and was truncated by a cut for the basement (572) (Figure 73). At its deepest, the surface was located at 2.42mbs. Context 565, a mid-bluish grey plastic clay, predated this surface. It contained small fragments of shell and is likely to have originated within the Bay.

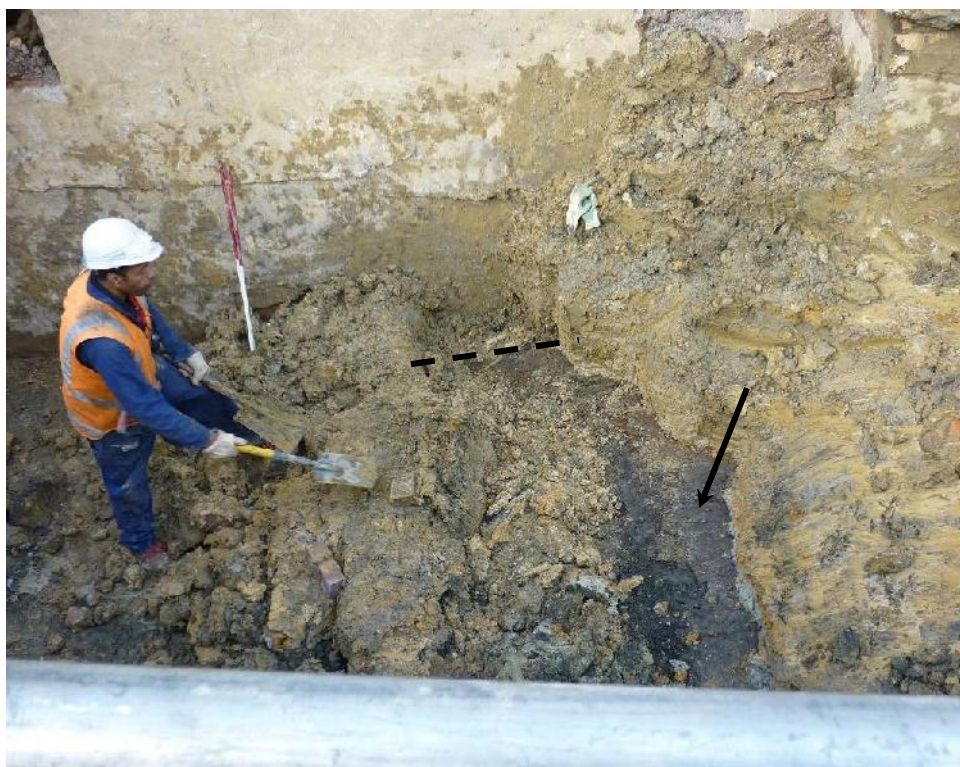
Figure 73. The former road surface, context 564 (arrow). The construction cut for the hotel basement is indicated by the dashed line. Facing east

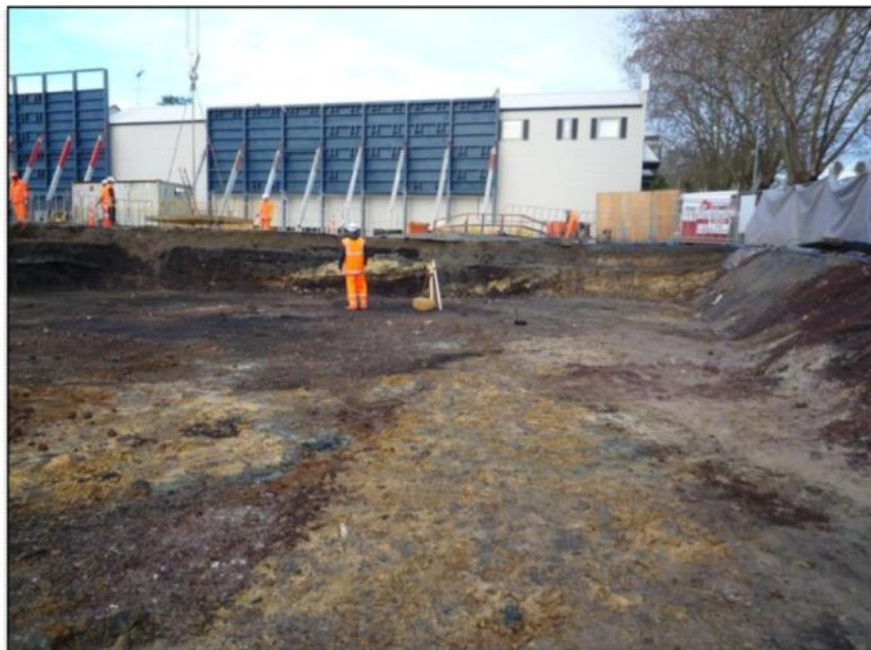
Figure 75. View facing south at the southern end of the main excavation trench. The yellow clay is context 651 and related to the original construction of Franklin Rd

A deposit of sterile yellow clay (context 651) was visible next to Franklin Road, extending 1.5m from the edge of the street and sloping into the allotment behind the building and is thought to be located at the original street level (Figure 74 and Figure 75).

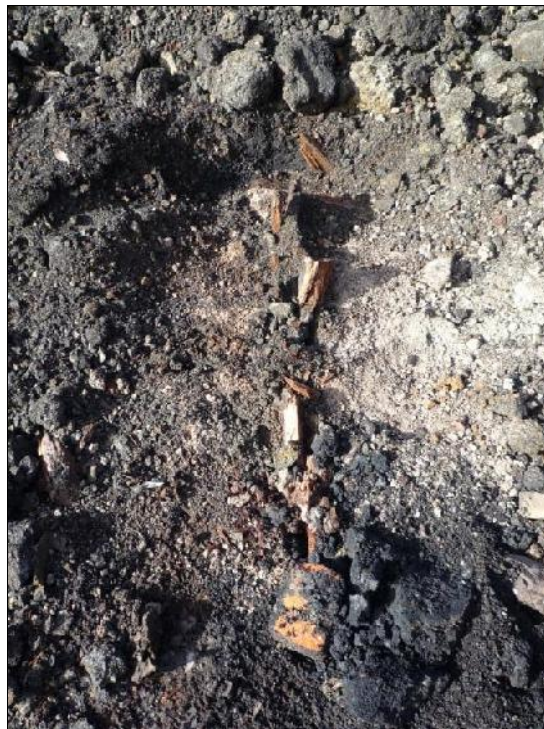
Figure 76. Close-up of feature (669), facing south-east

A small number of deposits and features were also revealed during the final phase of excavation at the southern boundary of the excavation. A row of 4 posts with connecting slot boards (context 669) was located about half way along the southern boundary and 5m away from the baulk (Figure 74 and Figure 76). In addition, a single larger split post (668) was located adjacent to this feature, at the base of the baulk. These two features are possibly related to a house that was built behind the Rob Roy Hotel (within Lot 1 DP 35525) prior to 1905 (Figure 17).

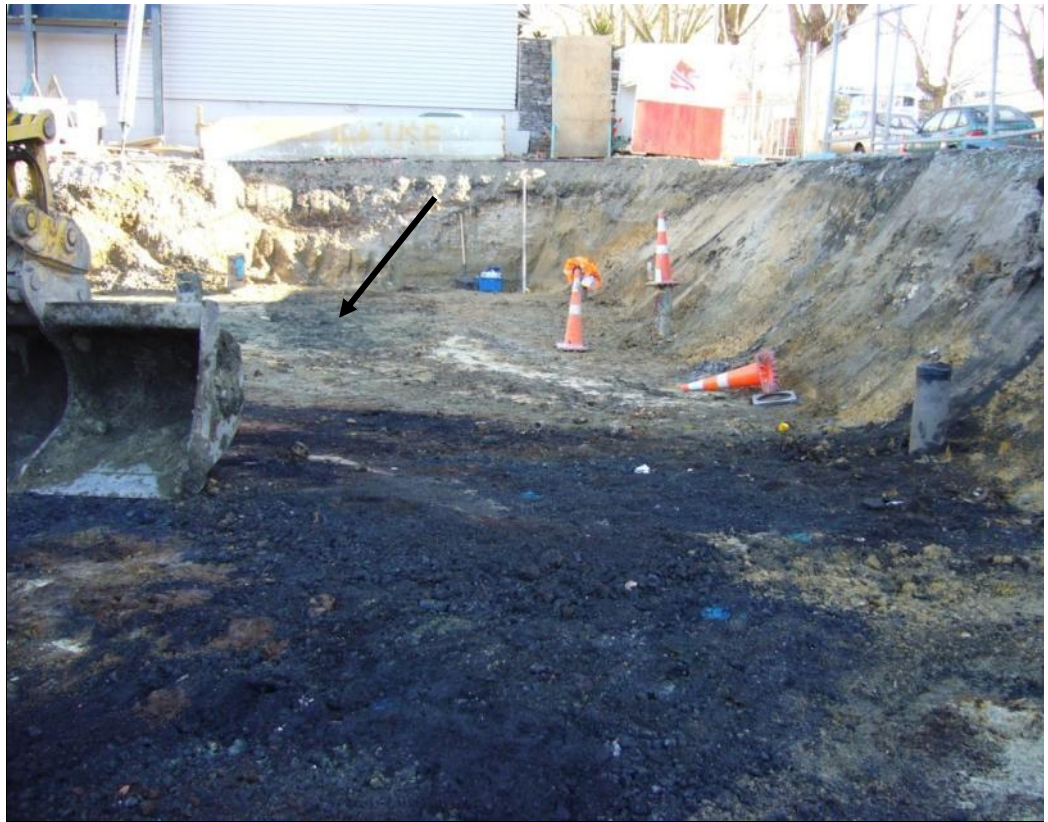
Figure 77.
Location of
context 653
(arrow) which
was likely to be
related to the
original house at
the back of the
allotment

Associated with these features was a friable light yellow brown clay fill (context 653), with some dispersed and broken ceramic and glass inclusions. This deposit was recorded at about 2m below the current road surface and was overlain by more modern fill layers. It had a clear boundary just beyond the row of posts (Figure 74 and Figure 77). Context 653 was overlaid to the east by a series of deposits comprising various clays and other dumped material (contexts 680 to 685). These are thought to be levelling fills added around the time the house was built on this allotment.

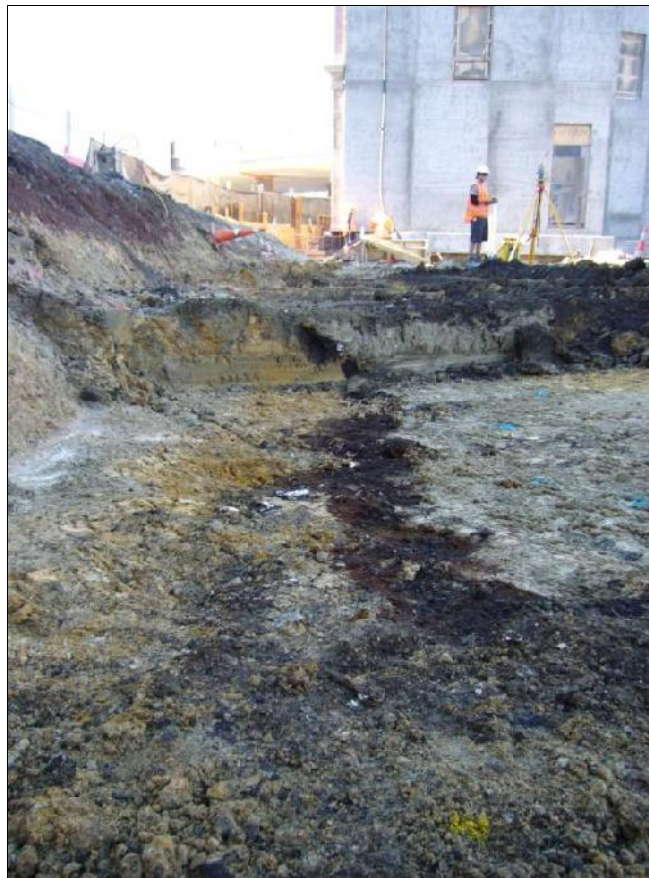
Figure 78. View facing north towards the Birdcage. Yellow brown clay (651) is present on the left and is overlaid by (670) and the probable Destructor deposits (656, 659)

In the main excavation area of the relocation trench a number of fill deposits were recorded (Figure 78–Figure 80). The earliest of these fill deposits consisted of waste material showing evidence of burning. A likely source of the fill would have been the City Refuse Destructor (now Victoria Park Markets) situated immediately opposite the Hotel on the other side of Union Street, which was constructed in 1905. However, other industrial sites around Freemans Bay may also have contributed. There were several lenses within the burnt ‘Destructor’ fill. A thin band of charcoal and dark silt was the basal layer for these deposits (context 654) overlain by a main pink ashy fill with dense concentrations of burnt artefacts (contexts 655–656). This was cut by a lens of thick dark silt and charcoal with pockets of burnt artefacts about 30cm thick (context 659), which was subsequently overlain by more ash fill. A mixed brown clay layer (670) was located on the boundary with Franklin Rd (see Figure 78) overlying the burnt material on this edge of the allotment. Various re-deposited clay and silt layers were placed on top of the ashy ‘Destructor’ fill, along with bricks, slag, gravel and more dispersed broken artefacts (contexts 662–663) as by-products of use of the allotments.

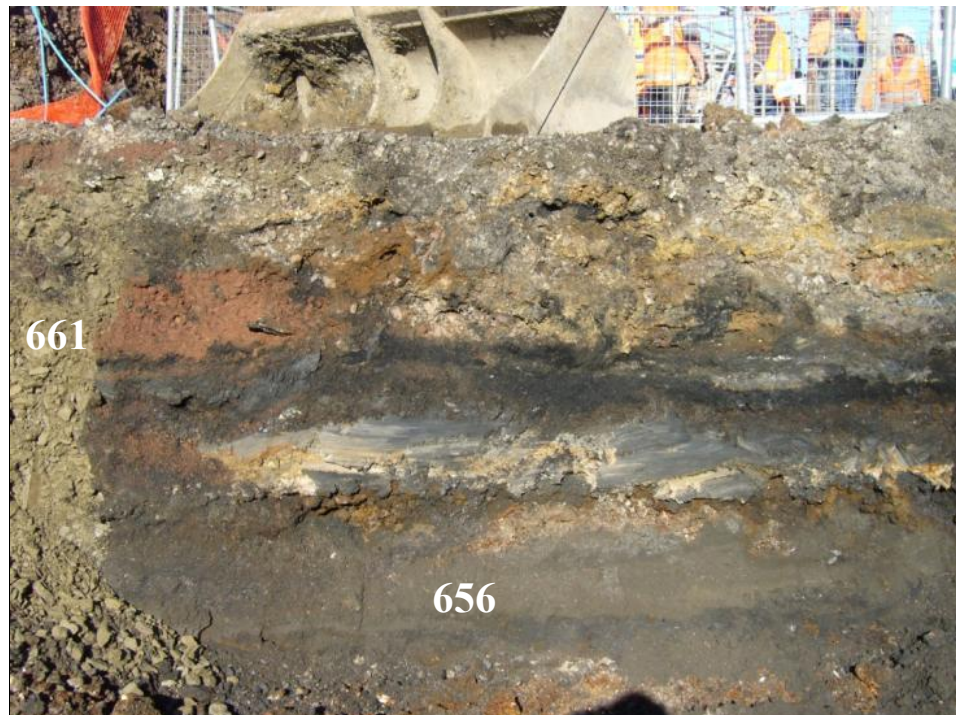
Figure 79. View showing the west facing section of main excavation. The dark brown ashy fill at the base is the probable Destructor material (656). Vertical line of greyish brown rock on the left of image shows the cut of a modern culvert (661)

In the relocation trench contexts 661 and 664-667 were mainly modern surfaces and fill deposits (see Figure 79-Figure 80, Figure 83). Contexts 664-667 were a range of tarseal and gravel surfaces. Additionally, a large stormwater culvert had recently been cut through the site and backfilled, primarily with clean crushed rock but also scoria and gravel (661, see Farley & Phear 2010). This feature vertically truncated most of the deposits, and was deeper than the base of the main excavation. Small services for power and phone cabling were also noted around the site.

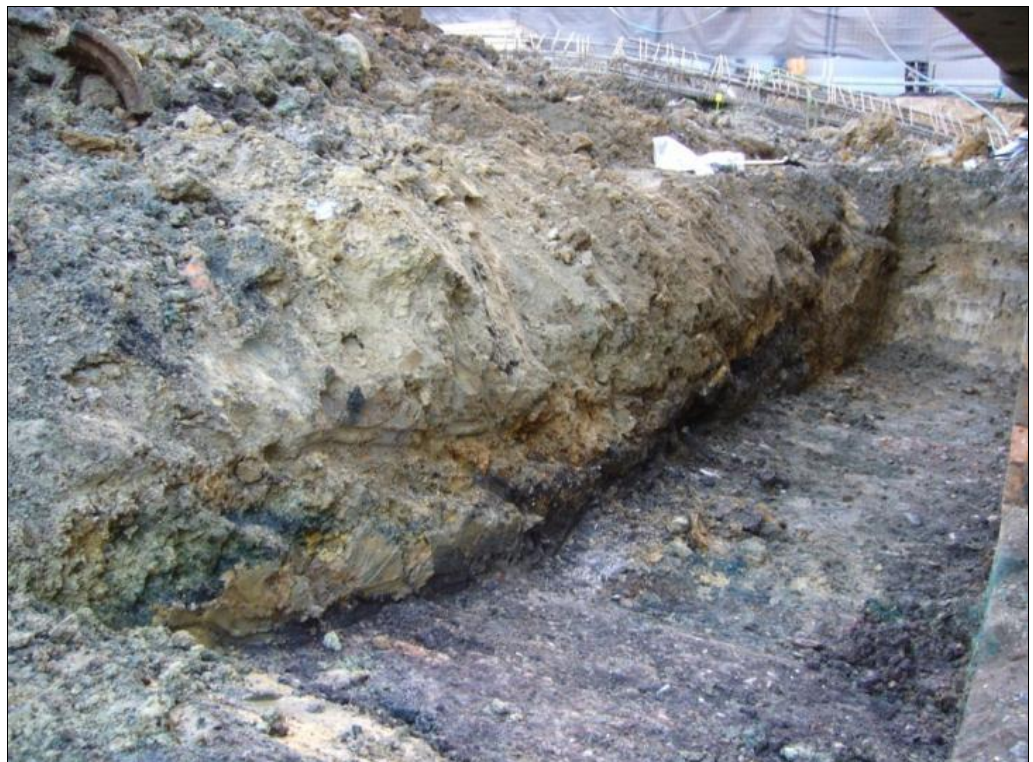
Figure 82. View facing south-west showing the profile of deposits within the smaller trench. Darker band is (671) with associated bottle dump

In the smaller trench located along the southwest wing of the Rob Roy Hotel (an extension of the footings trench 1, see Figure 74) several layers were observed that extended 1.5m deeper than the main excavation, and thus were located beneath the ‘Destructor’ deposits. The majority of the fill was composed of mixed yellow brown re-deposited silty clay (670) (Figure 81 and Figure 82). Below this was a thick lens of blackish-brown silty clay and iron slag, bricks and broken bottles (671). Some of the artefacts sampled from within this lens could be dated to earlier than 1900 but were mixed with 20th century material, and probably relate to rubbish being dumped to raise the ground surface at the rear of the hotel. At the base of the trench was friable green brown silty clay with some dispersed glass shards (672). The junction between this layer and the one above was heavily compacted at the corner of the building, indicating that this surface may have performed a particular function in the past.

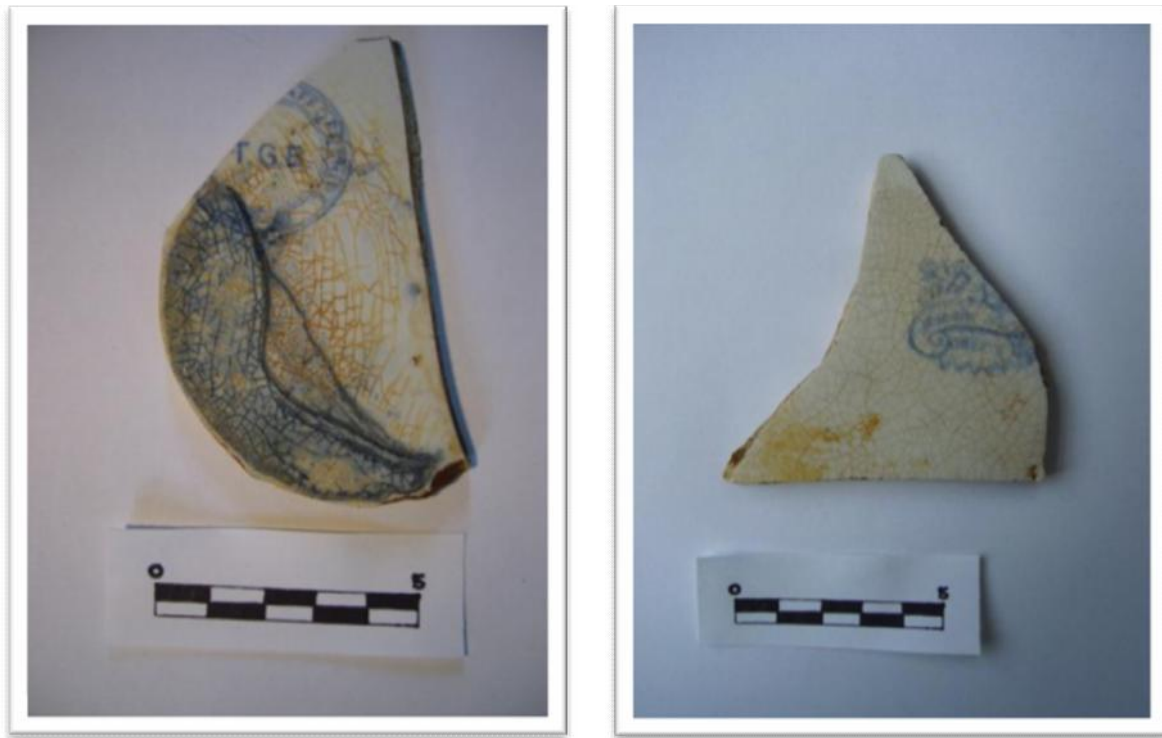
Figure 89. ‘TG Booth’ plate (left), and Old Hall Earthenware Co. Ltd plate (right)

In the smaller trench, a sample of ceramics derived from the rubbish dump within context 671 was examined. Sherds of earthenware plates and glazed serving dishes were represented. Two of the earthenware plate sherds had maker's marks on the underside. One of these was 'TGB' or 'TG Booth', made between 1876 and 1883 (Godden 1991: 86) (Figure 89). The other was an Old Hall Earthenware Co. Ltd plate, made between 1886 and 1902 (Godden 1991: 475). A single small clay pipe stem was also recovered, made by 'Davidsons' in Glasgow, and post dates 1862 (Walker 1983).
