Clough and Associates Monograph Series

NEW ZEALAND INTERNATIONAL CONVENTION CENTRE

Final Archaeological Report

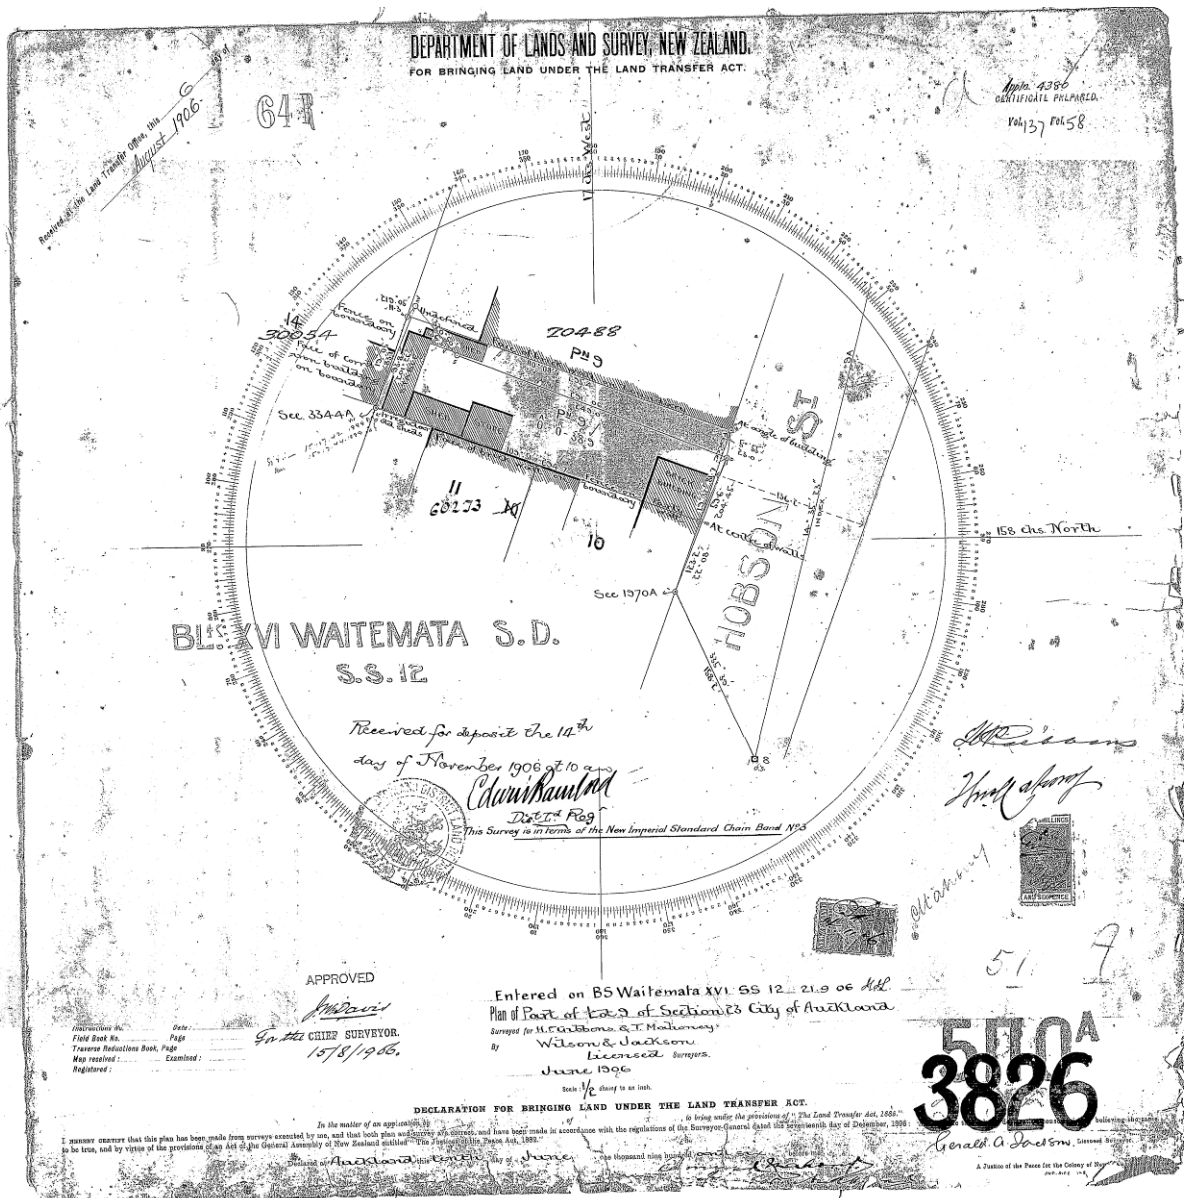
Figure 2.20. DP 3826, dated June 1906, showing buildings present on Pt Allotment 9, Section 23 (source: Quickmap)

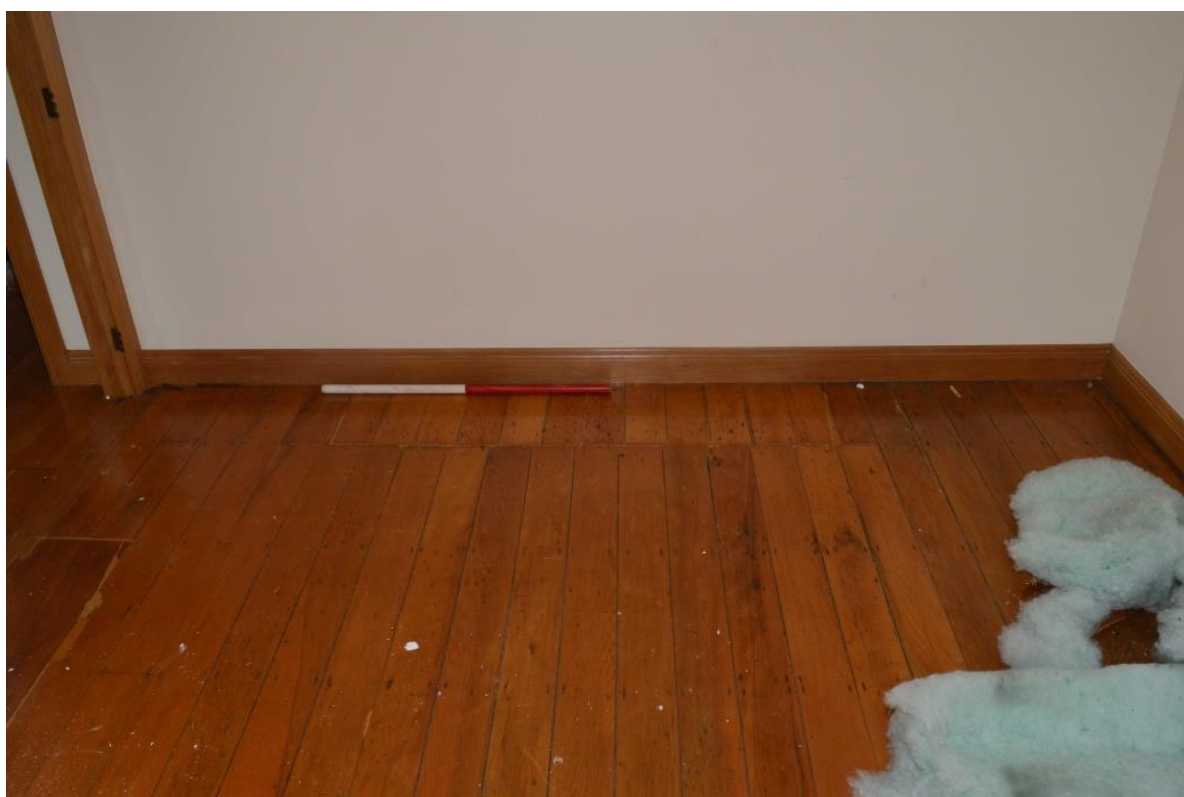
Figure 3.18. Removed double fireplace in north wall of F05 (source: Clough & Associates, 2015)

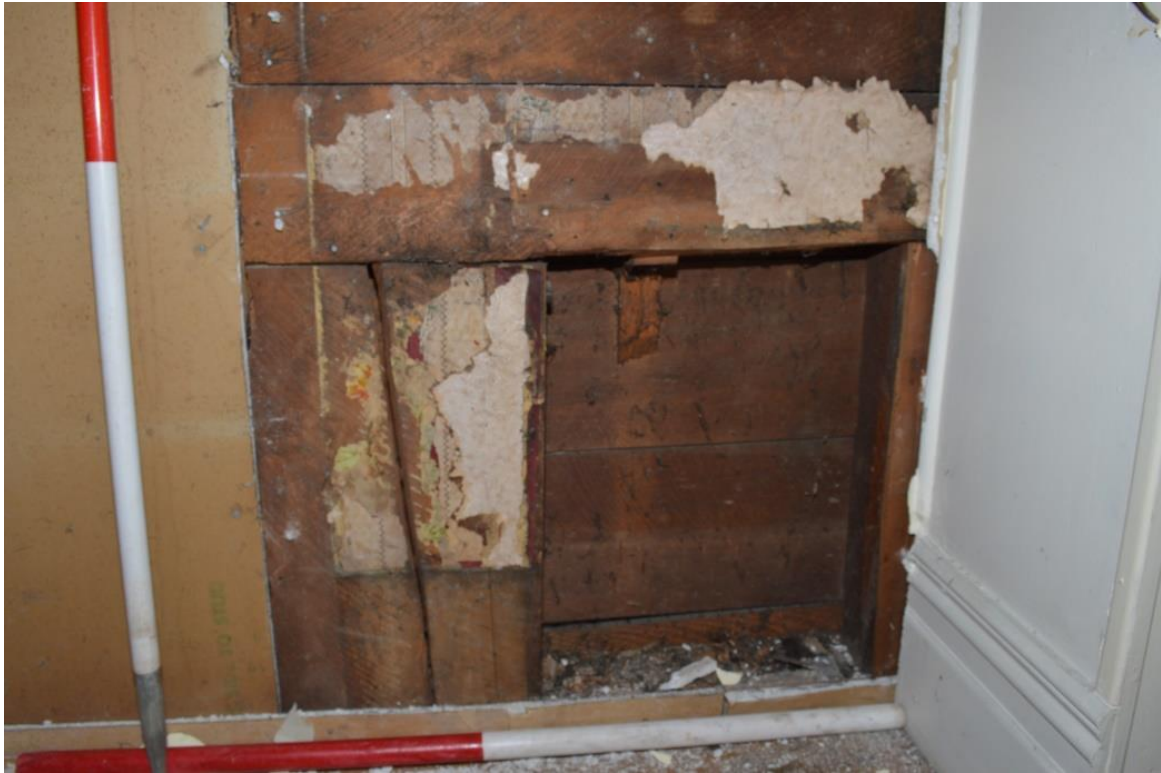
Figure 3.39. Degraded wallpaper layers in G02 and paint stain from blocked-up door architrave (source: Clough & Associates, 2015)

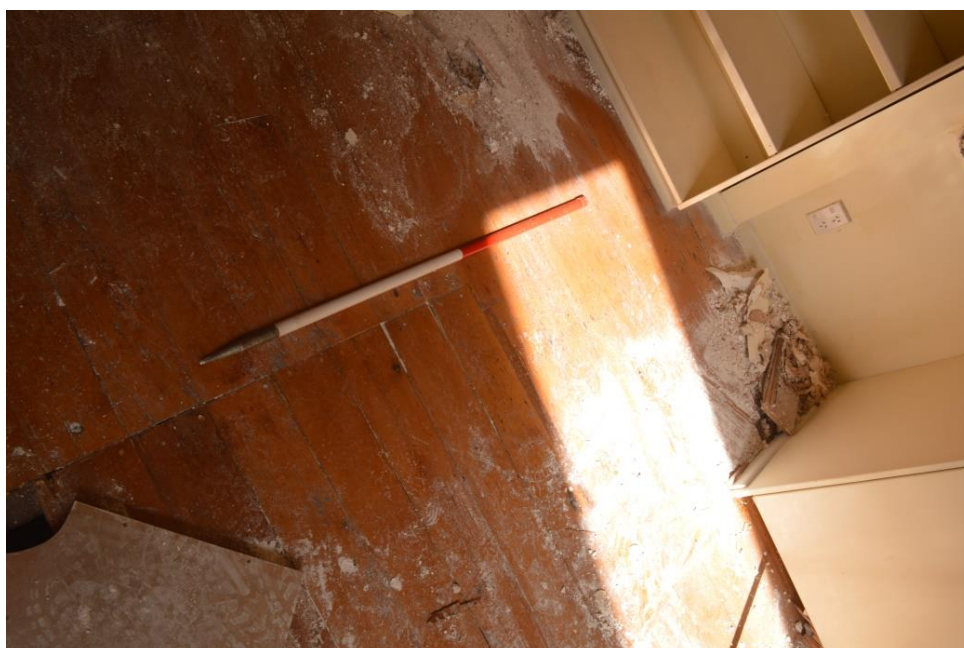
Figure 3.53. Photo showing abutted floorboards between G05a /Phase 1 and G05b /Phase 2 (source: Clough & Associates, 2015)

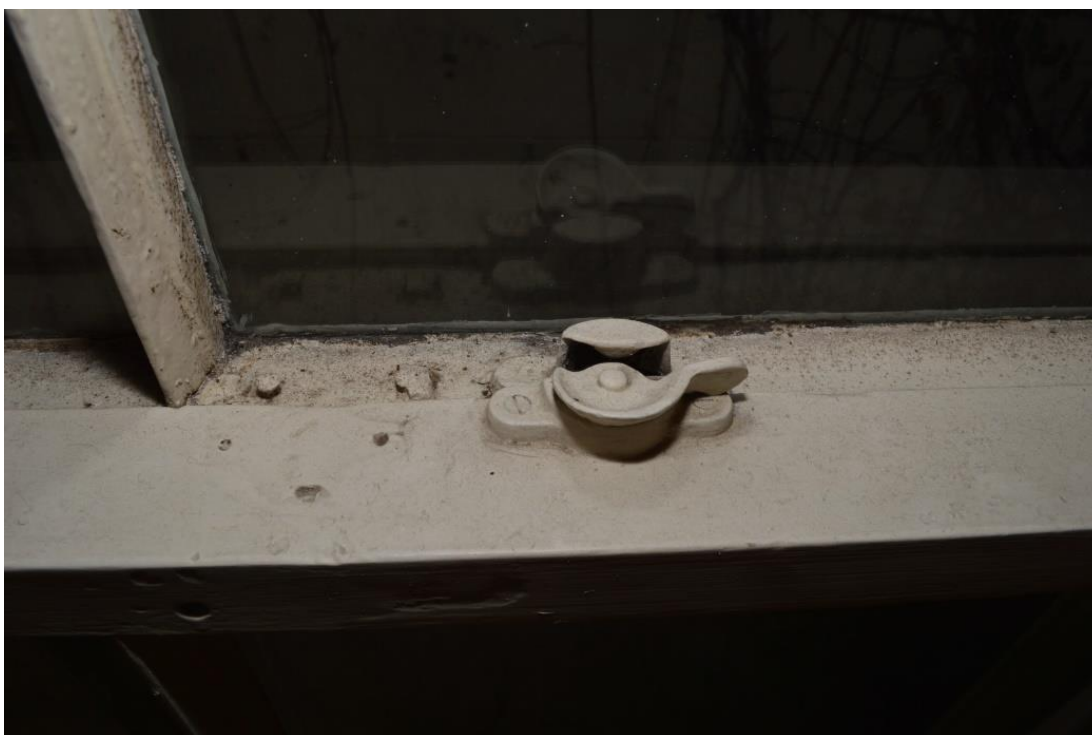
Figure 3.77. Replacement window fastener and scarring of original fastener in F03 (source: Clough & Associates, 2015)

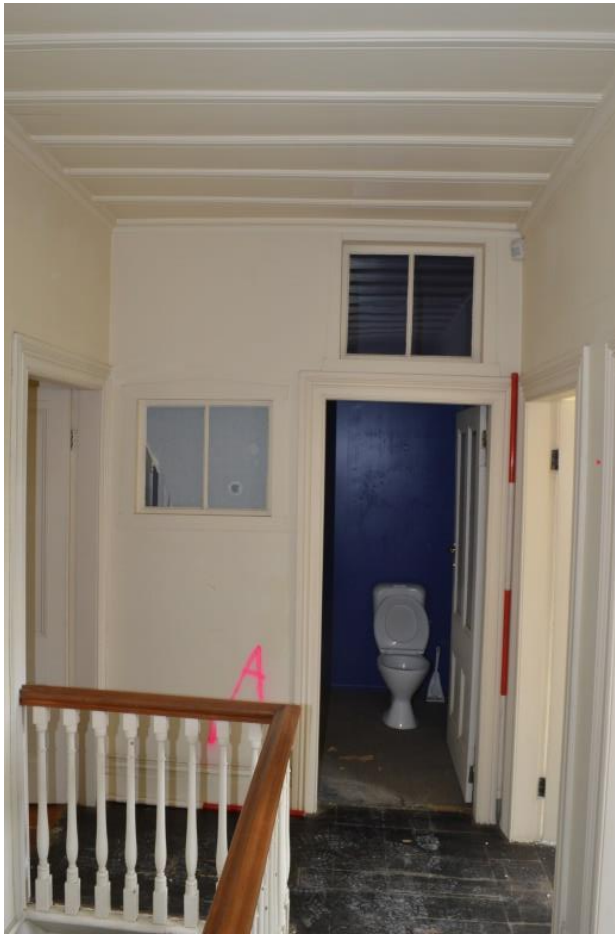
Figure 3.78. Inserted modern windows into F04
(source: Clough & Associates, 2015)

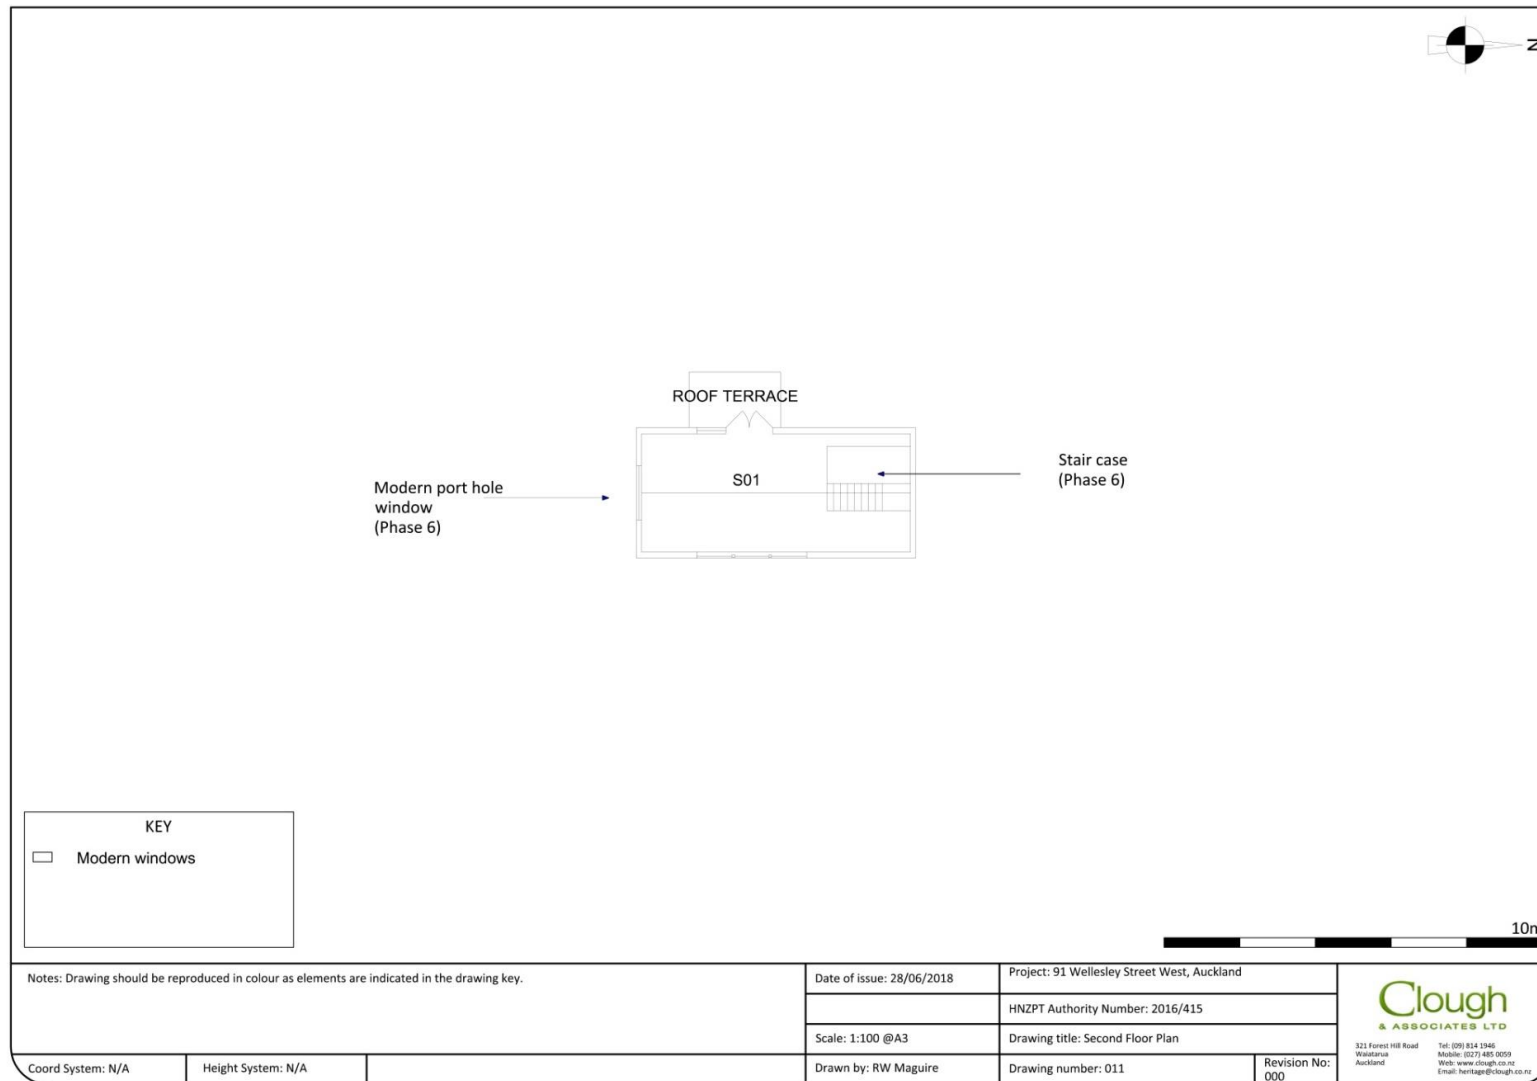
Figure 3.94. Plan of second floor of 91 Wellesley Street West (source: Clough & Associates, 2015)

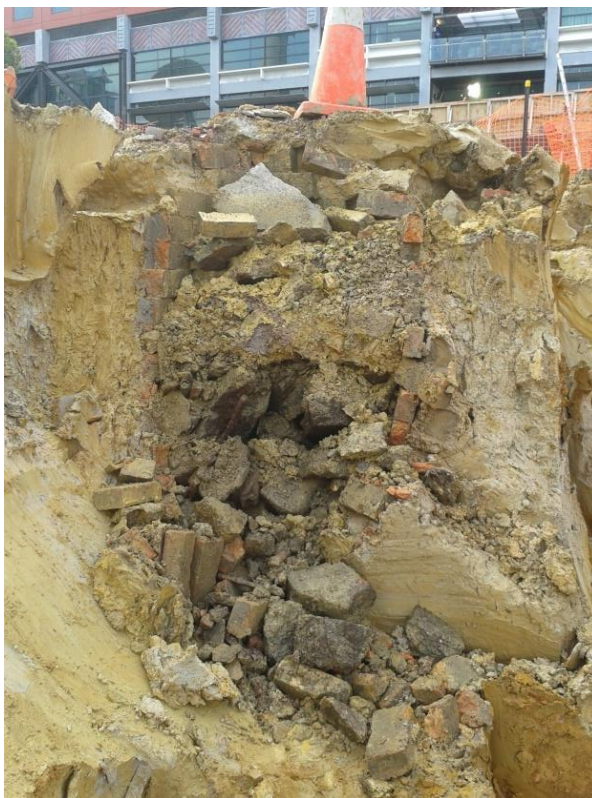
distinct layers. The upper 2m consisted of hard fill of brick, bluestone and scoria blocks, with some metal items including rebar and pipe. This appears to be consistent with an infilling event during the 1920s construction. The lower 2.8m consisted of a loose black silty matrix, with a moderate quantity of artefacts present. Excavation proceeded with the use of a mechanical excavator to scoop out the well contents and structure. The method was utilised primarily for safety reasons, but also time efficiency. Analysis of the artefacts indicated they were manufactured from the 1860s onwards. It is considered likely that the well was initially constructed in the 1860s for use of the house and stables, which dated from at least as early as 1866. The position of the well within the yard between the house and stables would seem ideal (Figure 4.1). Based on the fill layers it appears that the well was mostly left unfilled until the 1920s. It is noted that the well is not marked on plans from the 1860s, 1880s or 1908.

Figure 4.3. View showing well R11/3115 (Context 325), upper portion exposed in section

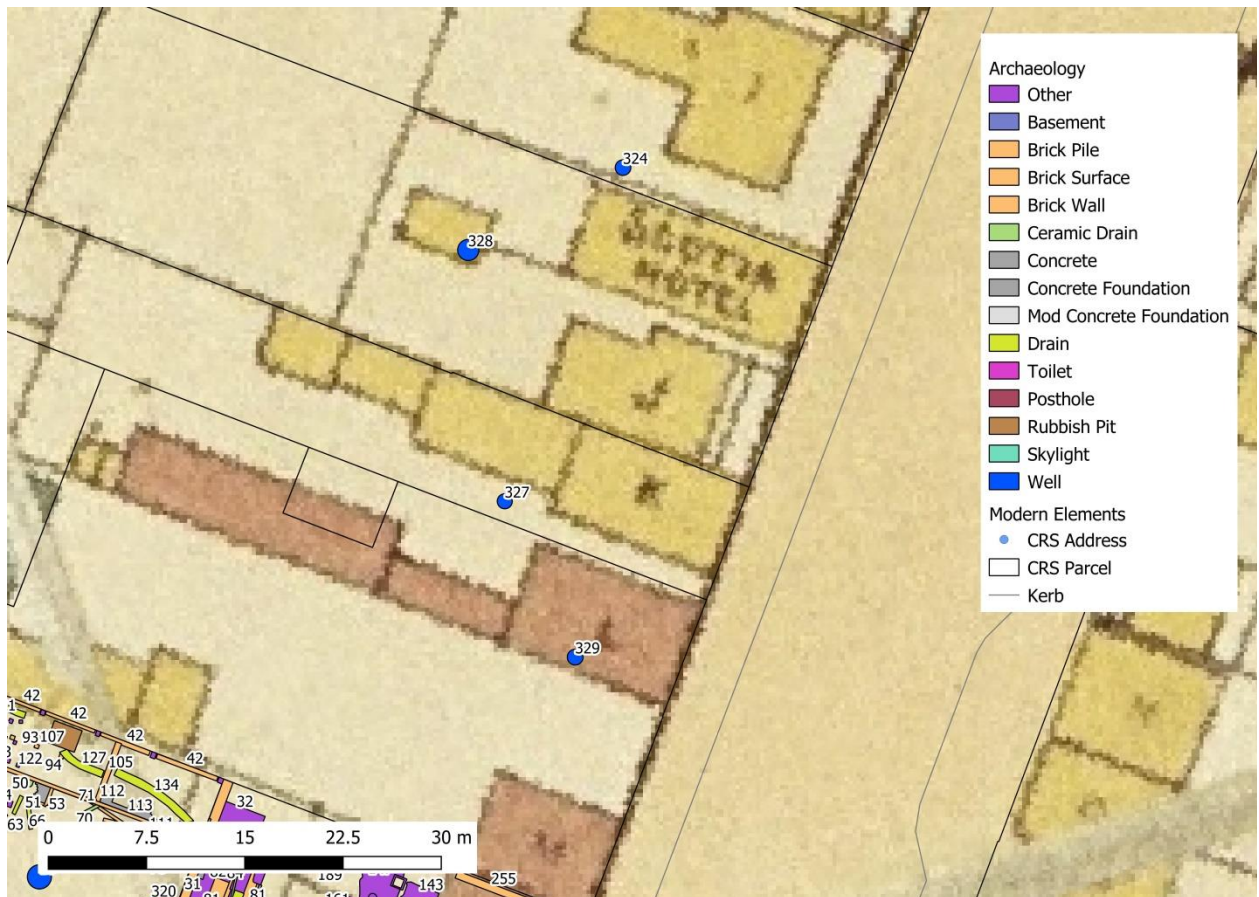
Figure 4.6. Plan showing archaeological features in relation to the 1882 Hickson plan of the area

The structure was unlined, being cut into the natural sandstone. There were some indications in the rock that possibly this lower part was originally brick lined but, if so, this appeared to have been removed, possibly during the 1990s development. The remaining structure measured 1.2m in diameter and was just 1.8m deep. The fill consisted of a loose dark greyish black silt with frequent gravels and artefacts. Excavation proceeded with the use of a mechanical excavator to scoop out the well contents and structure. The method was utilised primarily for safety reasons, but also time efficiency. Analysis of the artefacts indicated they were manufactured from the 1840s onwards, but that the period of deposition was likely to have been between the late 1880s or 1890s and 1910. It is possible that the well was initially constructed for use by the bakery, which began in 1863. The well was situated so that it would have been positioned within the bakery building fronting the street, which stood from 1863 well into the 20th century (see Figure 4.6).

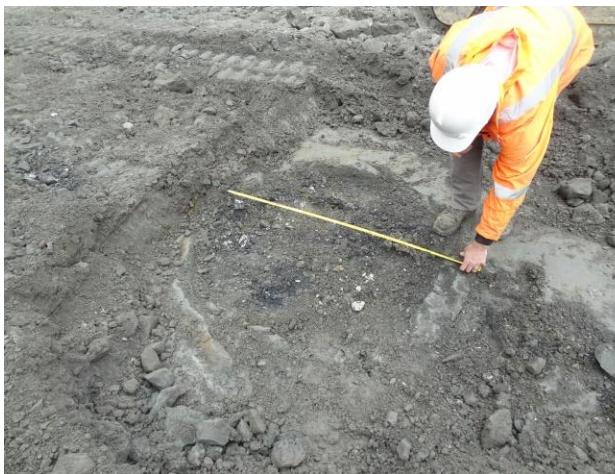
Figure 4.12. View showing well R11/3118 after exposure

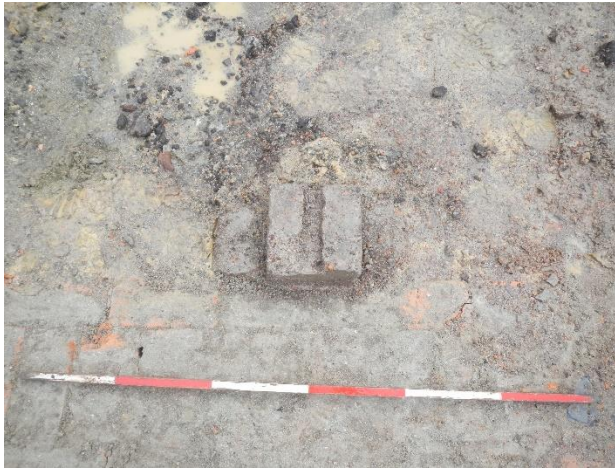
Figure 4.19. View showing concrete pile adjacent to part wall foundation

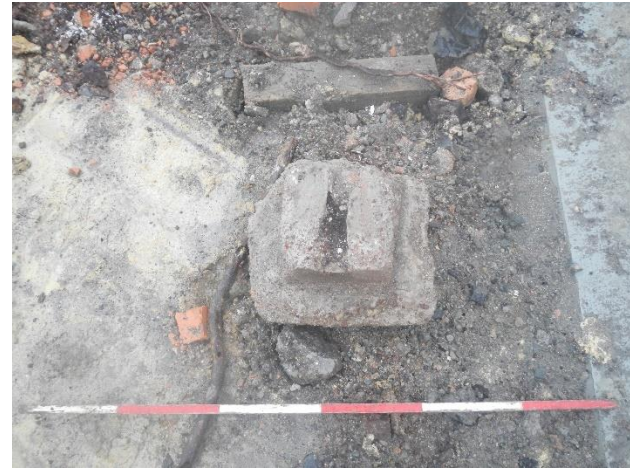
Figure 4.20. View showing concrete pile following removal from the construction cut

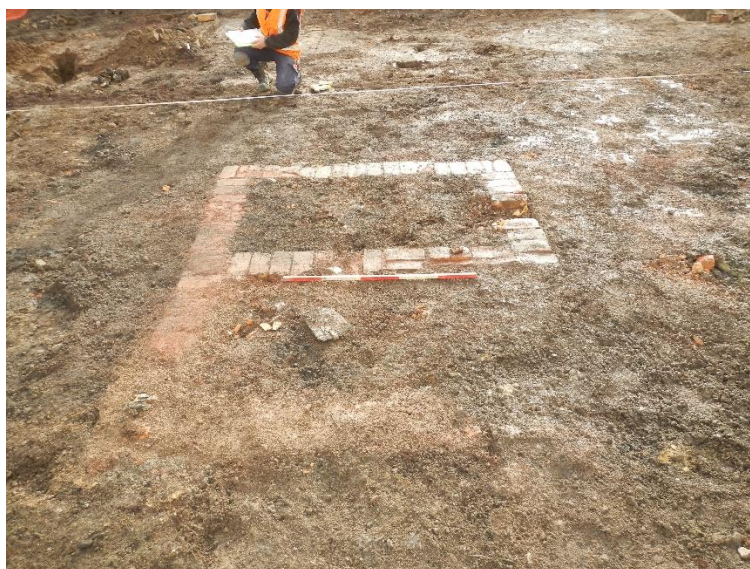
Figure 4.21. View showing Context 158 (brick structure)

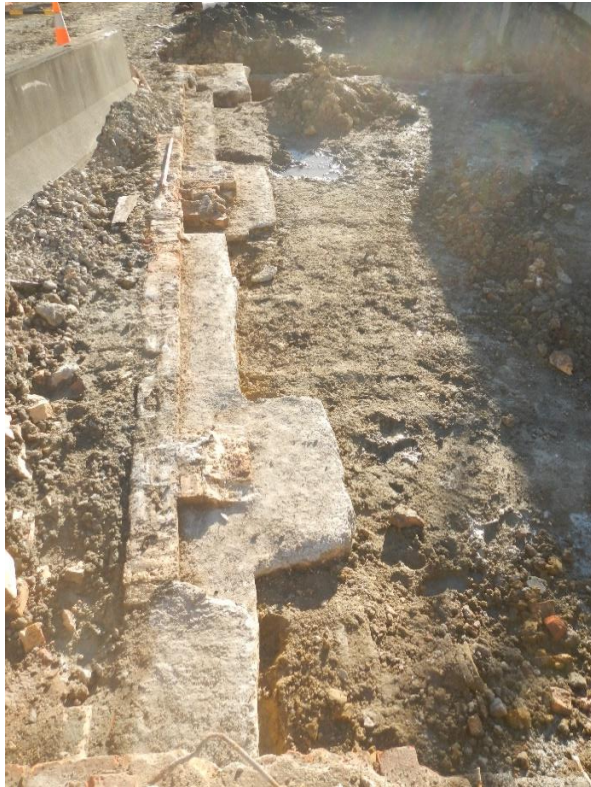
Figure 4.50. View facing west showing Contexts 111 (foundation), and 113, 114, and 115 (brick piles)

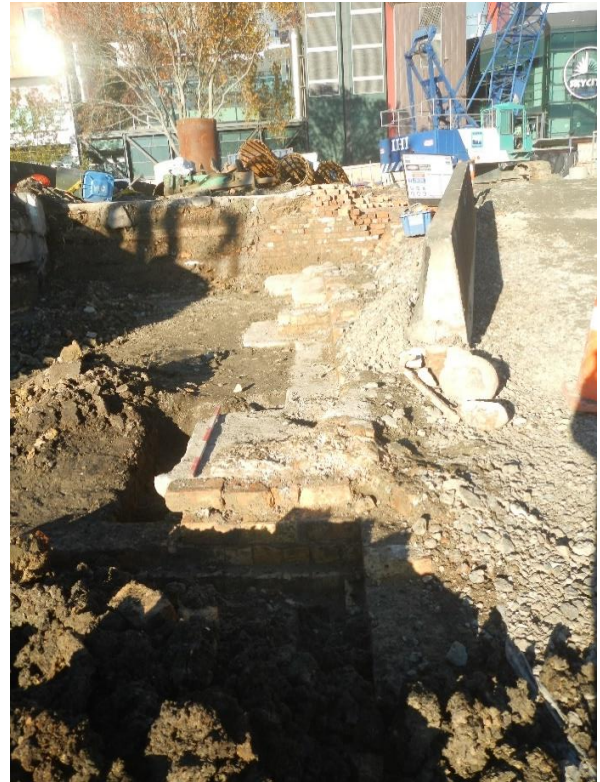
Figure 4.51. View facing east showing Contexts 111, 113, 114, and 115

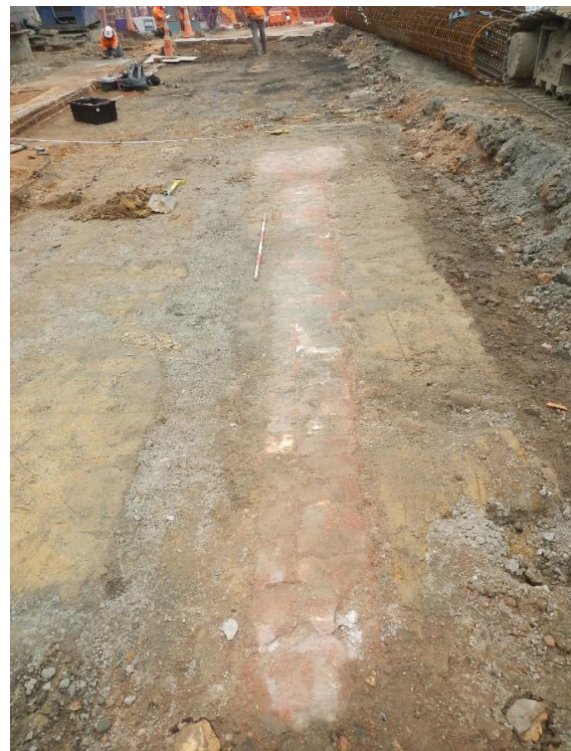
Figure 4.53. View facing west showing foundation wall, Context 200

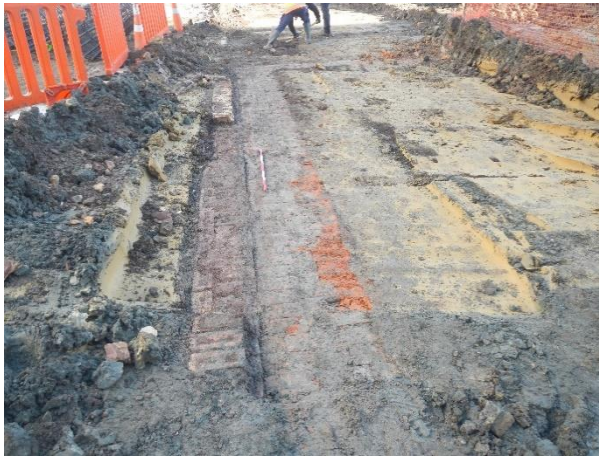
Figure 4.54. View facing west showing wall Context 203 (left) built hard against wall Context 280

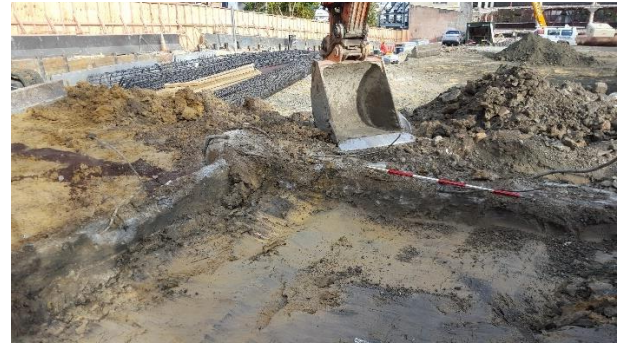
Figure 4.61. View showing foundation walls, Contexts 16, 17, 18 and Pile, Context 19

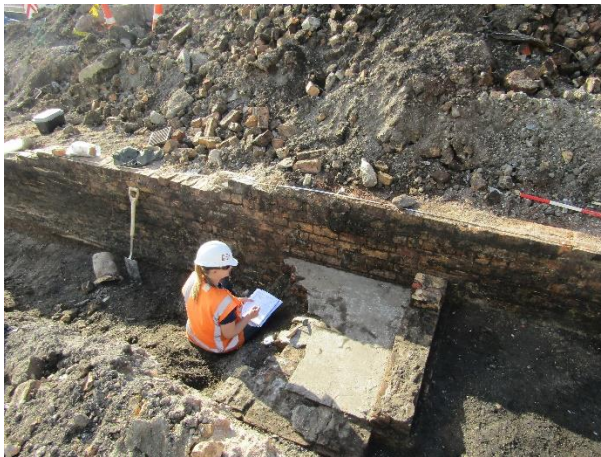
Figure 4.63. View showing brick surface and foundations, Contexts 51, 52, and 53, during recording, adjacent to wall Context 42

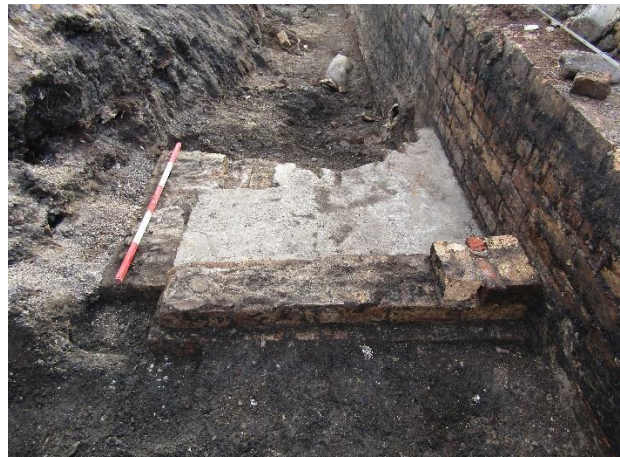
Figure 4.64. View showing Contexts 50, 51, 52, and 53
