FORESHOCK – AFTERSHOCK: THE ARCHAEOLOGY OF CHEWS LANE, WELLINGTON

Final Report in Fulfilment of
NZHPT Authority No. 2007/71

Prepared for
Willis Street Holdings Ltd

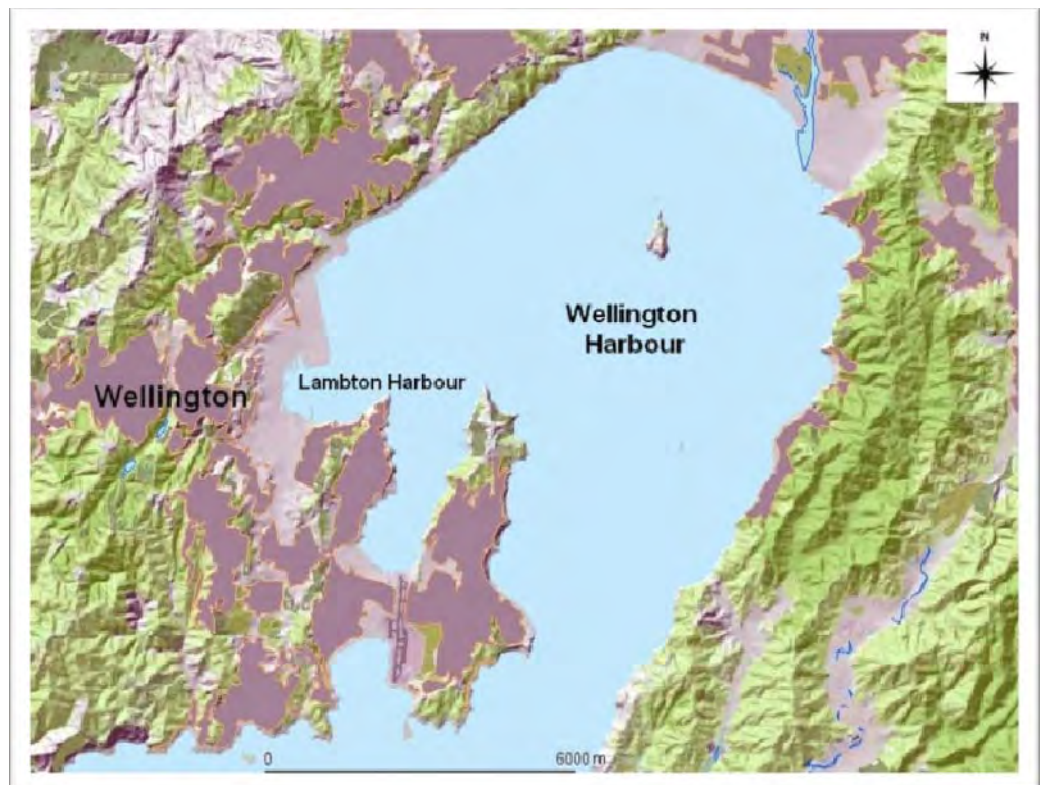
Figure 3.
Wellington and its geographic setting. The Wairarapa Fault is located off the picture to the right

In 1855, a magnitude 8+ earthquake shook Wellington (Grapes and Downes, 1997), which was then a small town on the southwest shore of Wellington Harbour (Figure 3). It was the second very large earthquake to strike Wellington since the town was founded in 1840, the first being the 1848 Marlborough Earthquake. Both earthquakes severely shook the region, causing severe damage.

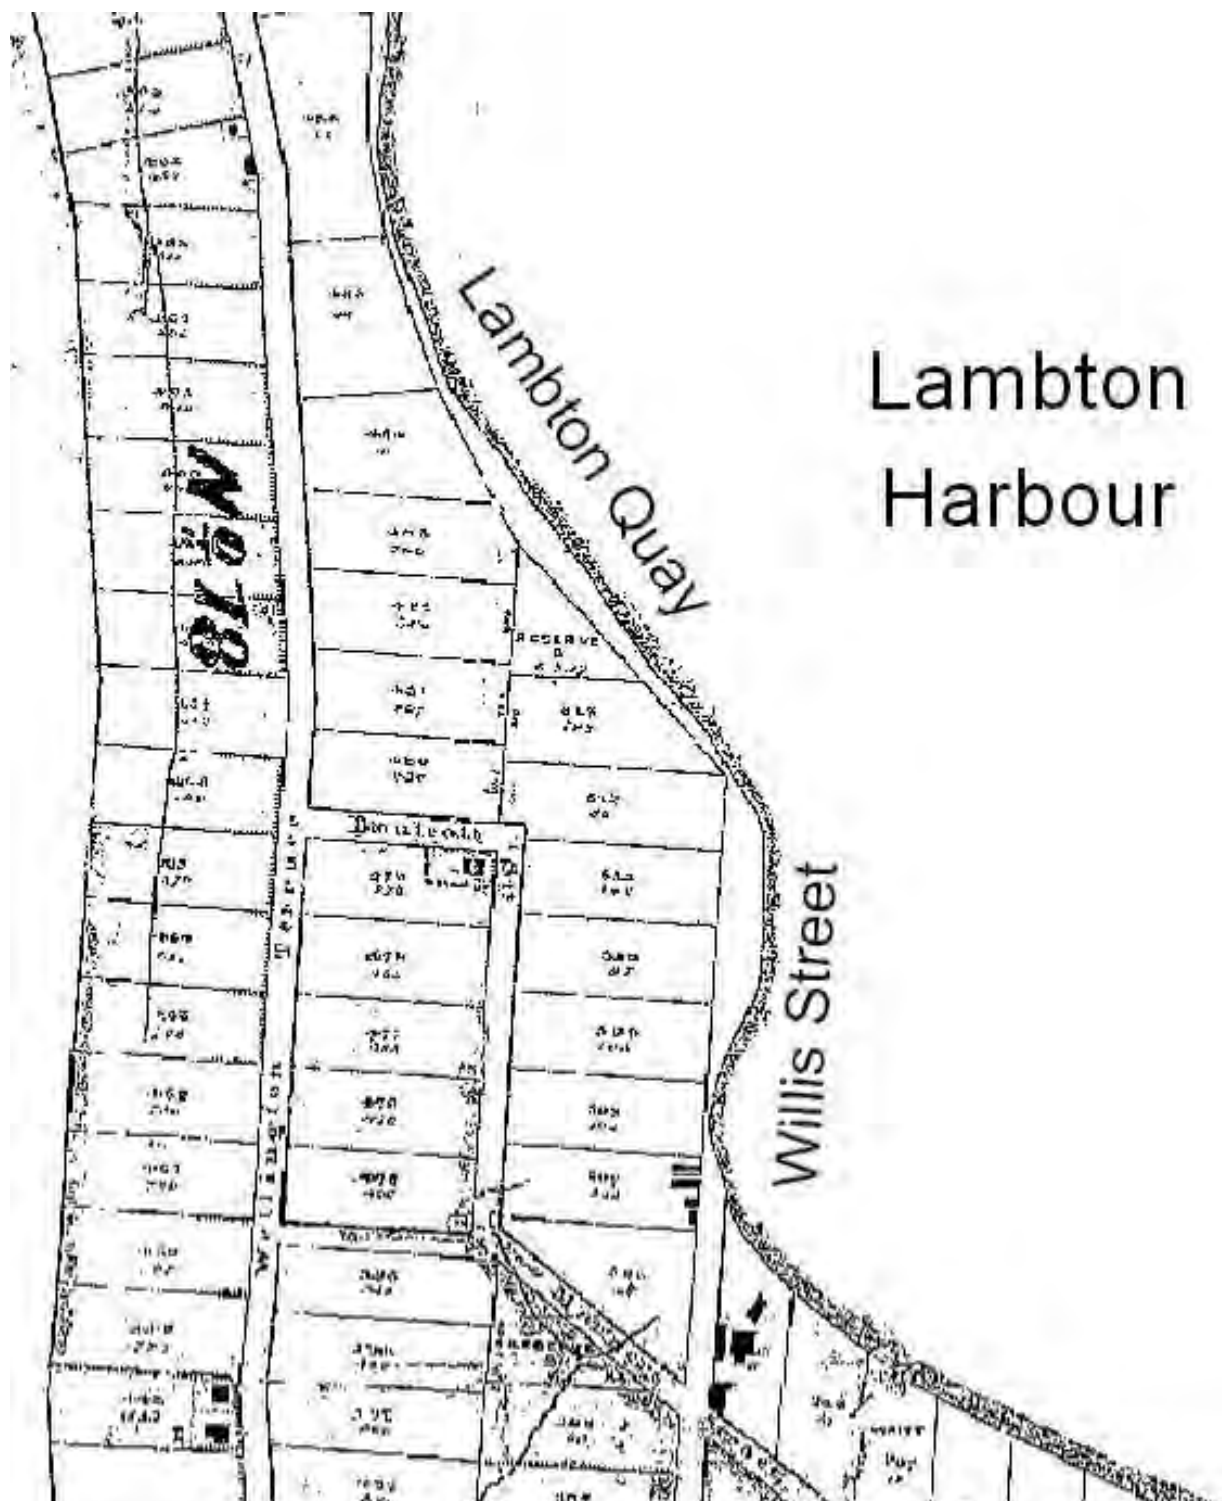
Figure 5. The shoreline along Lambton Quay and Willis Street before the 1855 earthquake (SO10569)

Before the earthquake, Wellington's foreshore ran south along Lambton Quay, and then along Willis Street (Figure 4, Figure 5, Figure 7). The first reclamation, "Sir George Grey's reclamation" (Baillie, 1924), was in 1852, along Willis Street south of what today is Chews Lane (Figure 6, Figure 8). Between 1857 and 1863, the land north of Chews Lane was reclaimed and became known as "Carter's reclamation" (Figure 6, Figure 8) (Baillie, 1924). In 1886, the harbour seaward of these two reclamations was filled in to the east of Victoria Street (Figure 6, Figure 9) (Wellington Harbour Board, 1936). The reclamations subsequently became part of the thriving commercial and business district of Wellington.

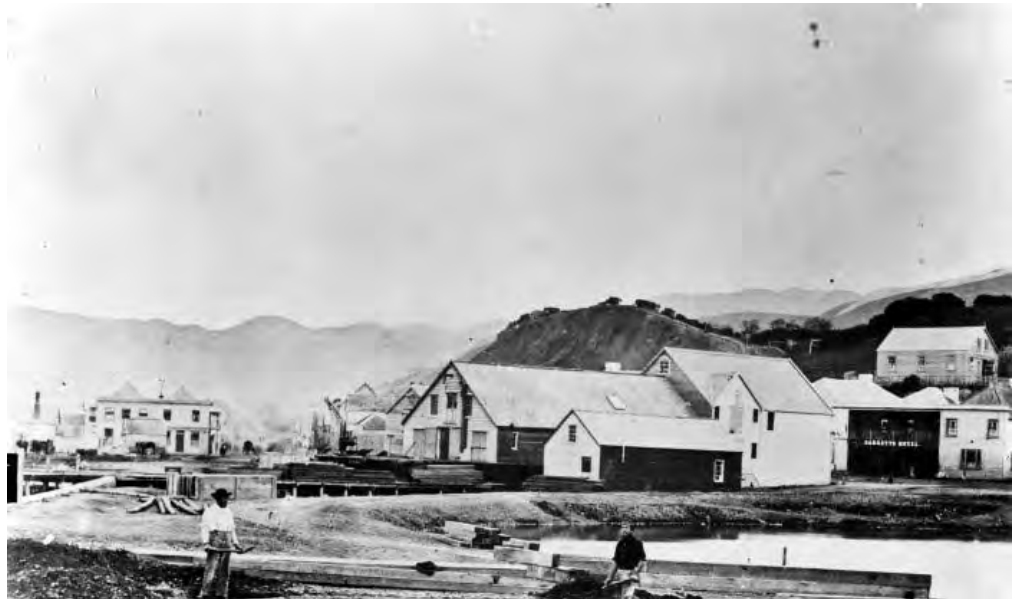
Figure 10. Area of Willis St in 1860s after 1857-63 reclamation. Empire Hotel on left (Alexander Turnbull Library 8506½)

Before redevelopment, the earliest of the 10 buildings in the Chews Lane precinct dated back to the 1890s (and in one case the mid 1880s), although with later modifications. The buildings at 37-43 Willis St were built before 1891, 29-33 Willis St in 1898, 55 Willis St possibly in 1896, and 58-60 Victoria St probably sometime in the 1890s, while the rest were of 20th century date (Bowman n.d.). However most of the properties had been in private ownership since 1852-3 (45-53 and 55 Willis St, in the Sir George Grey reclamation) or 1862-4 (the remaining Willis St properties created by the Carter reclamation). The properties along Victoria St would have been developed after 1886, when that area was reclaimed. There would therefore have been a variety of activities and businesses prior to the construction of the 10 buildings within the precinct, particularly along the Willis St side. Initially, most if not all of the buildings would have been constructed of timber (Figure 10, Figure 11).

One of the longest-lasting businesses in the area was the Empire Hotel, to the north of Chews Lane near the Lambton Quay intersection. This opened in 1865, replacing the former Swinburne's Packet Hotel and was rebuilt after being gutted by fire in 1876. It remained as a hotel until 1955 when it was converted to offices. The building was demolished in 1973 (Lawlor 1974: 38-9). The early timber hotel is shown in Figure 10 and Figure 11.

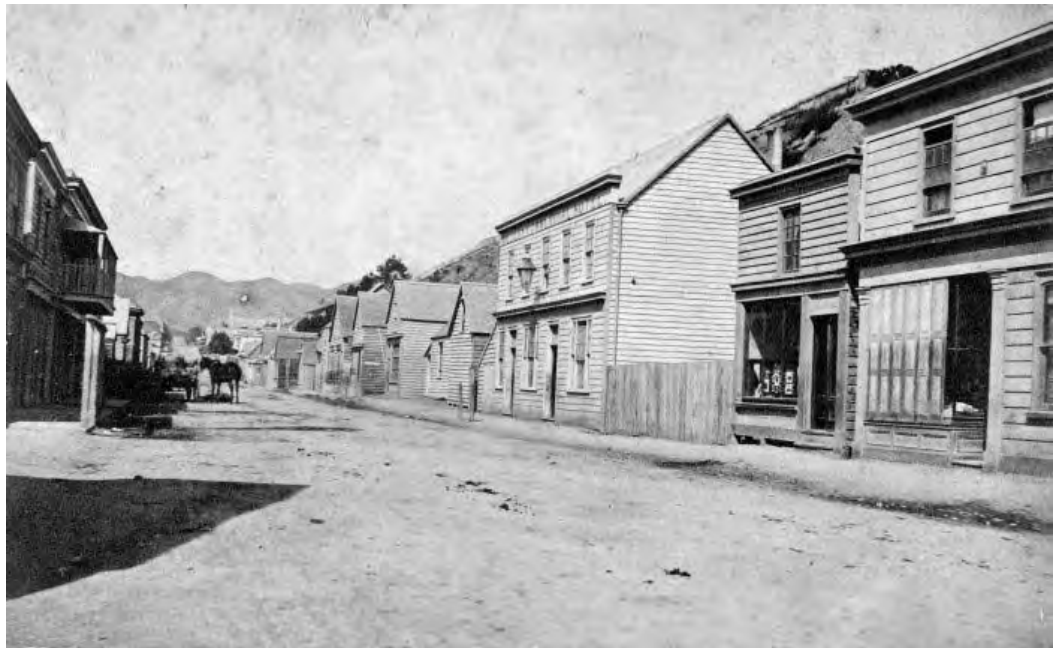
Figure 11. Buildings along Willis St 1860s. Empire Hotel on left, with balcony, Commercial Hotel opposite (Alexander Turnbull Library F31084½)

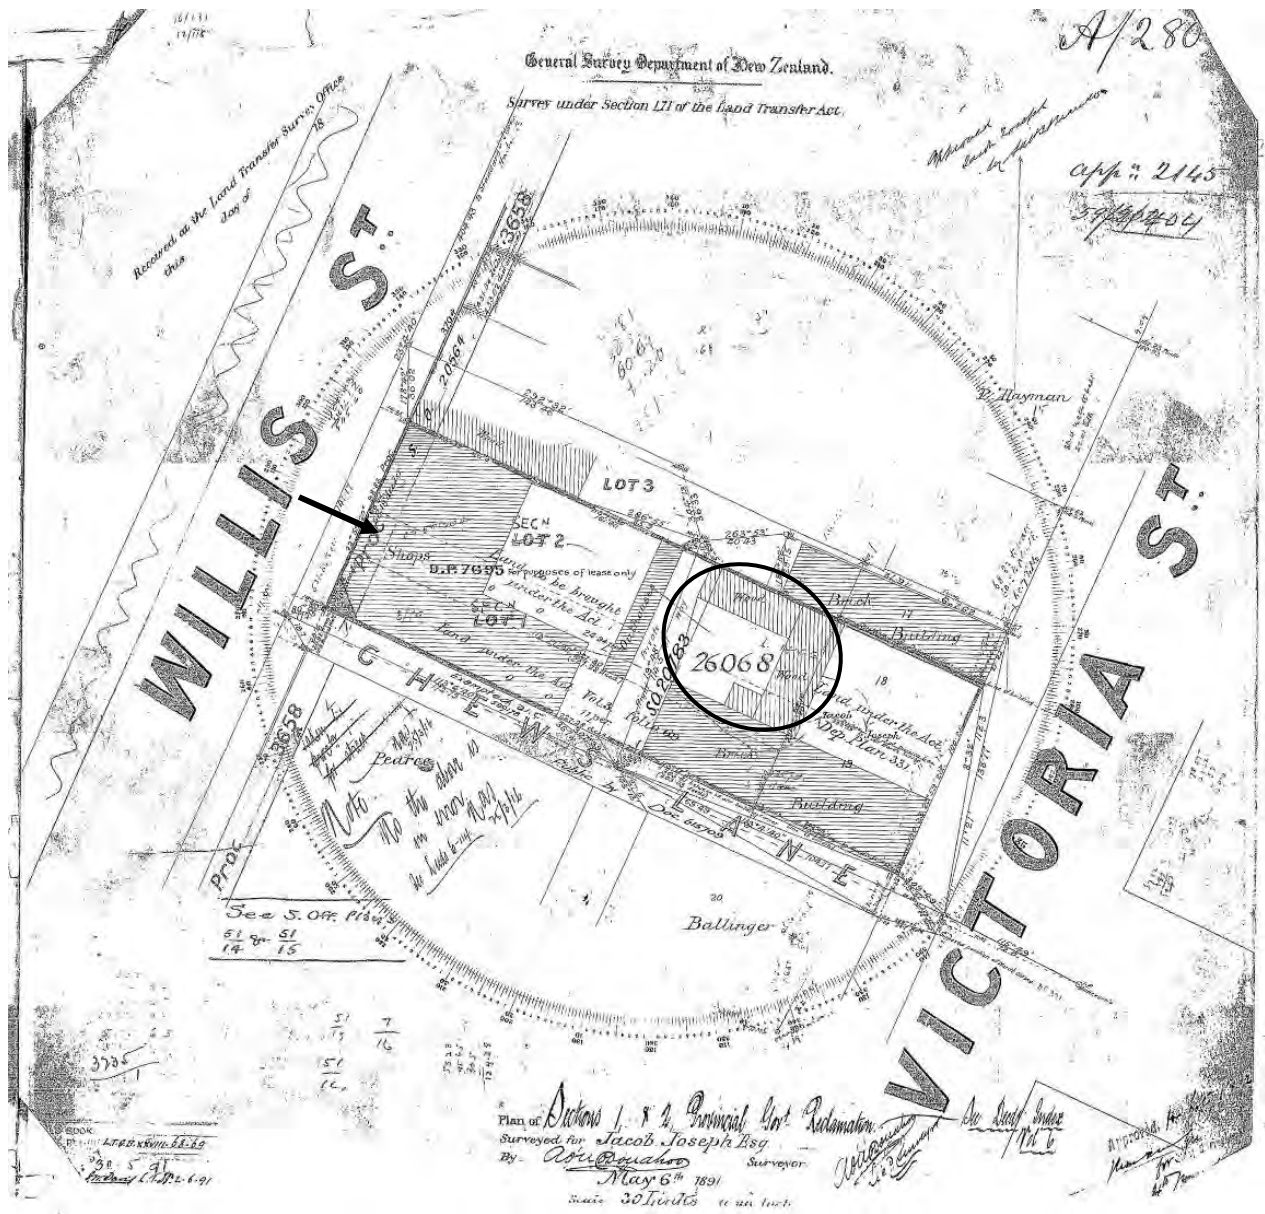
Figure 13. 1891 plan showing brick buildings on northern side of Chews Lane, within the area investigated (A280). The plan identifies shops (arrowed) on the Willis Street frontage. To the rear of the eastern brick buildings are wooden structures (circled)

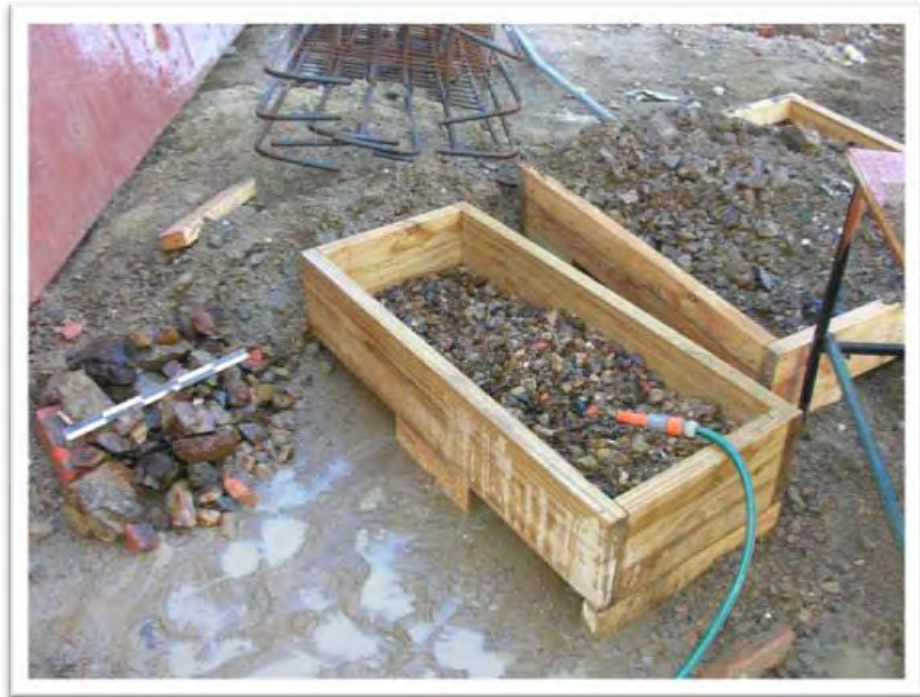
Figure 18. Sieves used for Chews Lane material

Sieving was carried out by dumping a bucket load of spoil from the trench digger into specially made sieves. The sieves comprised a piece of flat steel with round holes 7mm in diameter and a density of 41 per 100cm², either fixed to a bottomless wooden box about 30cm high (Figure 18), or placed on the steel frame of a table. Fines were then washed out with a hose and items remaining were picked out by hand. This resulted in the recovery of items as small as sewing pins.

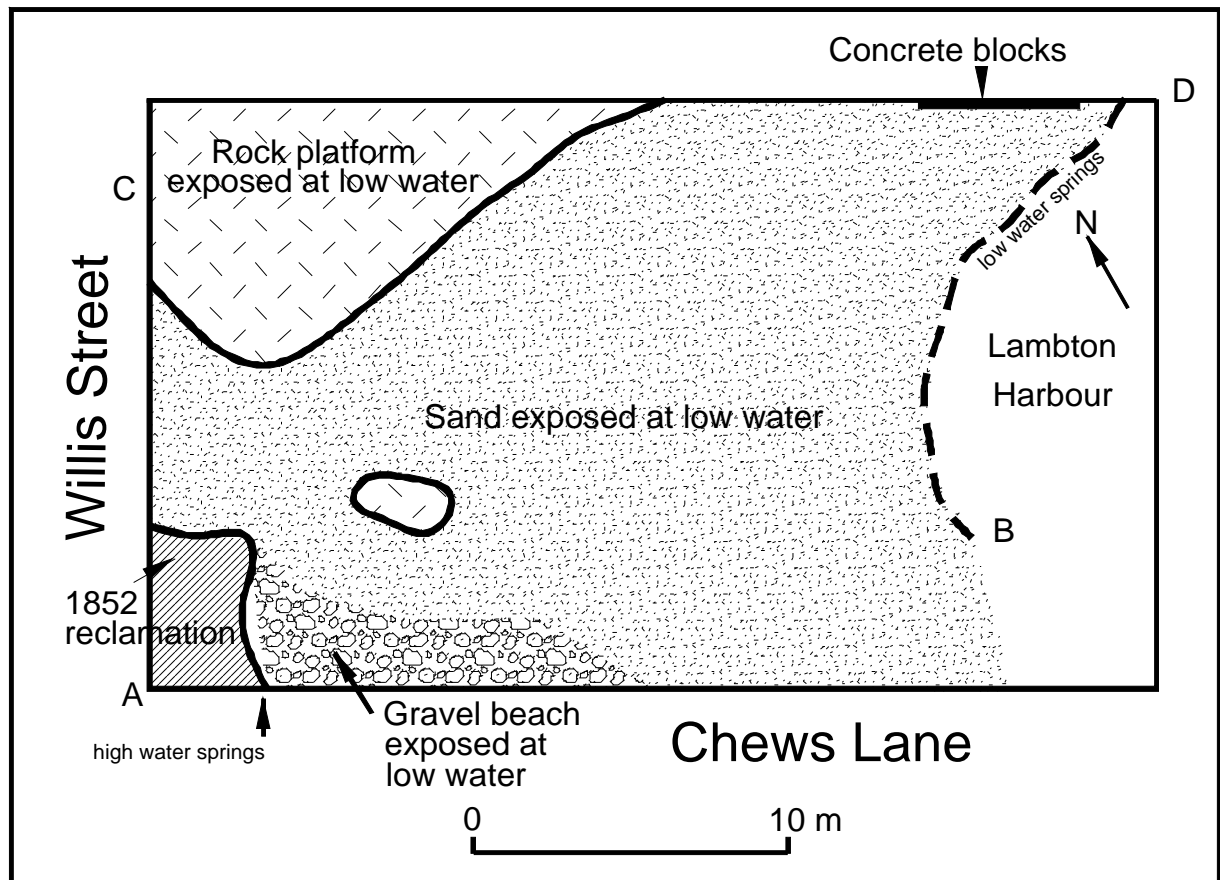
Figure 19. The western end of the construction site before the 1855 earthquake uplift, inferred from the stratigraphy exposed in the foundation trenches and pile holes

The tidal range for spring tides in Wellington is 1.32m (<http://www.linz.govt.nz/>). Tide levels adopted here for high water springs and low water springs, are +0.7m and -0.7m respectively. Although a record was made of the stratigraphy in many of the trenches, much of the stratigraphy was repetitive, and the detail consisted almost entirely of layers and lenses of reclamation fill, or disturbance of the upper layers of the reclamation from the excavation of foundations of later buildings. Across the middle of the construction site a substation had been built; this, and other recent excavations, effectively precluded a detailed stratigraphic link between the western and eastern parts of the site. With one exception – concrete blocks (interpreted as possibly the remains of a jetty) – there were no identifiable cultural remains older than the 1857-1863 reclamation found on the eastern part of the site, and the stratigraphic age of the concrete blocks depends on other criteria. Furthermore, apart from the inferred jetty, the eastern part of the site underneath the 1857-1863 reclamation is below present sea level, and it would have been even further below sea level before the 1855 earthquake. The stratigraphy is therefore represented by generalised sections across the western half of the site. Trench stratigraphy and the heights of features in relation to sea level allowed the topographic context of the site to be reconstructed before and after the 1855 earthquake, and this is shown by two plans (Figure 19 and Figure 22, below).

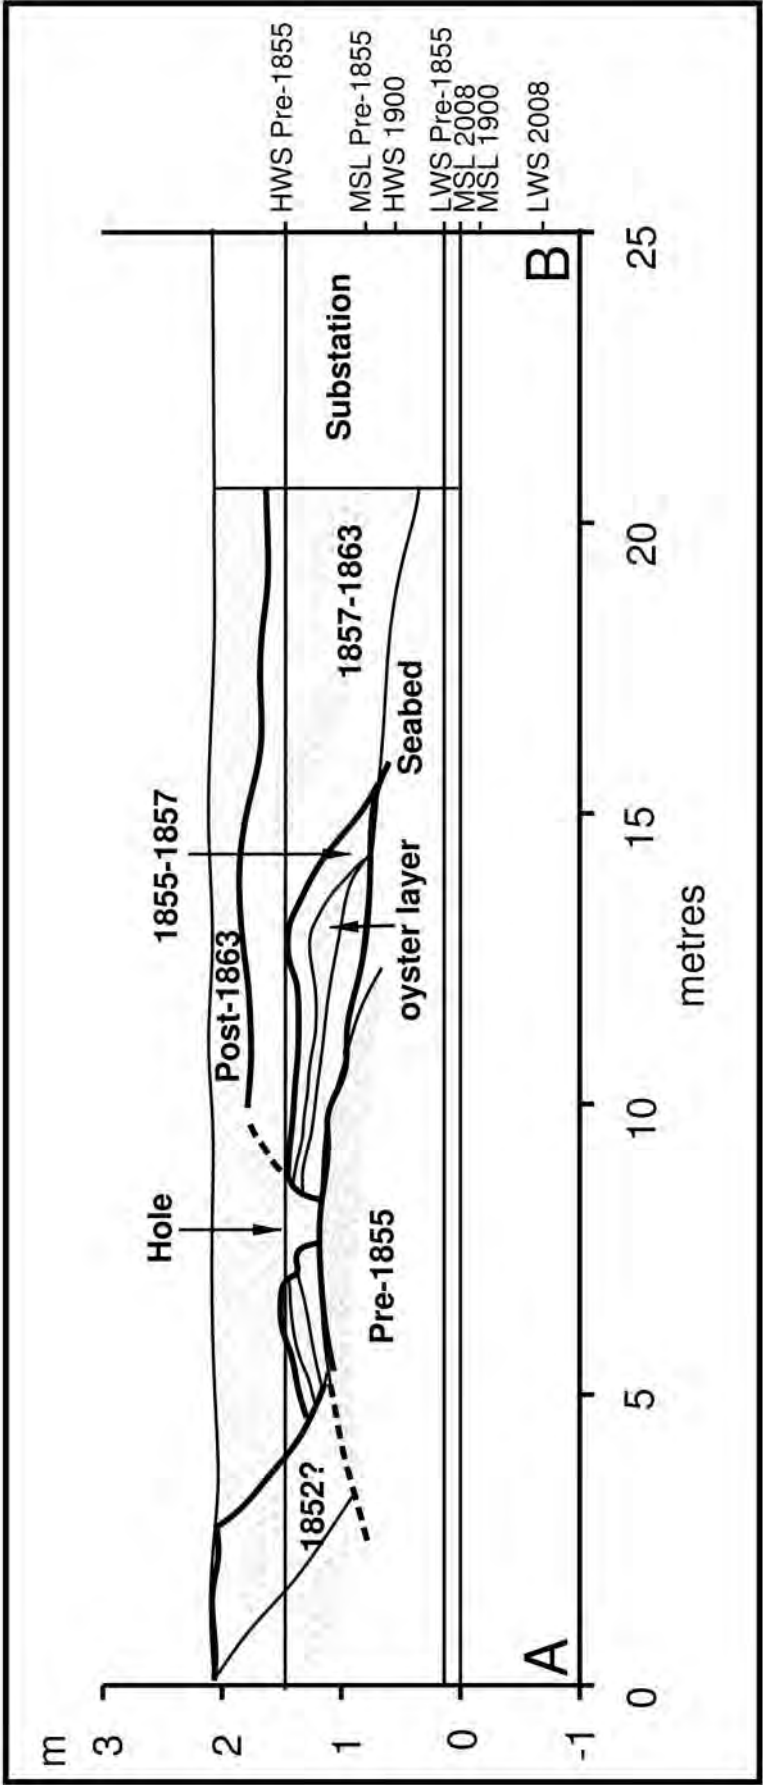
Figure 20. Generalised stratigraphy along line A-B, Figure 19. Stratigraphy indicated by light lines, boundaries of stratigraphic divisions indicated by heavy lines

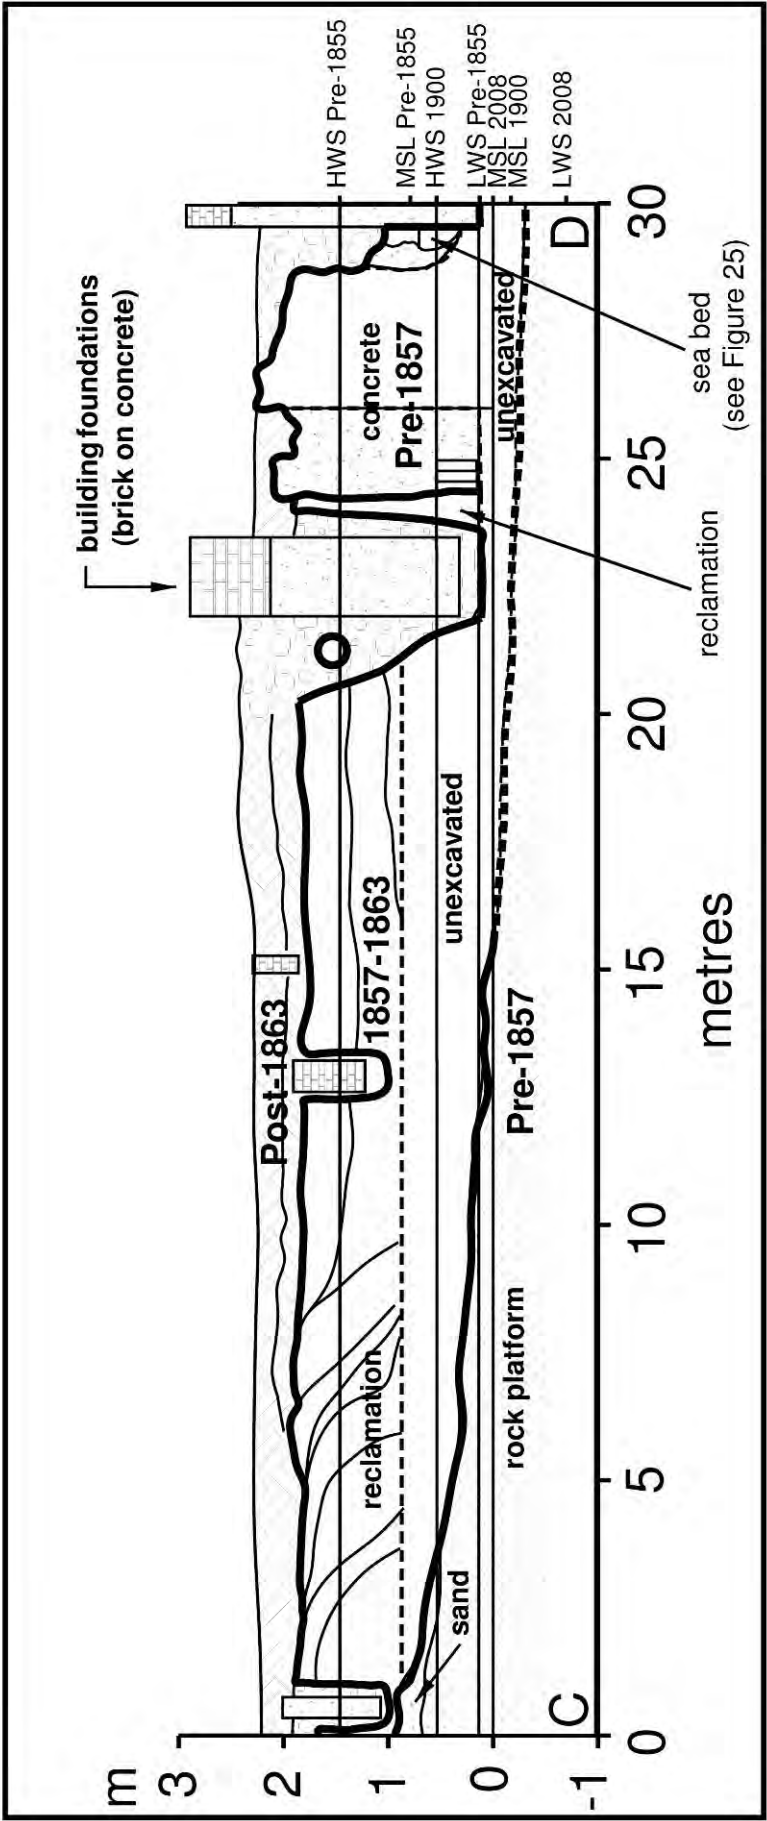
Figure 21. Generalised stratigraphy along line C-D, Figure 19. Stratigraphy indicated by light lines, boundaries of stratigraphic divisions indicated by heavy lines

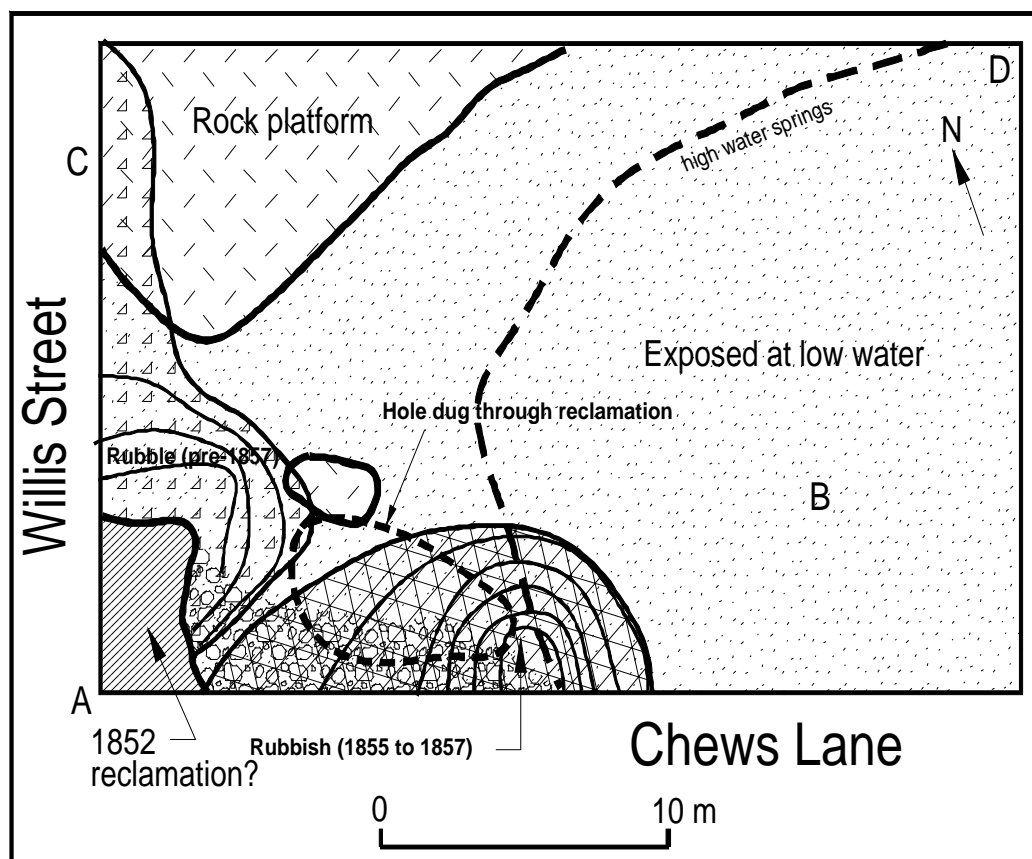
Figure 22. The western end of the construction site after the 1855 earthquake uplift, inferred from the stratigraphy exposed in the foundation trenches and pile holes

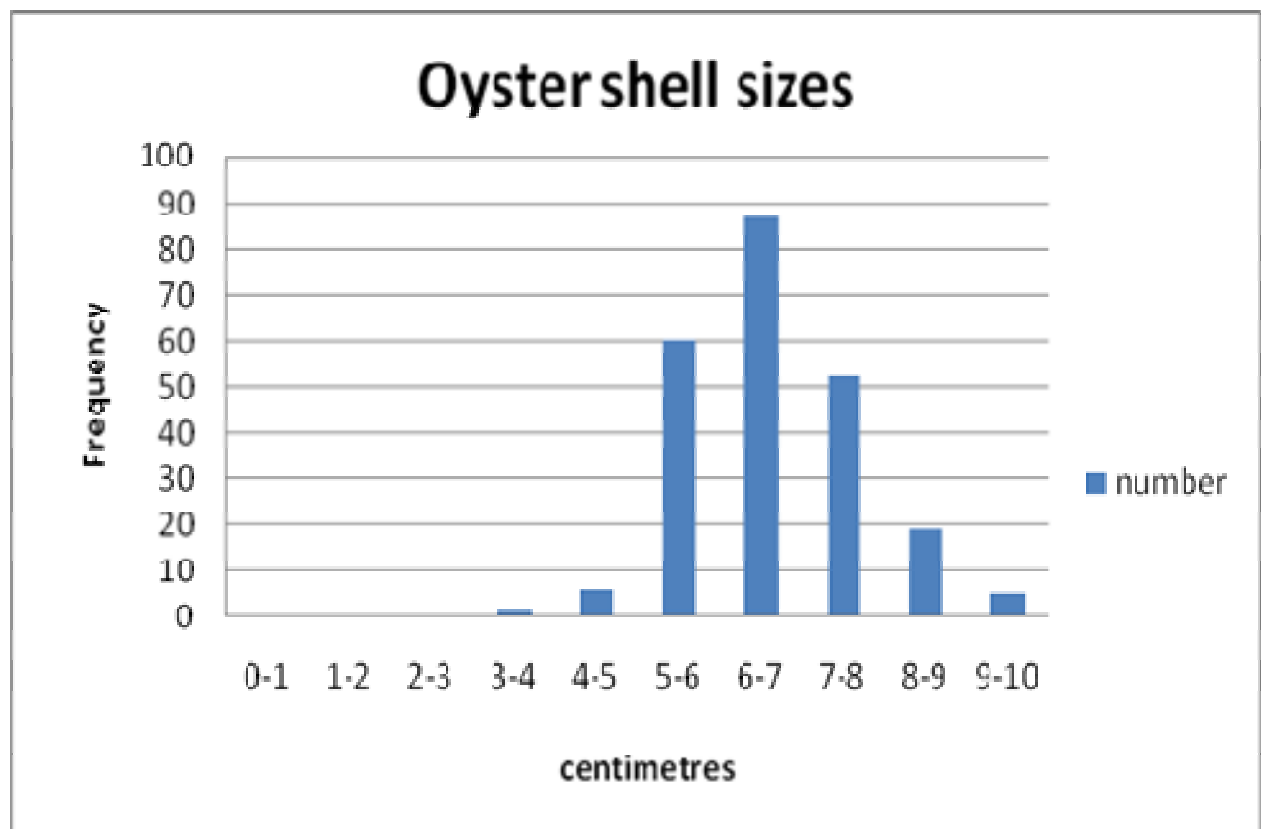
Figure 23. Histogram of the length of oyster shells (*Ostrea chilensis*) found on the post-1855 uplift beach

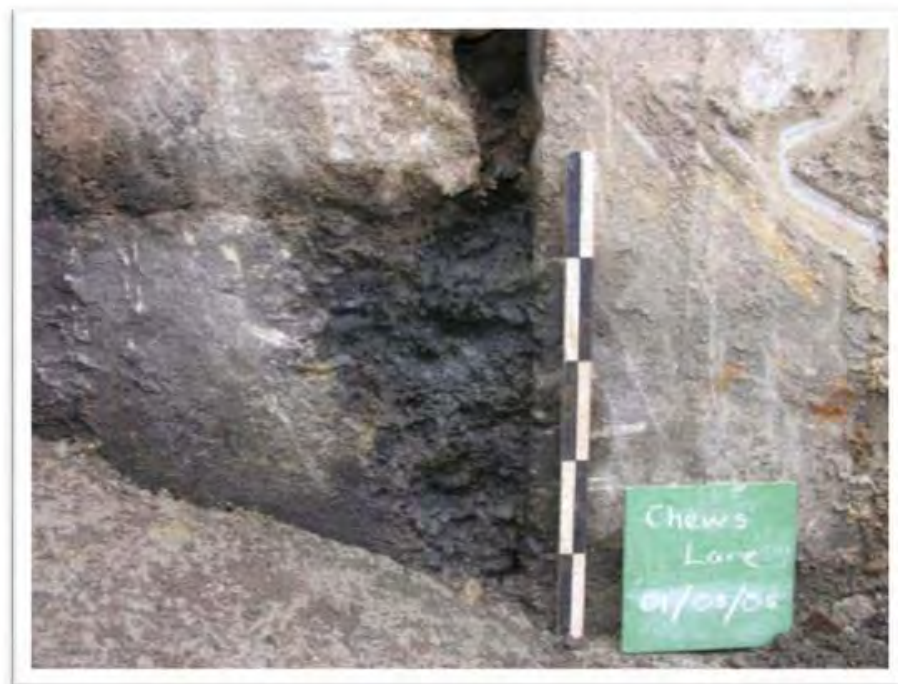
Figure 25.
Concrete blocks showing the marine deposits of muddy sand and round gravel sandwiched between the blocks and the foundation wall of an existing building. The bottom of the trench is recently-poured concrete

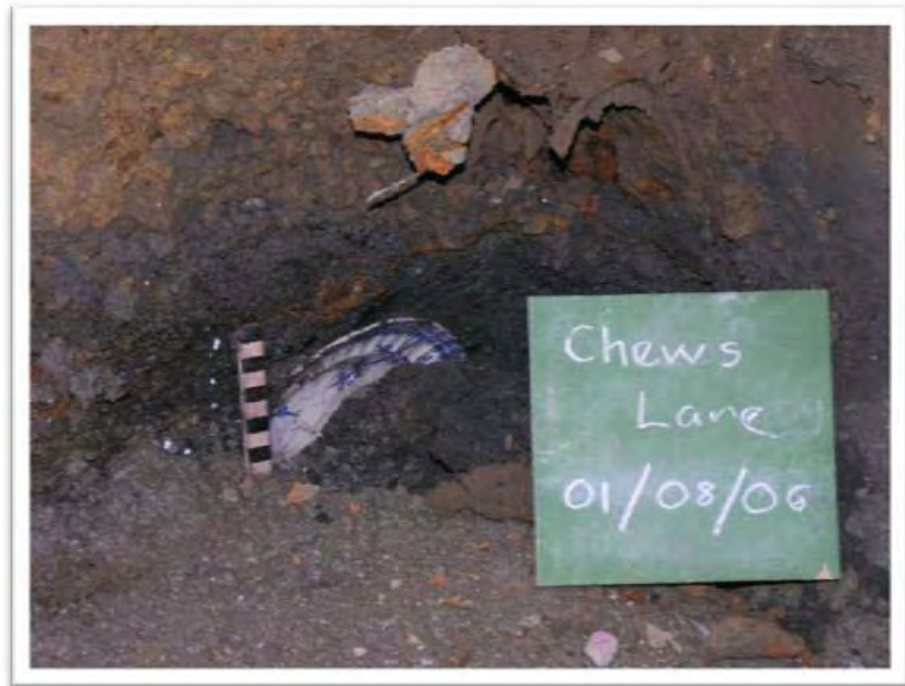
Figure 26. China plate (CP180, Appendix 1), embedded in the sea bed below Carter's reclamation. The rusty coloured material in the reclamation above the china is iron sheet

Immediately south of the blocks and embedded in the sea bed beneath what is apparently clay reclamation fill from Carter’s reclamation, was a piece of china plate with a blue bramble pattern around its rim (Figure 26; CP180, Appendix 1). The rear of the plate had the mark “K & Co,” with the pattern name “Thorn” above it. The mark has not been positively identified, but appears it could be younger than 1886. This poses a dilemma as to how and when it became embedded in the old sea bed. The most likely possibility is that it was thrown into an old rubbish pit that was removed when the foundation trench was dug, leaving just the edge of the pit and the undercut portion in which the china was preserved.

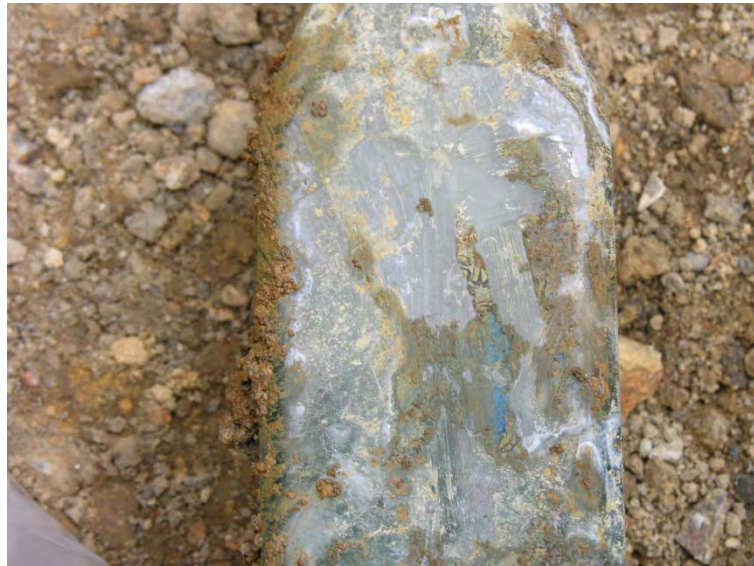
APPENDIX 7: BOTTLE WITH LABEL

Photograph (DSCN1791) of bottle with label found in the 1857-1863 reclamation material, in the trench between piles C5 and D5 (Appendix 2). The remains of the label are the light blue patch in the bottom left quadrant of the bottle image

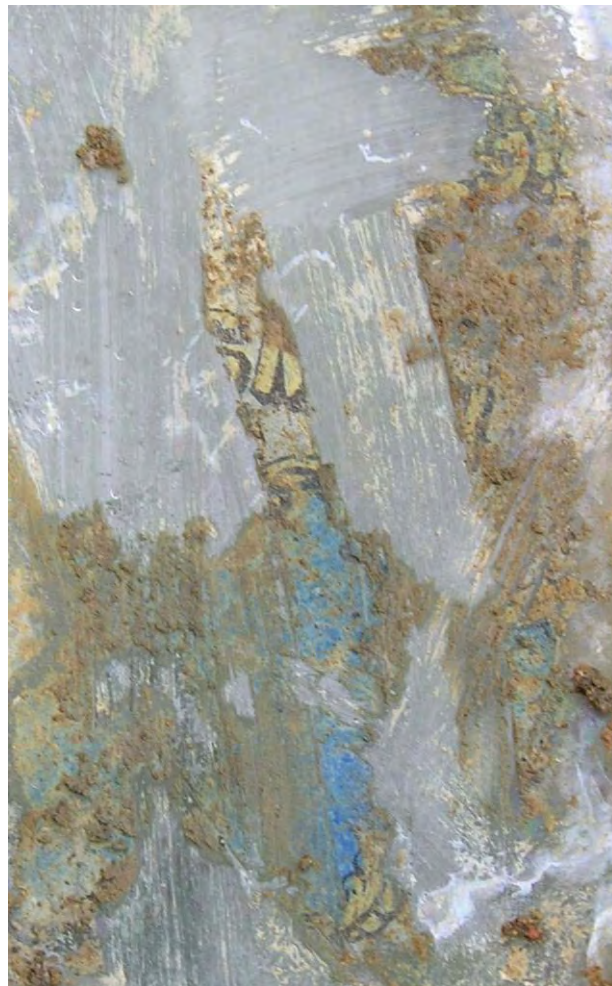
Detail of the label shown in the previous photograph. Note the letters SM in yellow at the top of the label

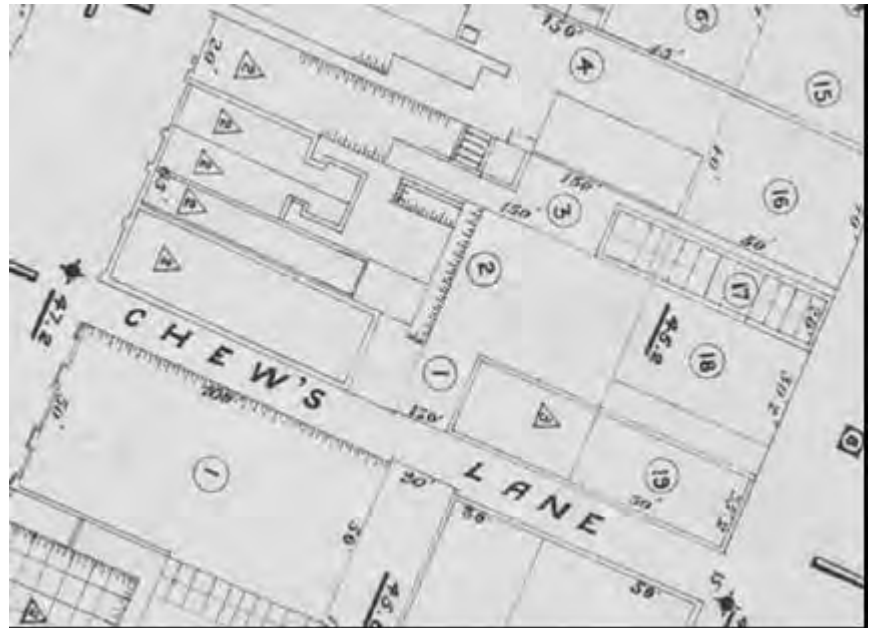
Figure A9.3. Thomas Ward Plan (part of Sheet 29) showing 1891 building footprints on the north side of Chews Lane and some construction details. Numbers in triangles indicate the number of floors in the buildings greater than one. The four buildings fronting Willis Street have 2 floors; the rear of the building fronting Victoria Street and Chews Lane has three floors, the front buildings one floor. Double lines depicting buildings indicate brick walls; single lines, wooden walls; hatched lines, iron walls

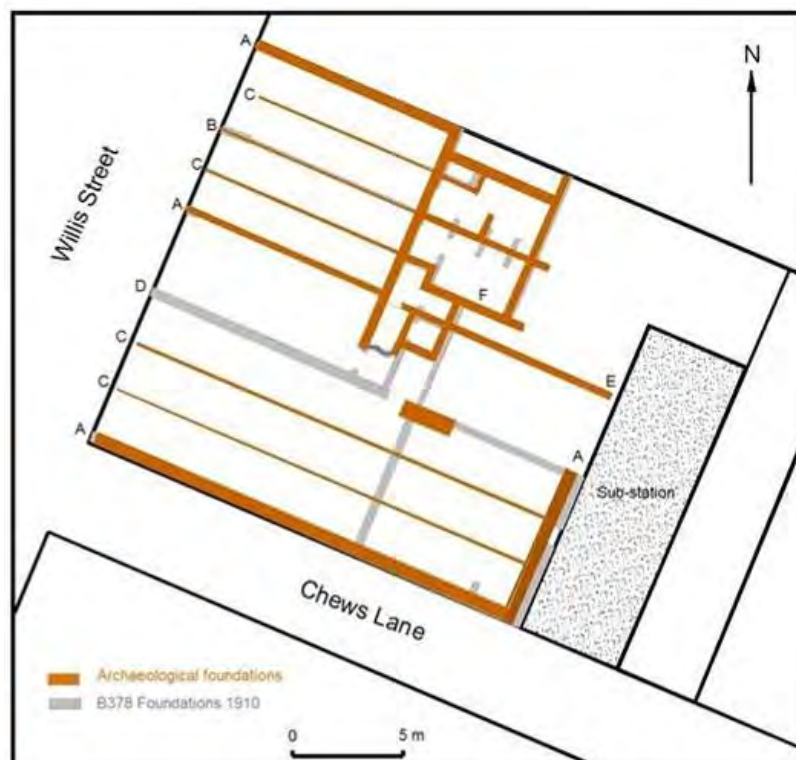
Figure A9.6. Plan showing the archaeological foundations and building footprints fronting Willis Street. A = foundations below external walls, B = foundation below internal wall separating two shops in the same building. C = foundations not beneath walls, probably used to support floor joists. D = foundation below external wall present in the section along the Willis Street road frontage, showing signs of later strengthening. E = a foundation for the external wall of a building erected after 1910. F = external wall of 1910 building annex

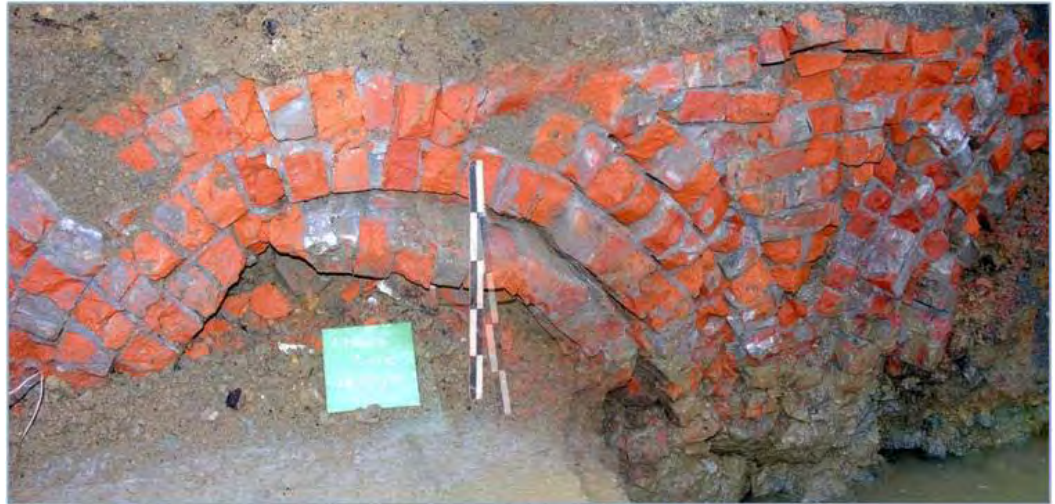
Figure A9.7.
Brick arch
foundation along
the south end of
the Victoria
Street road
frontage (A,
Figure A9.5)
(image compiled
from two
overlapping
photographs).
Note the infill of
brick between
the complete
arch and the next
arch at the right
hand side of the
photograph.
Scale = 50cm

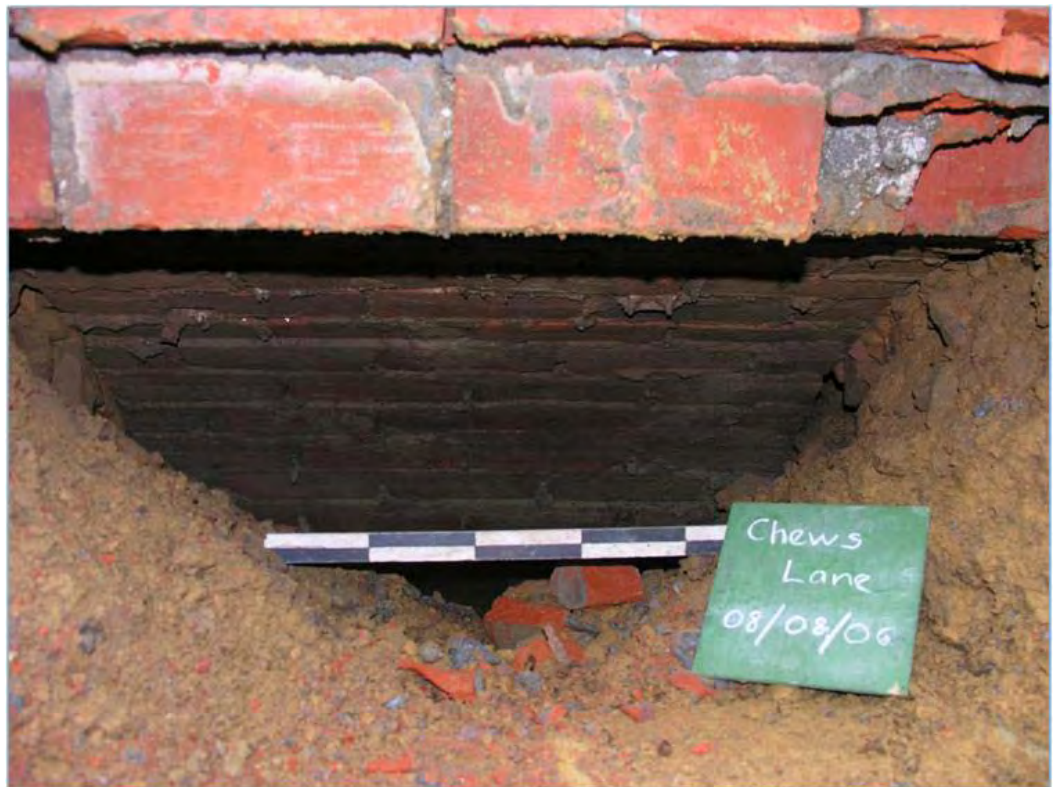
Figure A9.8.
Underside of
brick arch
foundation, along
the north side of
the three story
building fronting
Victoria Street
(A', Figure A9.5)

Figure A9.10.
Brick arch foundation (Figure A9.8) with the younger, abutting concrete footing and bricks of the foundation of the building to the north. Concrete aggregate included angular stones more than 10cm long, and round beach gravel and pebbles (See Figure A9.11)

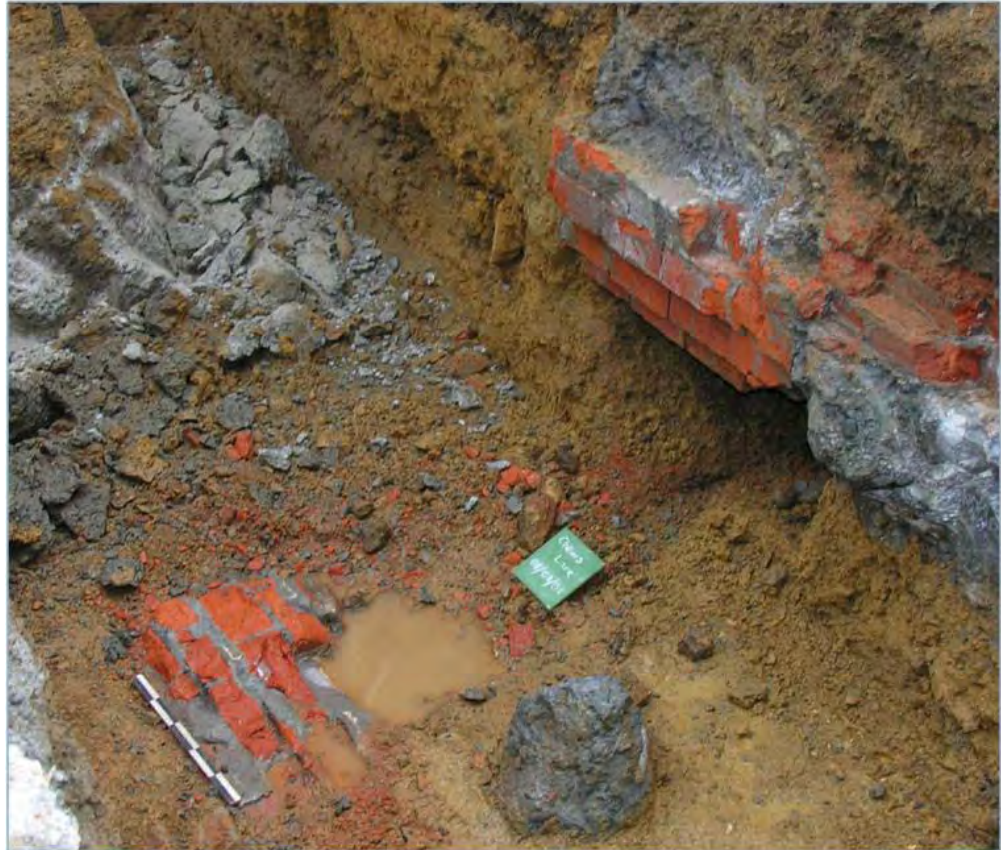
Figure A9.9.
Brick arch (at right) after removal of the left hand section of curve, and the arch support pile (bottom left)

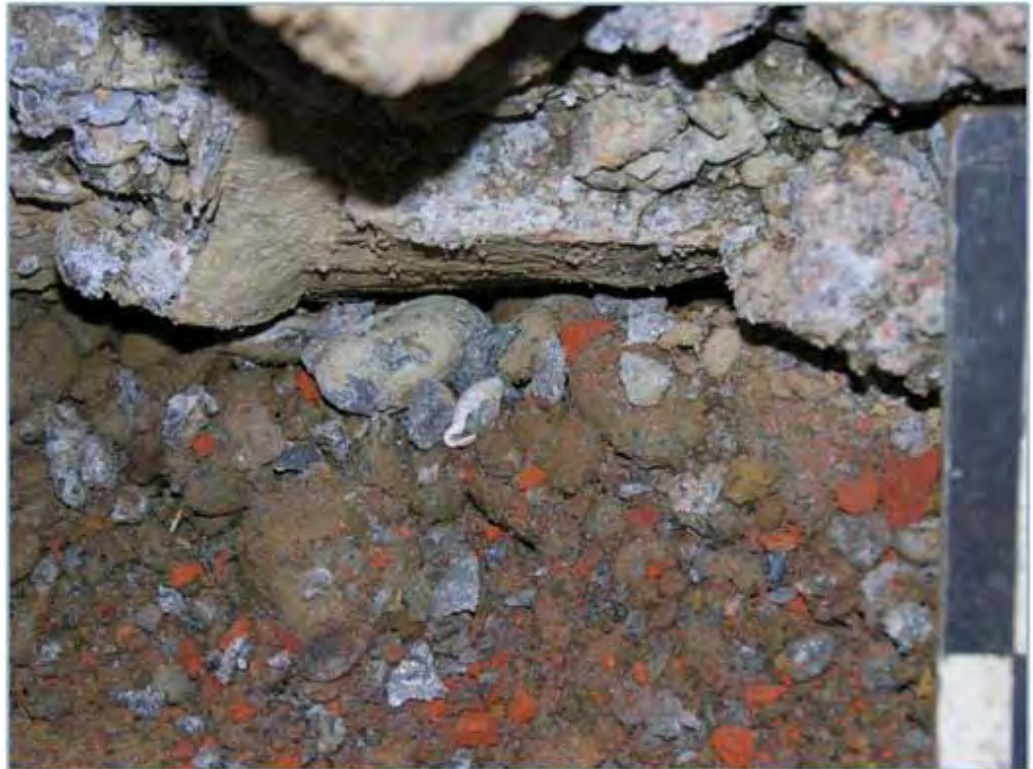
Figure A9.11.
Round gravel
and pebbles with
sea shell from
poorly cemented
aggregate
forming part of
the concrete
foundation
footing (C,
Figure A9.5)

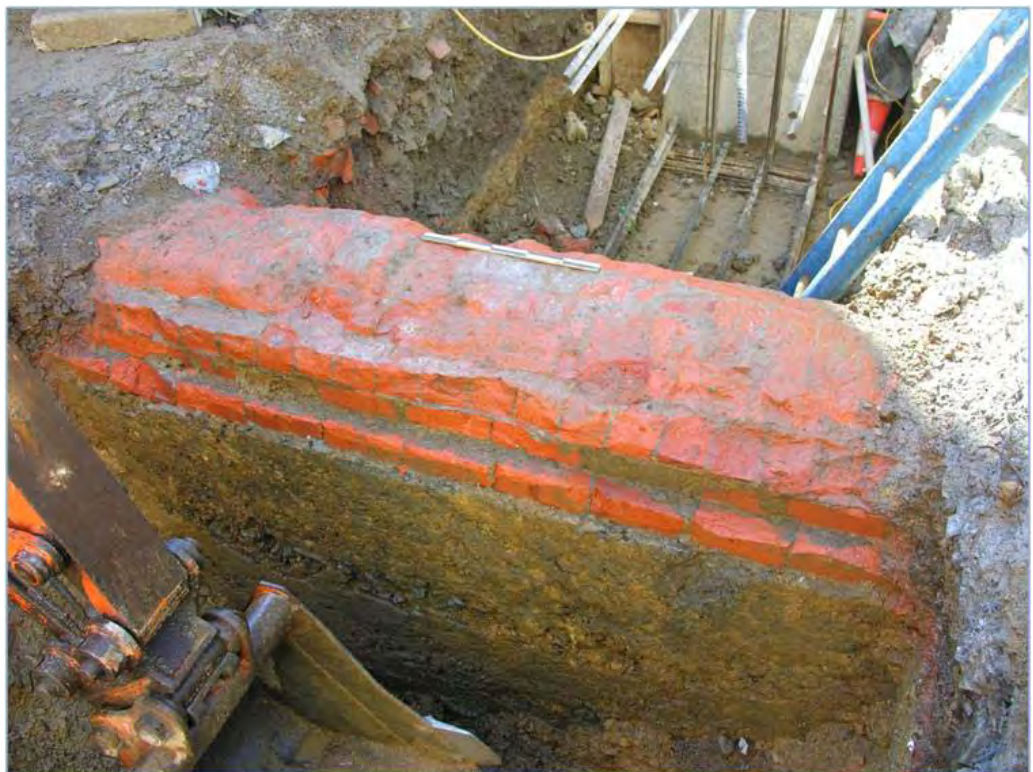
Figure A9.12.
Foundation with
a massive
concrete footing
and bricks above
(B, Figure A9.5).
Note the
rounding of the
brick upper
surface, probably
a result of
demolition of the
wall in
preparation for a
new building

Figure A9.13.
Concrete
aggregate used in
the massive
concrete footing
(Figure A9.12).
Note the round
and sub-round
gravel and
pebbles

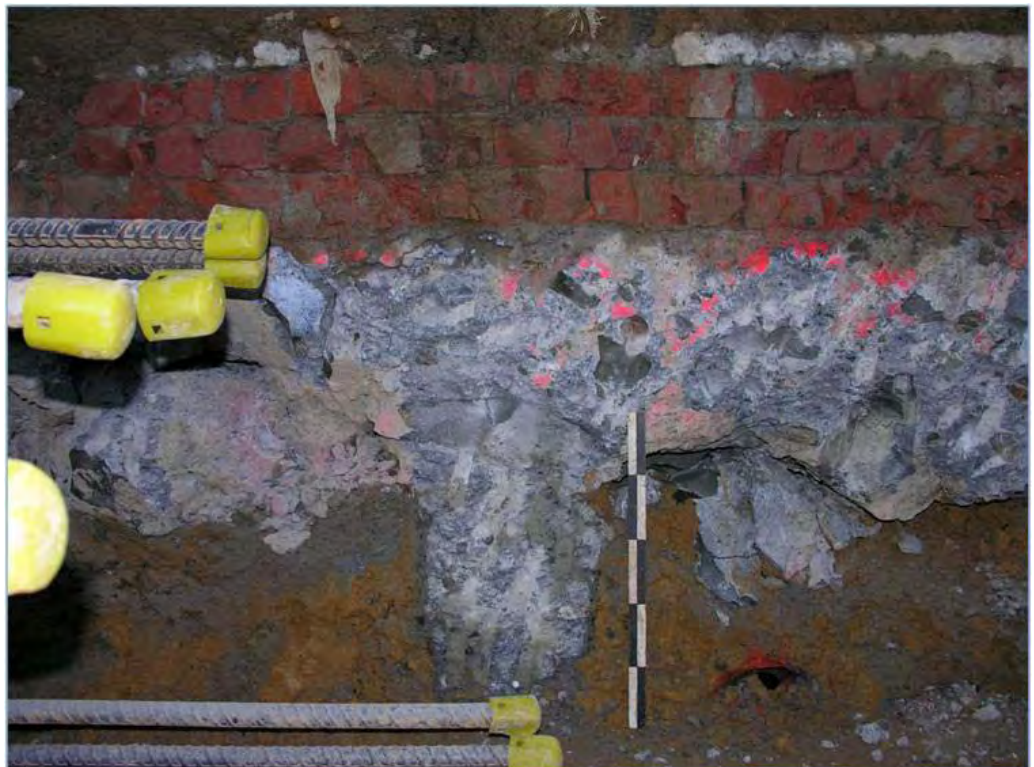
Figure A9.14.
Concrete footing
with piles
beneath along the
front of the four
story building
fronting Victoria
Street (C', Figure
A9.5)
