FORESHOCK – AFTERSHOCK: THE ARCHAEOLOGY OF CHEWS LANE, WELLINGTON

Final Report in Fulfilment of
NZHPT Authority No. 2007/71

Prepared for
Willis Street Holdings Ltd

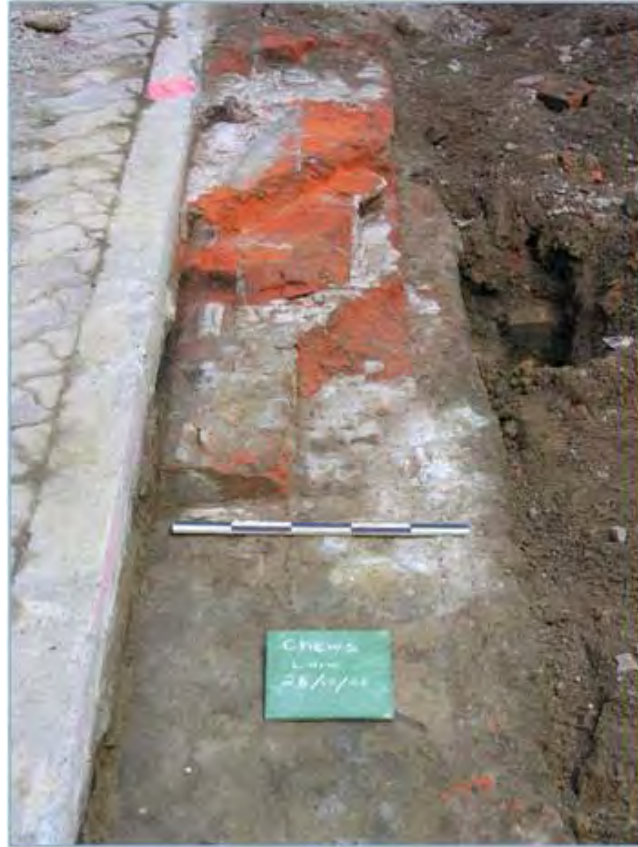
Figure A9.15.
Concrete footing
with bricks above
forming the
foundation for
the external wall
of the building on
the corner of
Chews Lane and
Willis Street (A',
Figure A9.6)

Figure A9.16.
Concrete footing
of the foundation
shown in Figure
A9.15 showing a
flat surface that
is probably the
result of wooden
formwork.
Whether the
formwork was
part of the
original
foundation
construction or
dates from when
the foundation
was strengthened
is not known

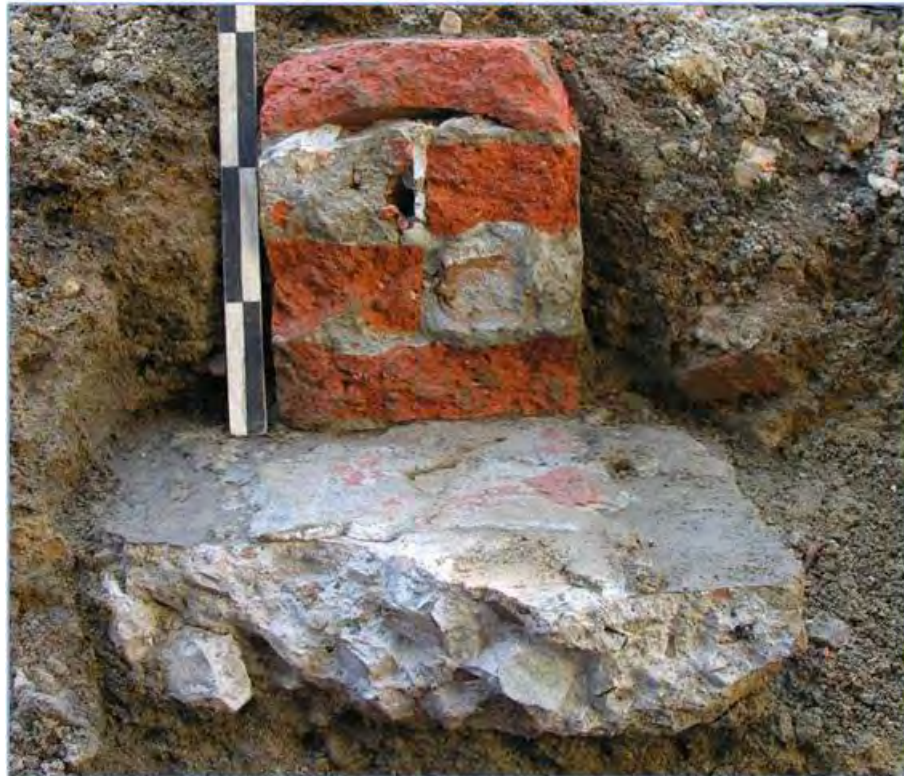
Figure A9.17.
Concrete footing
of brick wall the
width of one
brick laid
laterally across
the footing, or
two bricks laid
longitudinally
along the footing
(B, Figure A9.6)

Figure A9.18.
Laterally laid
bricks of building
wall similar to
that shown in
Figure A9.17

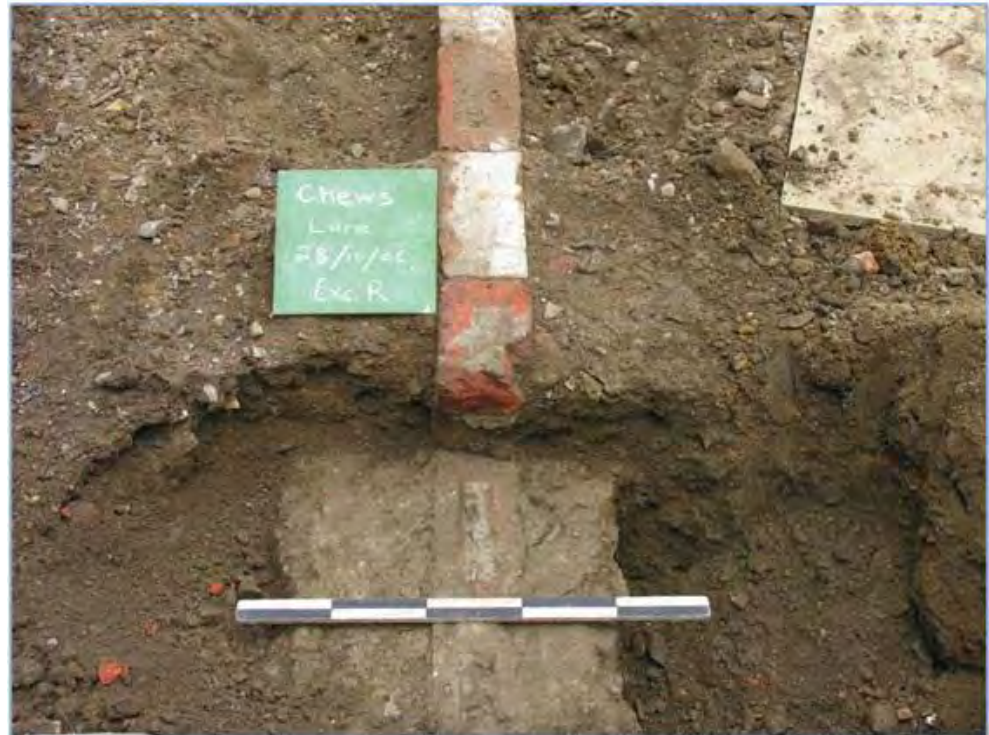
Figure A9.19.
Single brick
alignment on a
concrete footing
(C, Figure A9.6),
probably used to
support floor
joists (see Figure
A9.20)

Figure A9.20.
Wooden floor
joist on top of a
single brick
alignment
(Figure A9.19).
The concrete at
the top of the
joist is from a
later floor. Scale
= 10cm

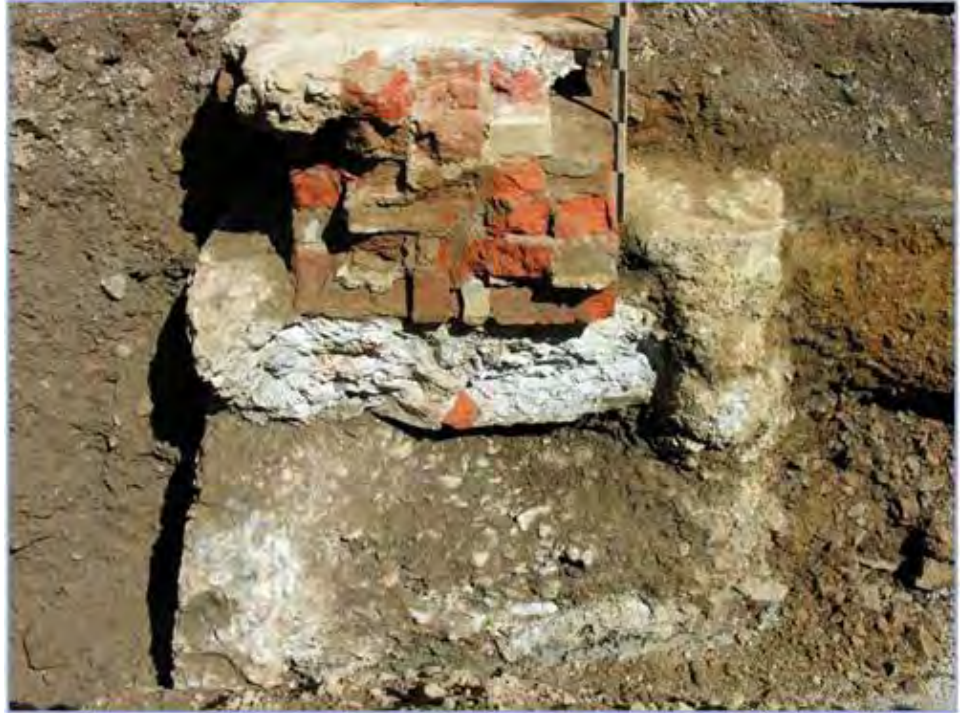
Figure A9.21. Concrete footing and brick work of external wall of building at D, Figure A9.6, on the Willis Street road frontage. The original footing is the lighter-coloured concrete immediately below the bricks. The slightly darker concrete below the light coloured concrete, and to the left and right of the bricks, is later and probably to strengthen the foundation below the building frontage when Willis Street was widened
