139 ARNEY ROAD, REMUERA

Final Archaeological Report R11/2341,
NZHPT Authority No 2006/80

139 ARNEY ROAD (SITE R11/2341), REMUERA: FINAL ARCHAEOLOGICAL REPORT

In Fulfilment of NZHPT Authority No. 2006/80

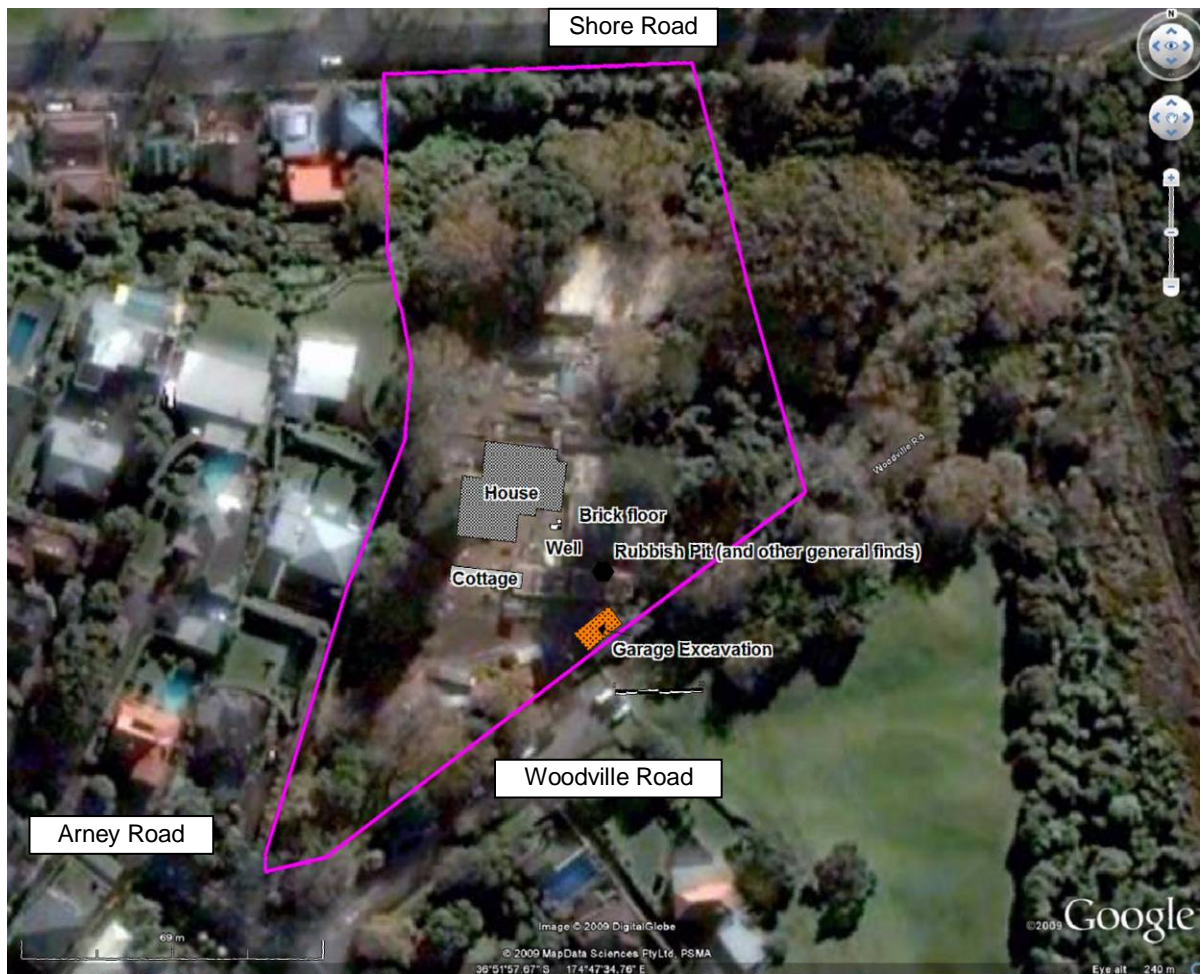
Figure 4. Showing the location of the house, cottage, garage and other features investigated and recorded on the property

The main entrance to the property was located at the corner of Arney and Woodville Roads (Figure 4) marked by a pair of large gateposts and gates. A tarmac driveway lined with mature oaks led down the western boundary to a turning/parking area west of the house. The driveway continued across the front of the house and around the eastern side to the rear court area, and across to the garage on the eastern boundary.

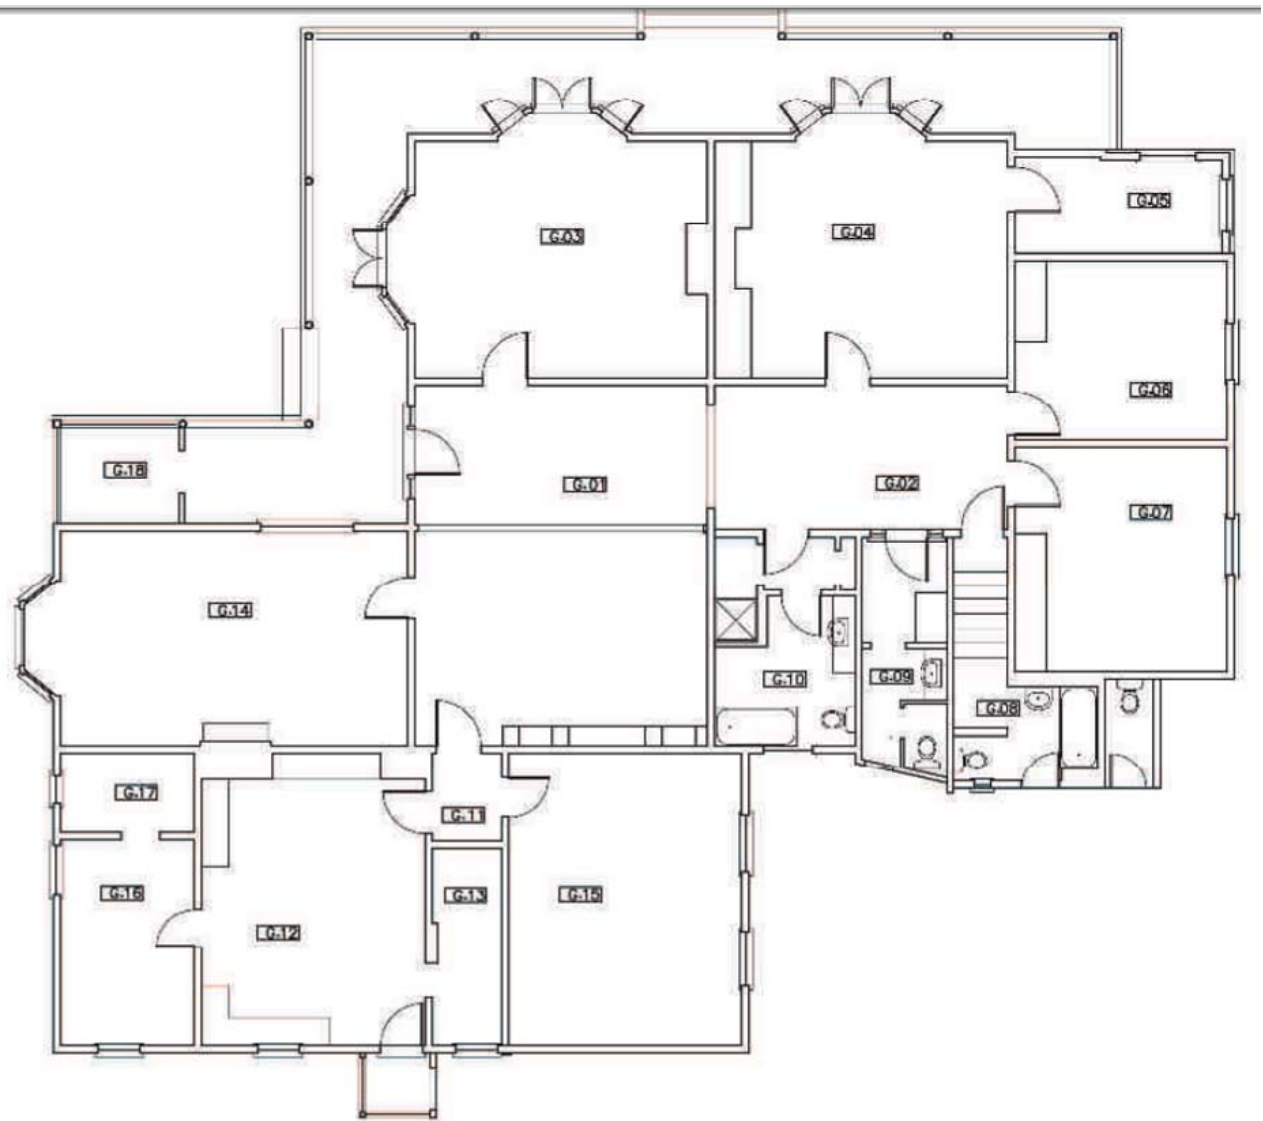
Figure 5. Pearson (2005: 18) plan of the rooms in the main house.

Prior to removal the house had 17 rooms on the main level, a bathroom at a lower level accessed from the main level and outside, and a toilet at the lower level accessed only from outside (Figure 5 and Figure 7). The main lounge (G03) was on the northern side leading onto a 2.1m wide verandah which extended across the northern elevation of the house, returning on the western side and then extended across the northern wall of the sitting room. A small room G18 had been created at the western end of the verandah. The front door of the house was positioned in the western wall and led from the verandah into the central reception room G01. The main bedroom (G04) was adjacent to the lounge, with access to a closed in sun porch (G05). Other bedrooms were located on the eastern side of the house (G06, G07), and another bedroom (G16) in the south-western corner of the house. On the western side of the house was a large sitting room (G14). In the south-western area of the house were the kitchen (G12), separated from the dining room (G15) by a square hall (G11) and a laundry (G13). The ablutions area was in the south-eastern corner of the house and comprised the main bathroom G10, a cloakroom G09, and another bathroom G08 at a lower level accessed from the hall (G02). (Pearson 2005, and see Figure 5).

Details of the recording of the buildings as they were in 2005 are described in Pearson (2005) and are not repeated here. Photographic recording of the building was also carried out by Hamish Macdonald and this information is provided on CD accompanying the report. Additional recording of the structures was carried out by the archaeological team prior to and during demolition/removal of the buildings by the archaeological team. The recording used the floor plan system described by Pearson (2005) and shown in Figure 5 (and Figure 6 for the cottage). Particular attention was paid to the following items:

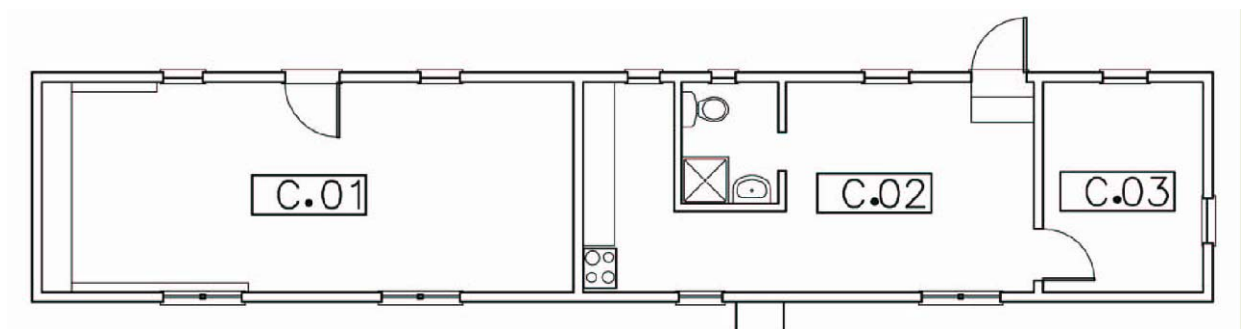
Figure 6. Plan of the cottage (Pearson 2005: 19)

The cottage, behind the house, comprised two separate sections, both with outside access but with no internal connection. The western portion consisted of one large room (C01 on Pearson 2005 plan, see Figure 6) while the eastern contained a living space and kitchen (C02), a bathroom and a bedroom (C03).

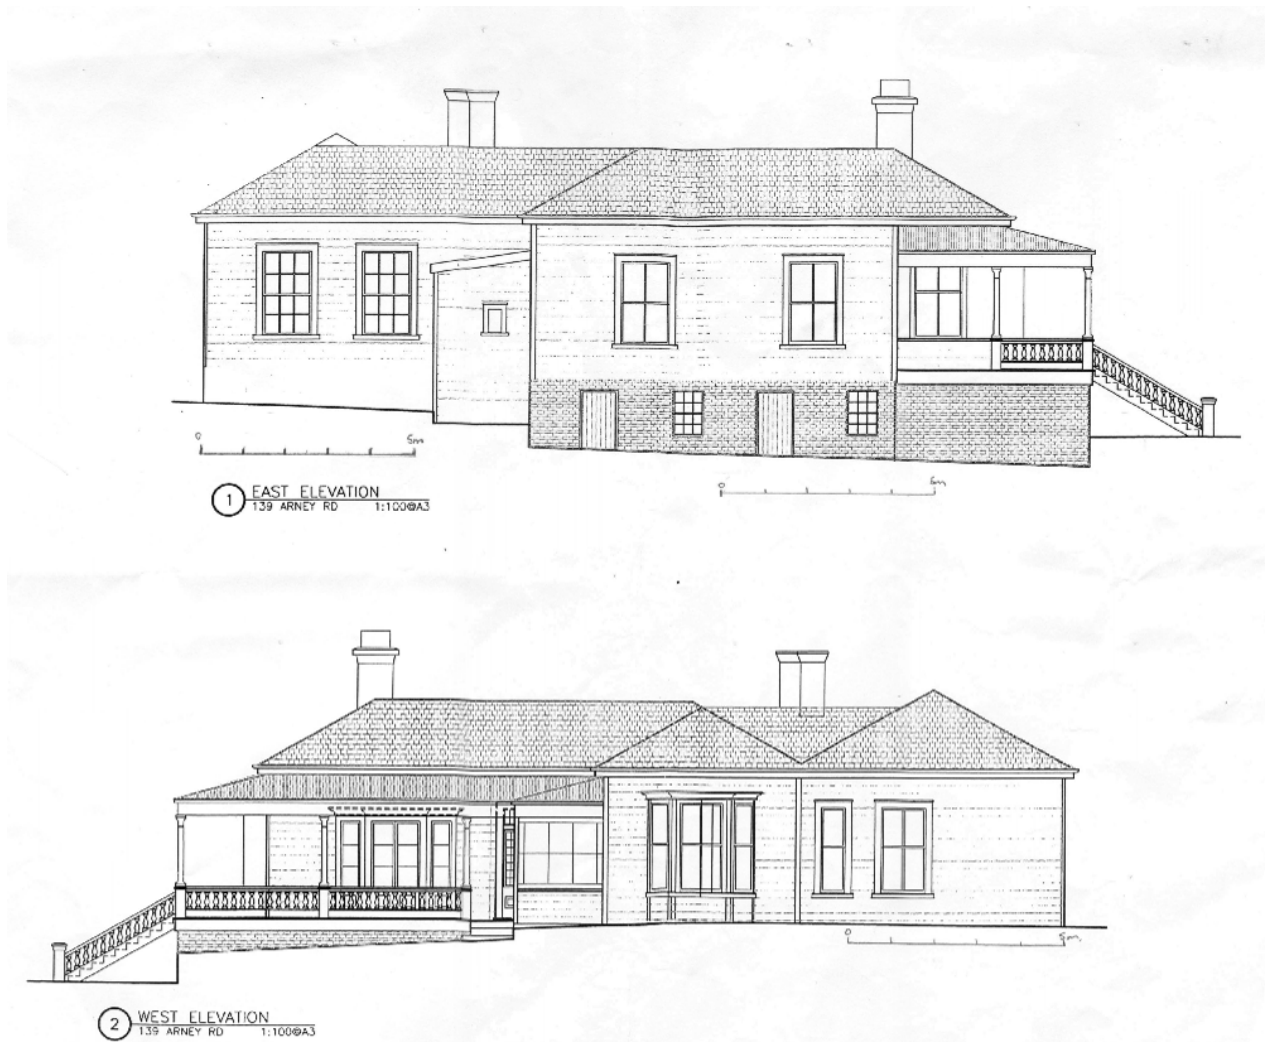
Figure 7. Measured drawings of the east and west elevations of the house by Dave Pearson Architects

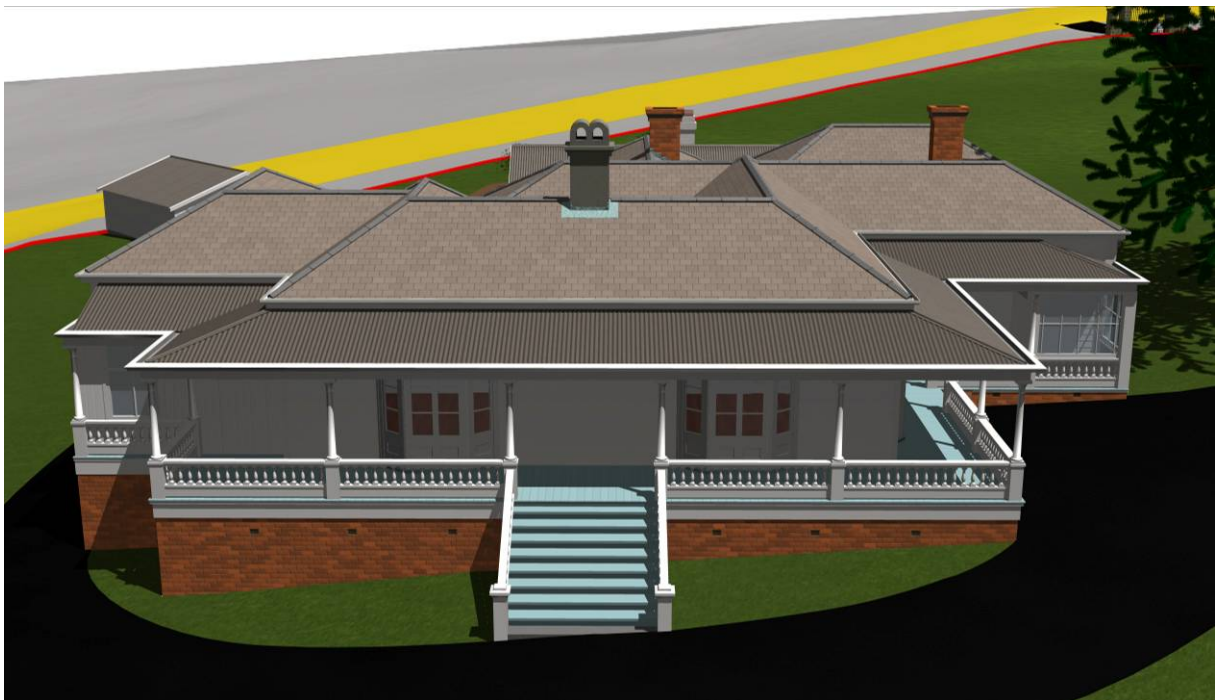
Figure 9. 3D Model of the house, looking south

The 3D model of the house was developed by Thomas Macdiarmid and Simon Bickler to aid in the illustration of the results of the recording (Figure 9). The model does not incorporate all the details recorded in the detailed profiles but is used to build the developmental model of the property through time. The model could also be further developed with the additional archival information available, particularly in relationship to the wider suburban landscape, but that is beyond the scope of the current project.

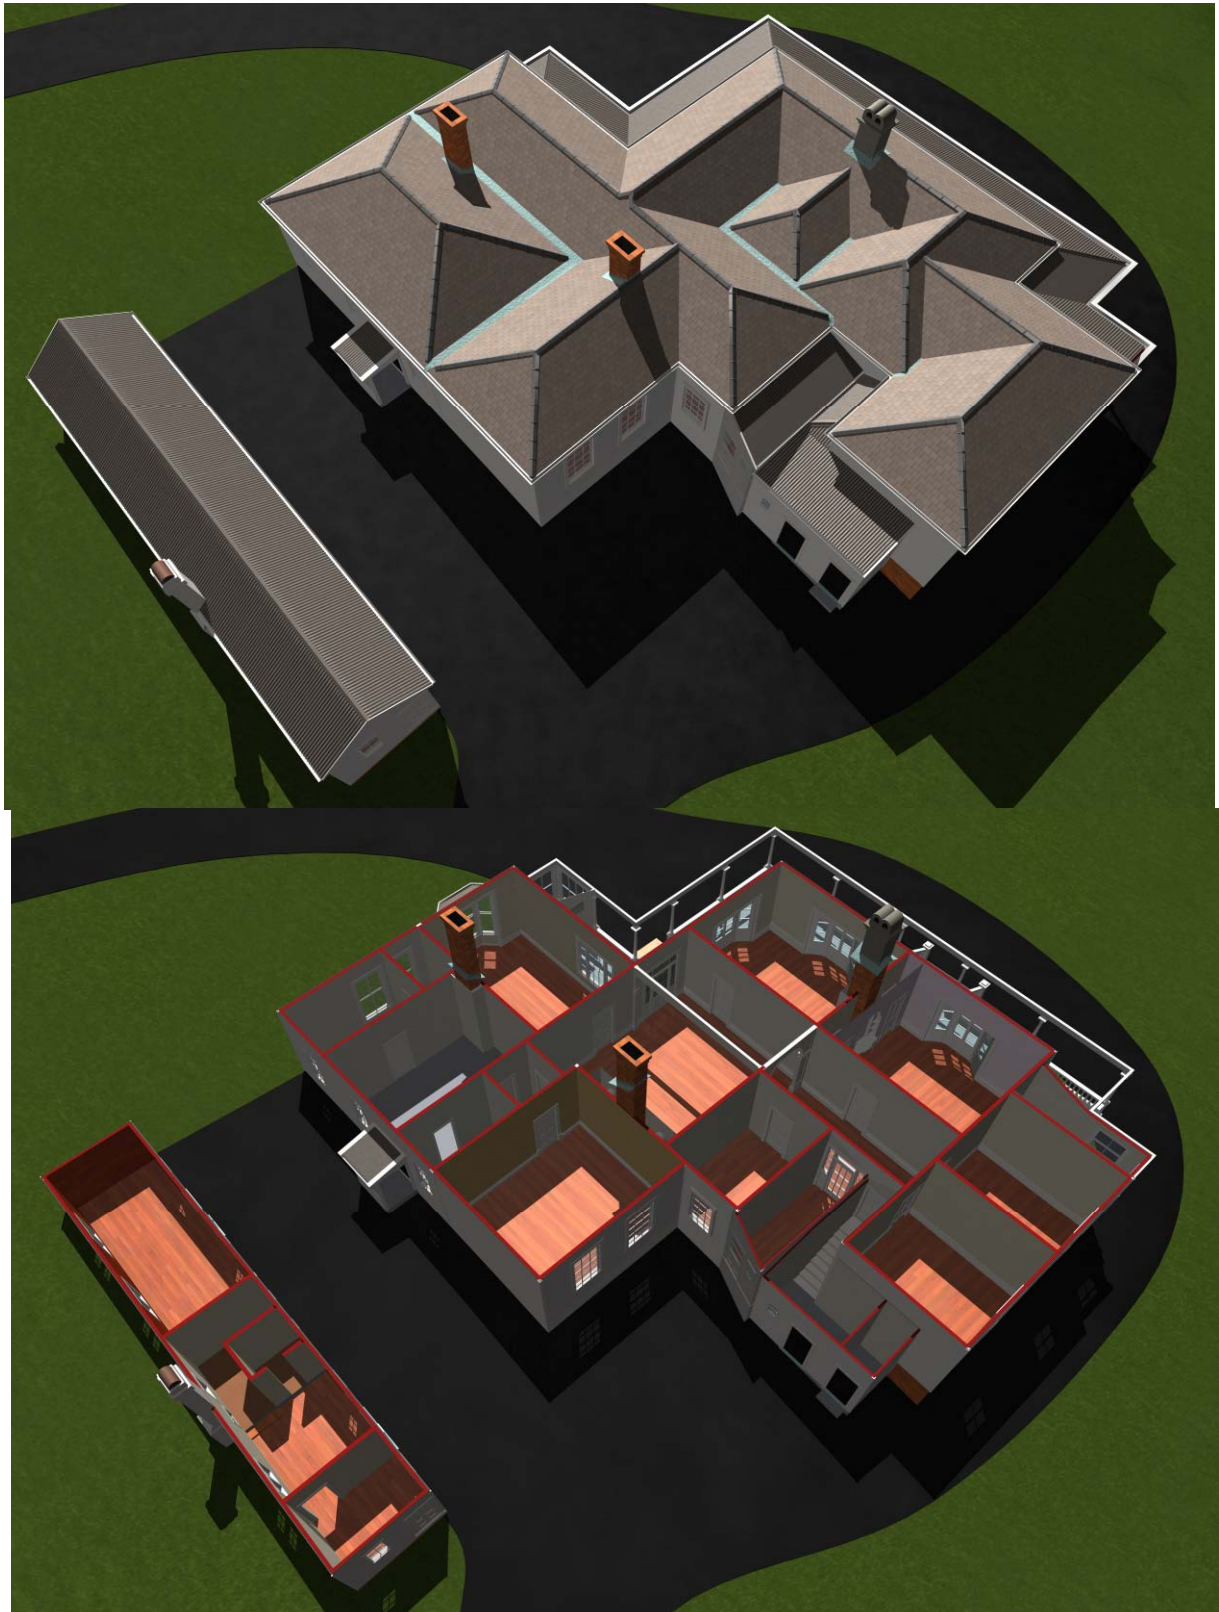
Figure 10. Oblique aerial views of the house and cottage, showing roof (top) and interior (bottom)

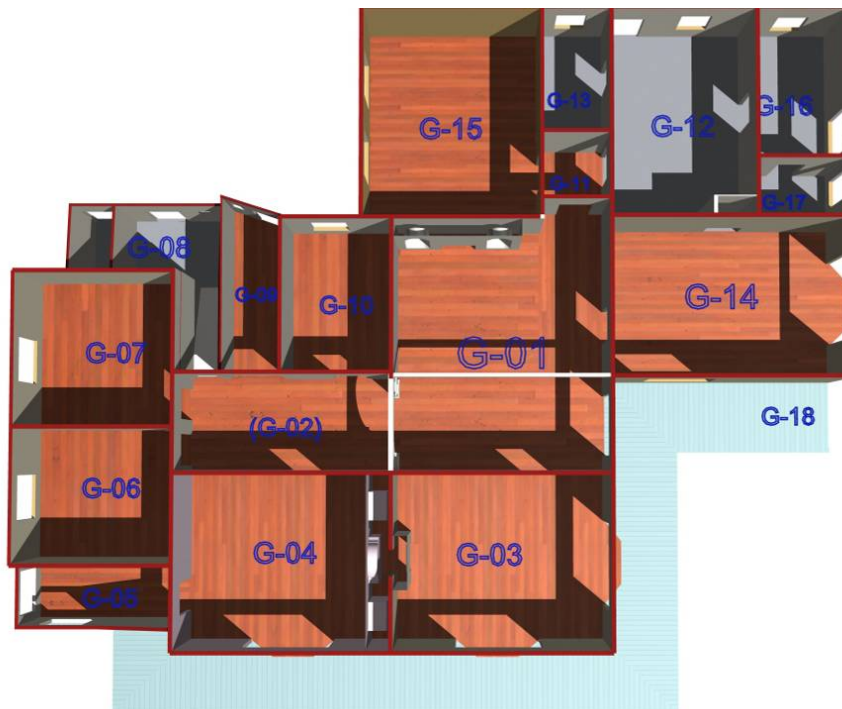
Figure 11. Floorboard orientation in the interior of the house

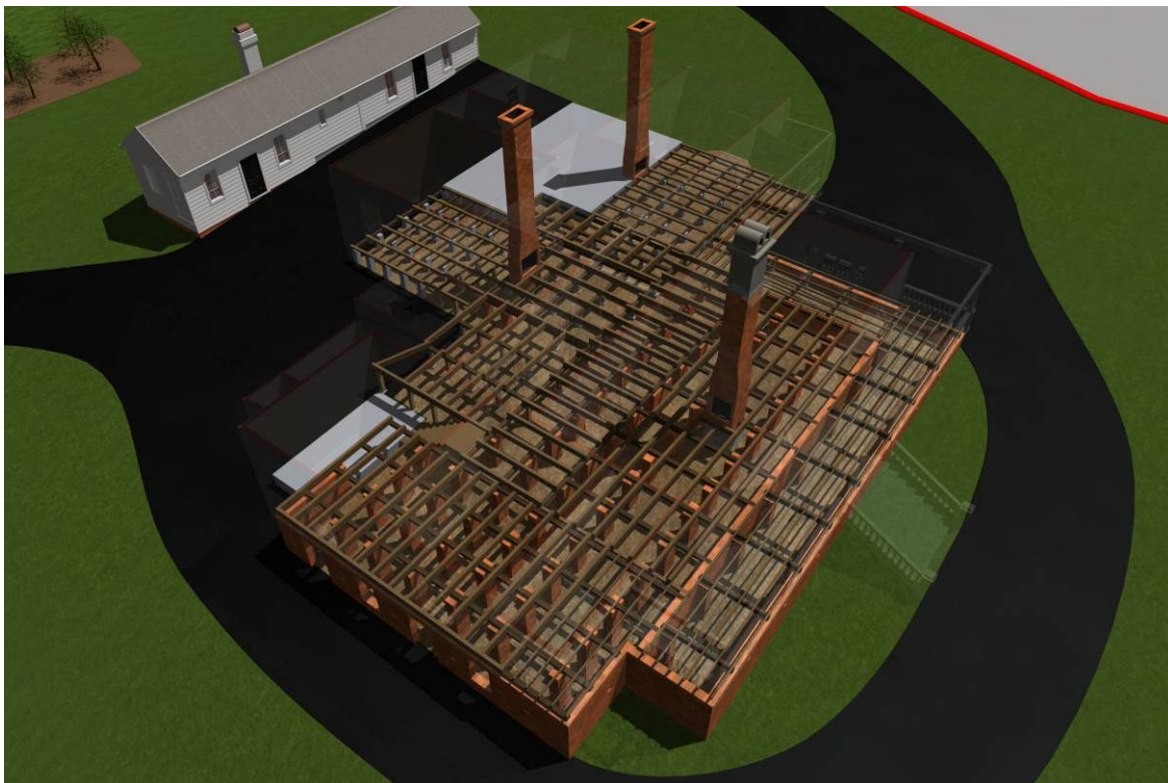
Figure 12. View through the house showing floor joists and foundations

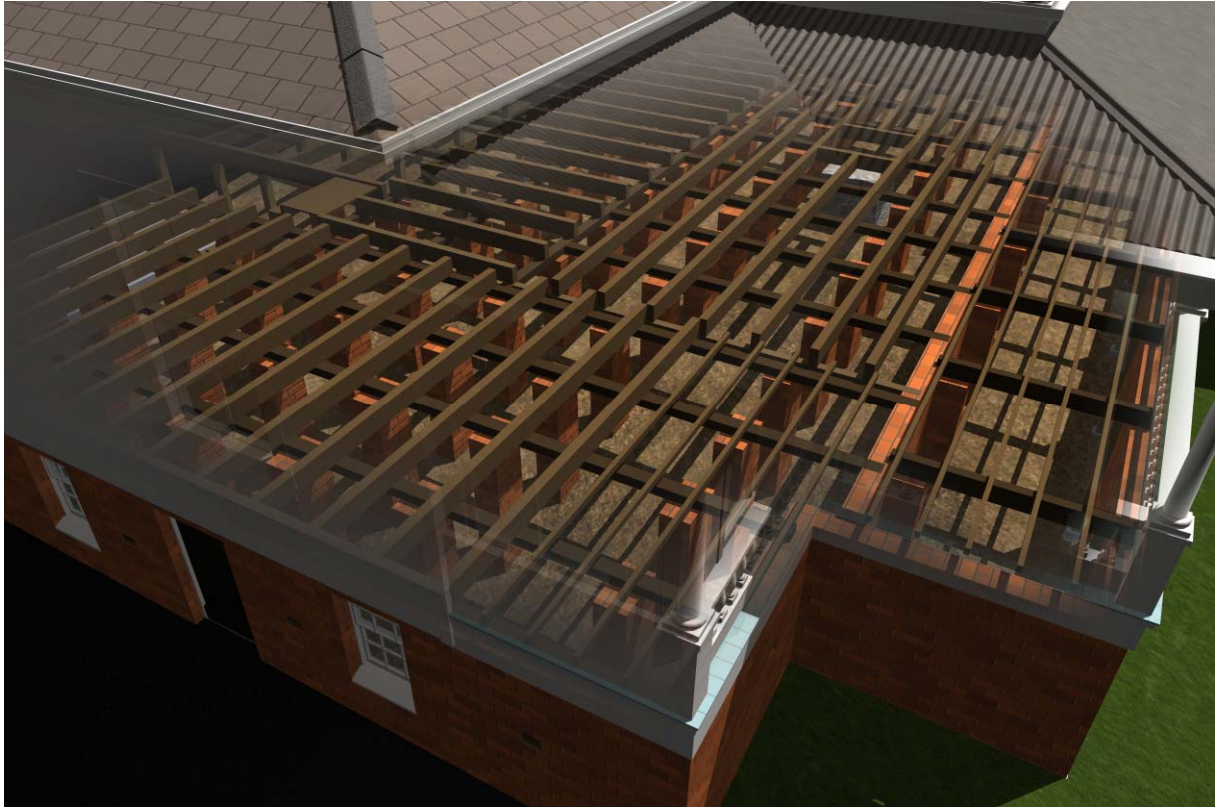
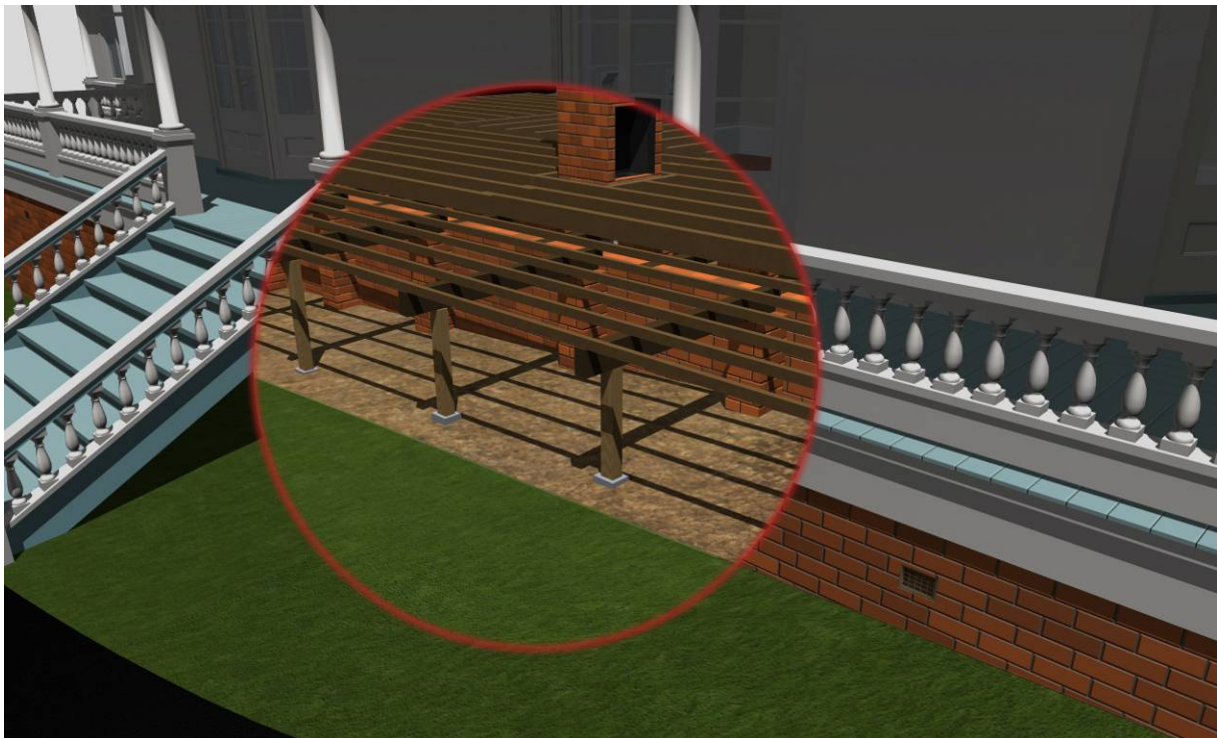
Figure 13. Close-ups of the underfloor of the house showing the northeast corner (top) and northern verandah (bottom)

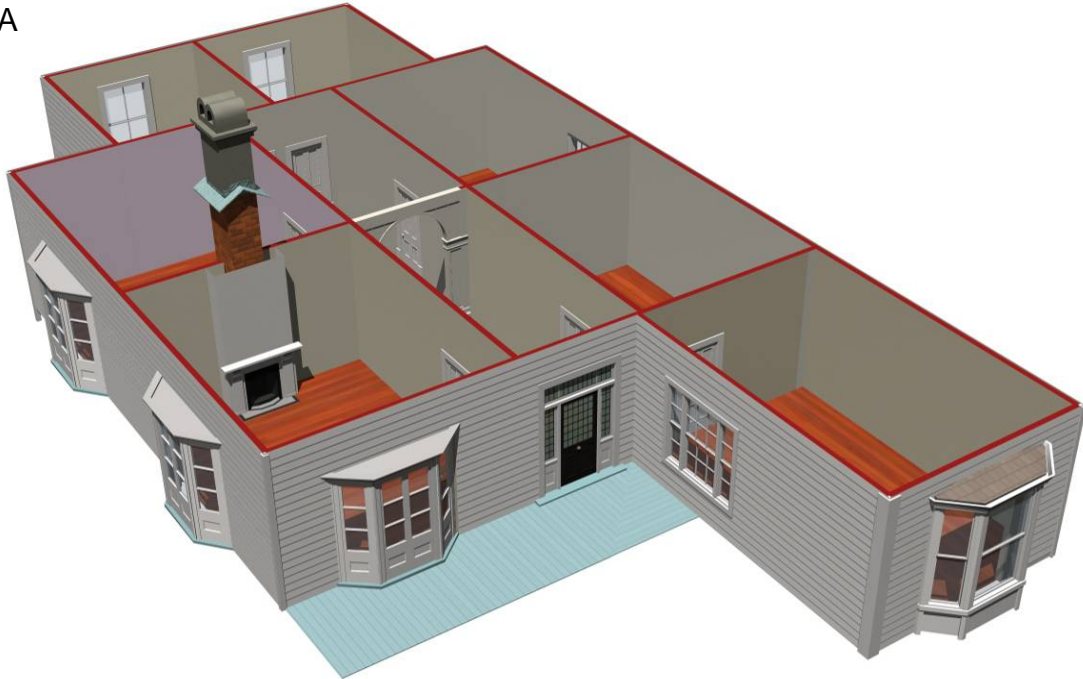
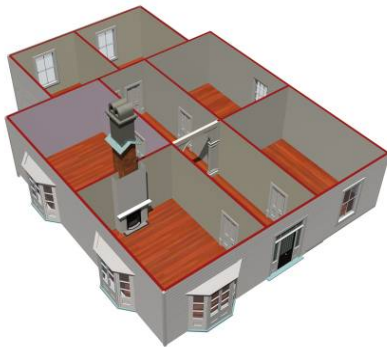
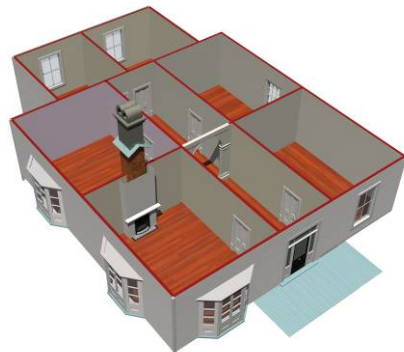
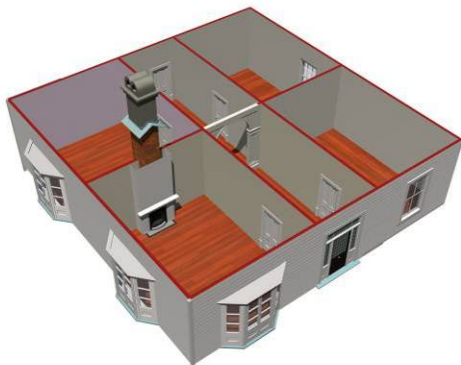
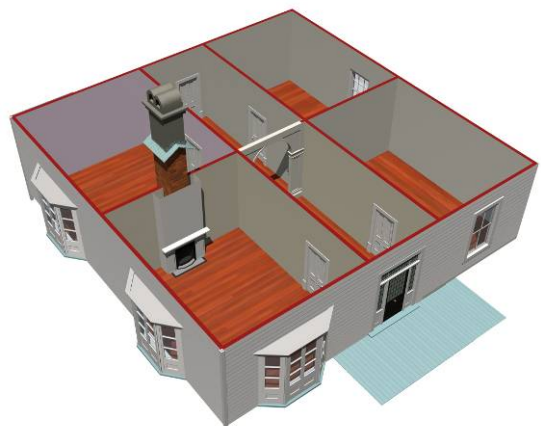
Figure 17. Possible layouts of the original house

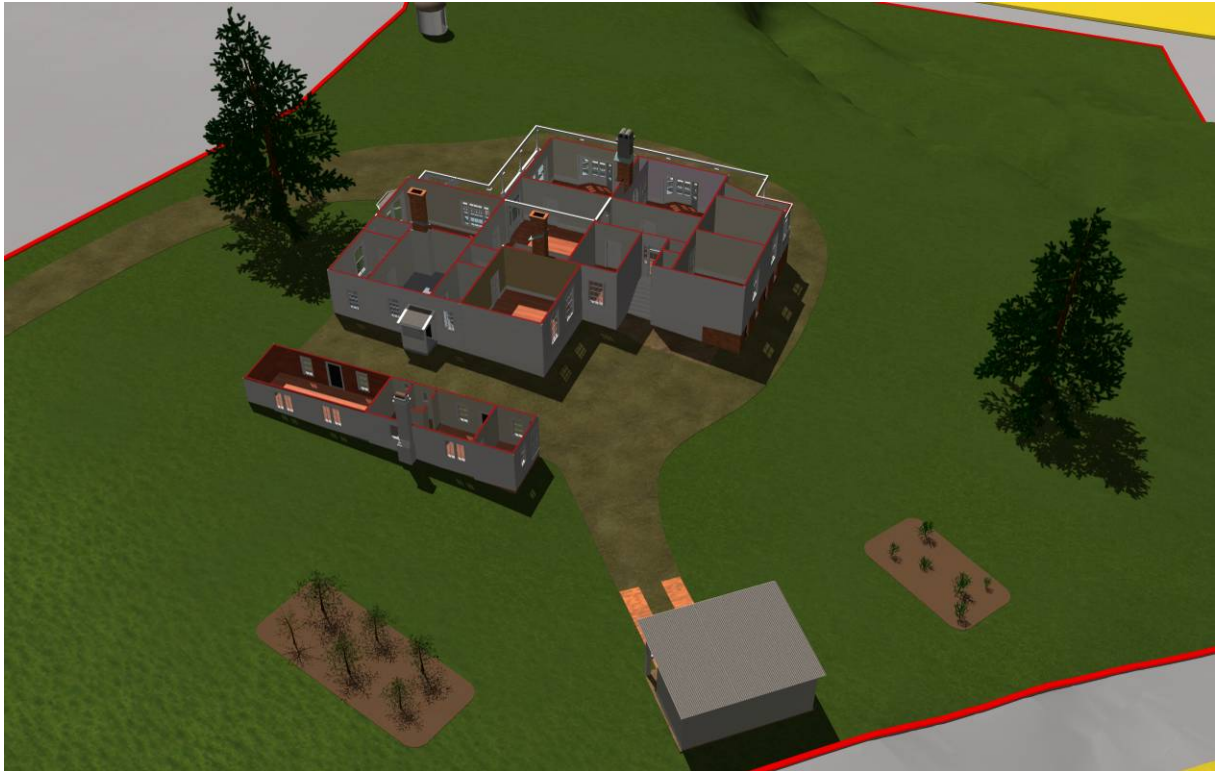
Figure 18. Middle phase of the property with cottage and stables pre-1950s (roofs removed to show interior)

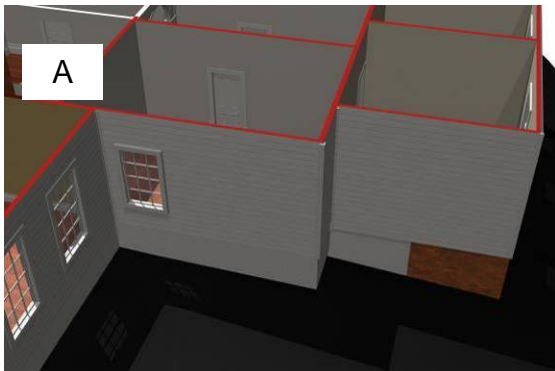
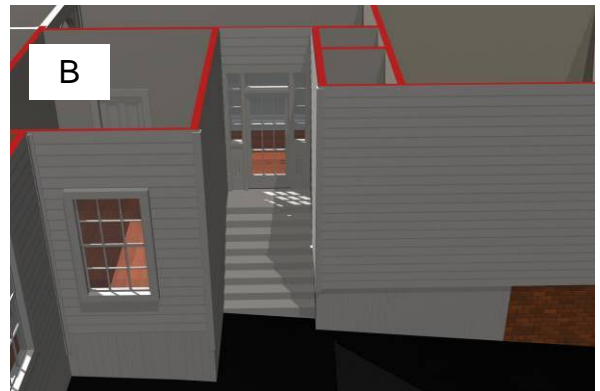
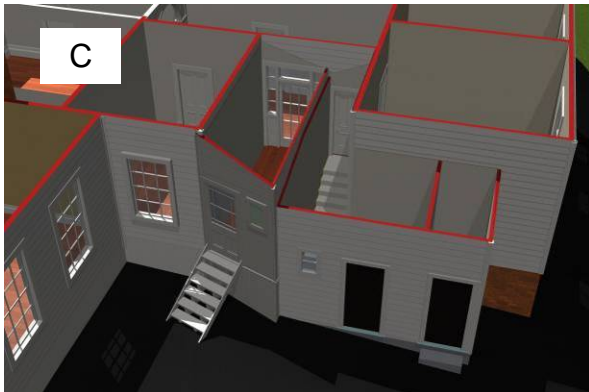
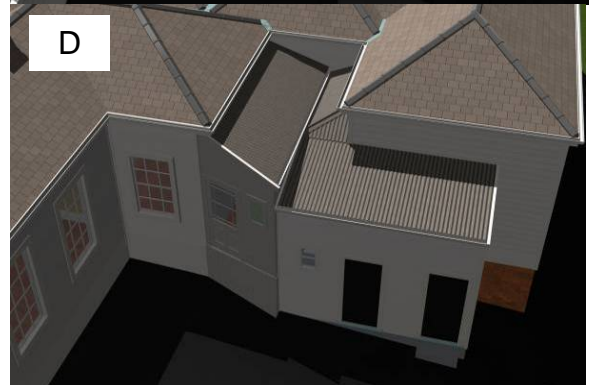
Figure 19. Reconstruction sequence for the south-east corner of the house

Other changes to this area were made in Phase 3. The plans for the Wright's renovations in the 1950s (see above, Figure 3, and Pearson 2005) show the entrance (G09) being enclosed and turned into a cloakroom (Figure 19C) and sometime soon after the outhouse, which had been serving as a bathroom for servants living in the cottage (see Pearson 2005), was incorporated into the main house (Figure 19D).

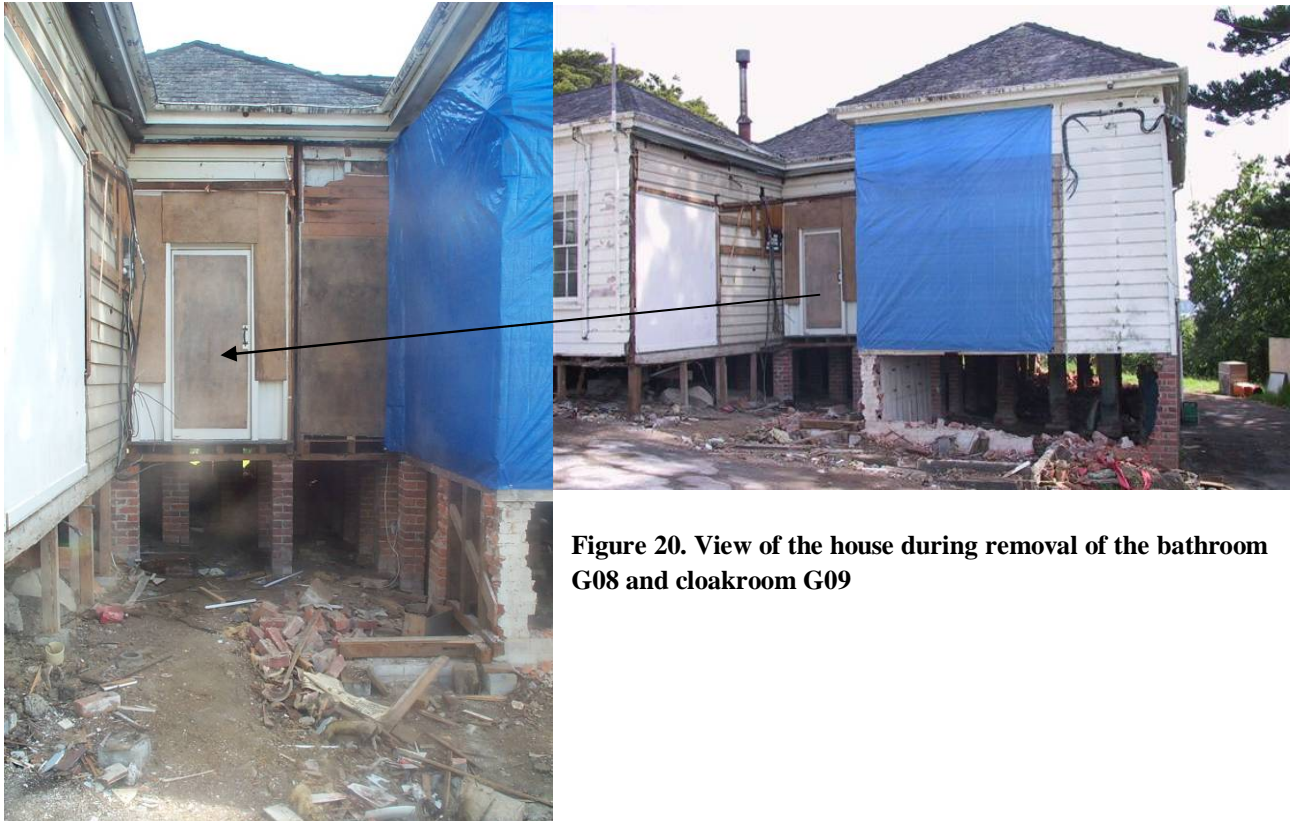
Figure 20. View of the house during removal of the bathroom G08 and cloakroom G09

This reconstruction gains some support from the presence of the later wood on concrete piles used in G15 seen in Figure 20, and reconstructed in more detail in Figure 21.

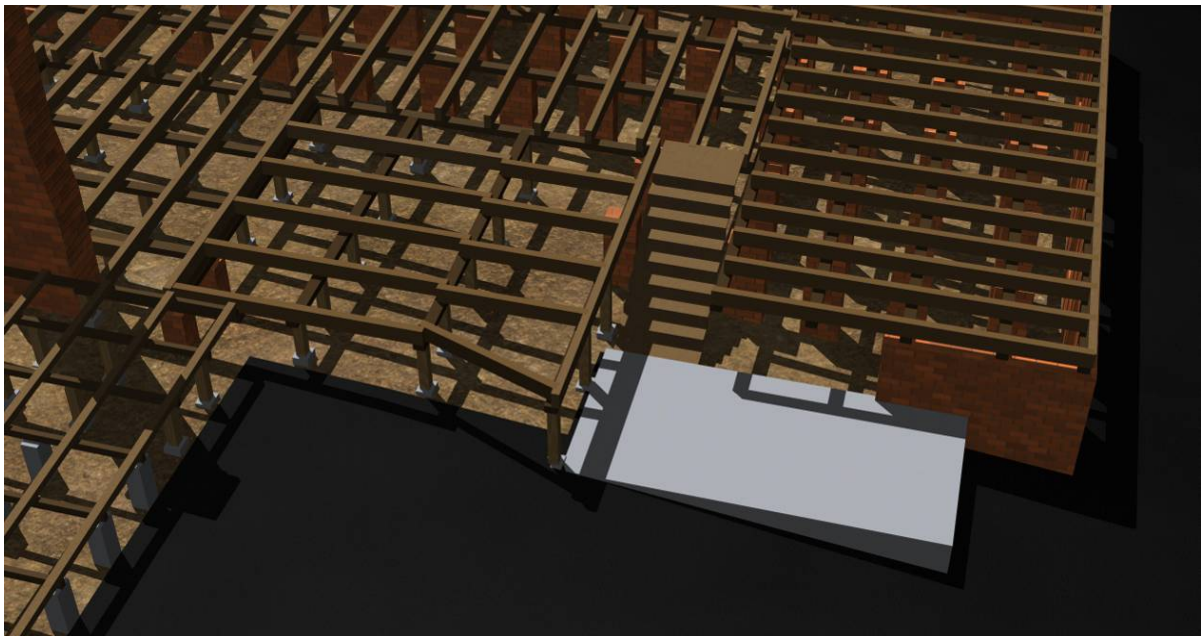
Figure 21. Pad for room G08 (bathroom)

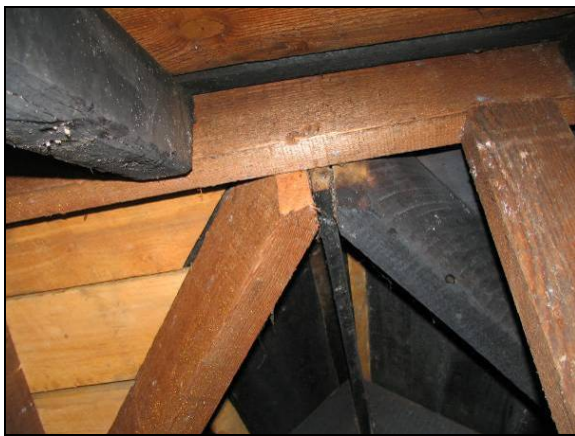
Figure 22. Inside the roof showing use of burnt beams that survived the fire and reconstruction

The most dramatic event, though, was the fire that occurred in the house in the late 1950s. This resulted in substantial rebuilding of the roof (Figure 22) and renovation of the kitchen. Changes in the roof are indicated by the boarding up of a chimney in the area of the kitchen (Figure 23). Other changes include incorporating part of the hallway into the main reception room to create G01 (Figure 24).

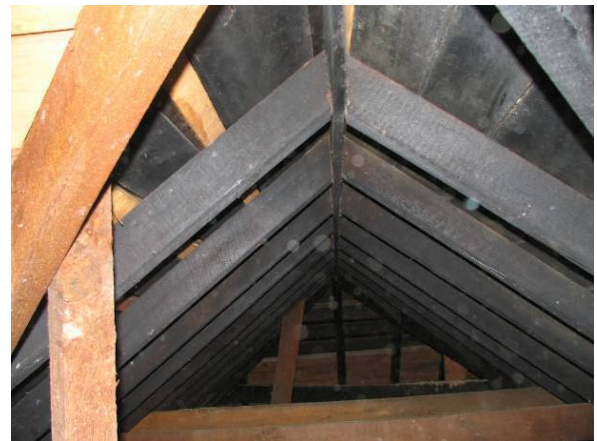
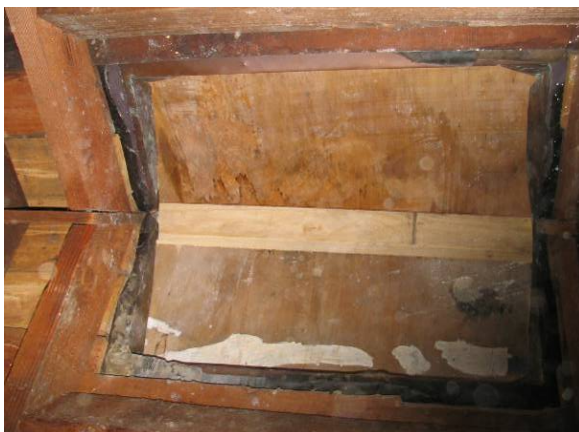
Figure 23. View of boarded up chimney hole in roof above kitchen

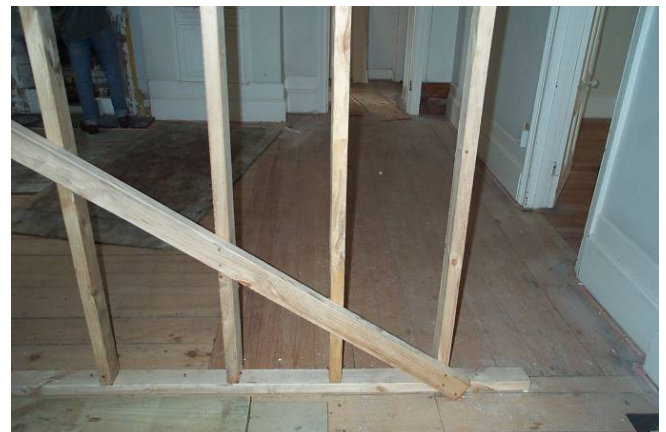
Figure 24. Room G01 showing rebuilt hallway

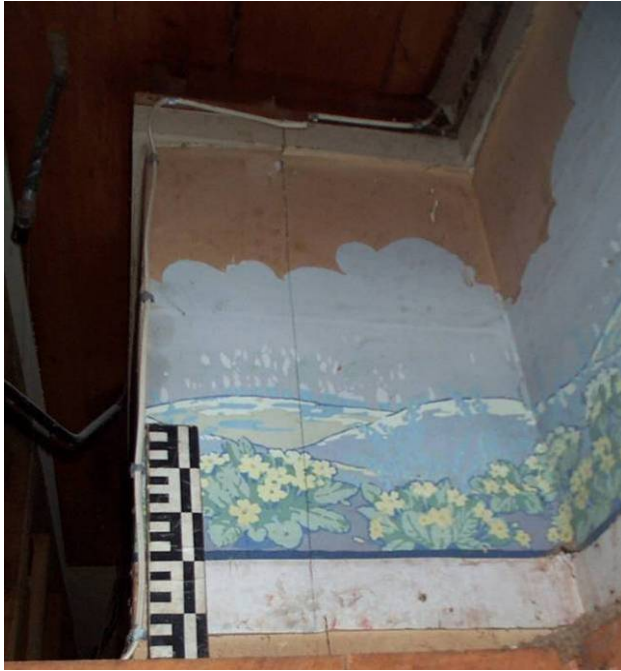
Figure 25. Wallpaper in cupboard in G04

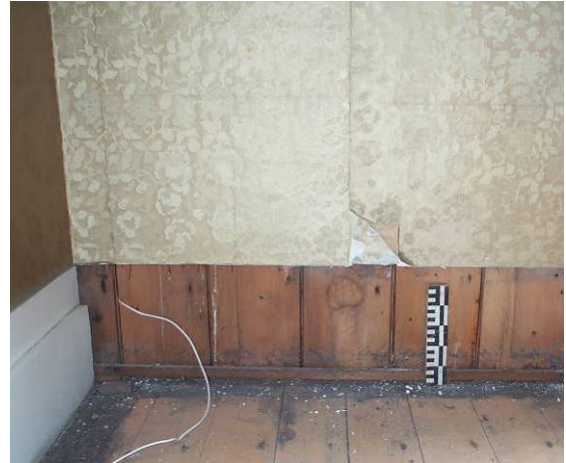
Figure 26. Wallpaper over vertical kauri sarking in dining room (G14)

Wallpaper was also present in the main dining room (G15) and as Figure 26 shows was laid on board over vertical rough panelling. However, this wallpaper probably dates to the Wright era and is not particularly old.

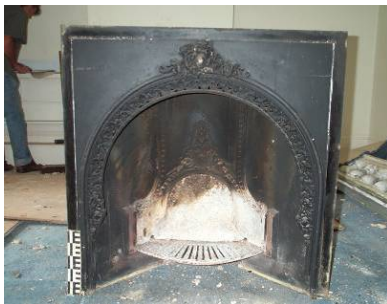
Figure 27. Fireplace in room G03

Only one early fireplace was identified, in the main lounge (room G03) (Figure 27). It was made of cast iron and of relatively simple design. The other fireplaces in room G01 (Figure 28), and G14 (Figure 29) were lined with marble and obviously later (the chimney in G01 had been removed prior to our work). This supports the theory that the G01 and G14 chimneys were later than the G03 chimney.

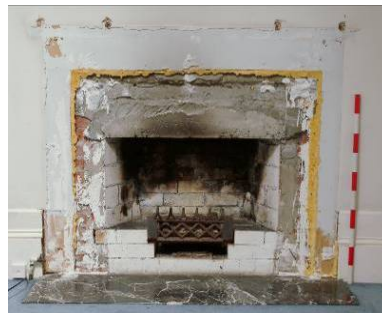
Figure 28. Fireplace in room G01

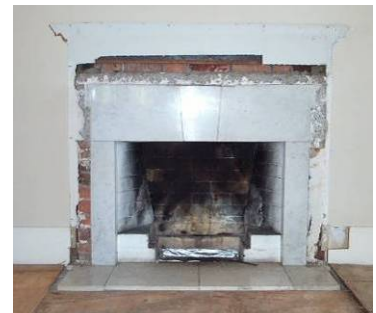
Figure 29. Fireplace in Room G14

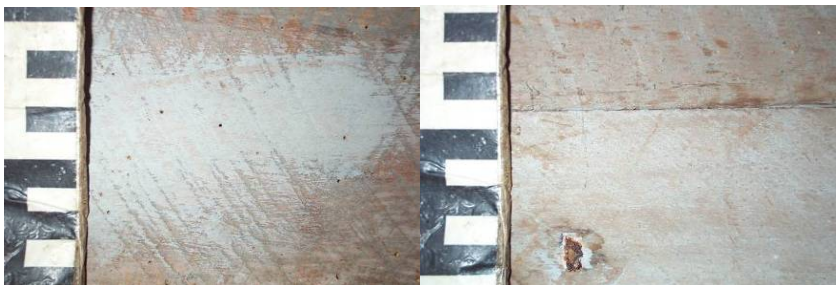
Figure 30. Circular (left) and banded (right) saw marks on kauri floorboards

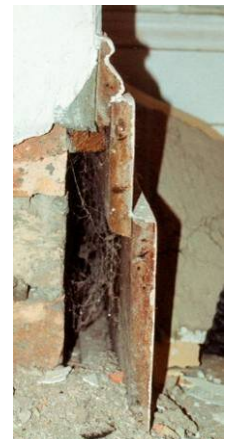
Figure 31. Example of skirting

A number of other components including the plaster work on the ceilings and the skirting (Figure 31) do suggest that many of the rooms were refurbished at various times. The older rooms in the core of the house have relatively high skirting which is fairly complex and made up of up to three pieces of wood, while in later rooms this was simplified.

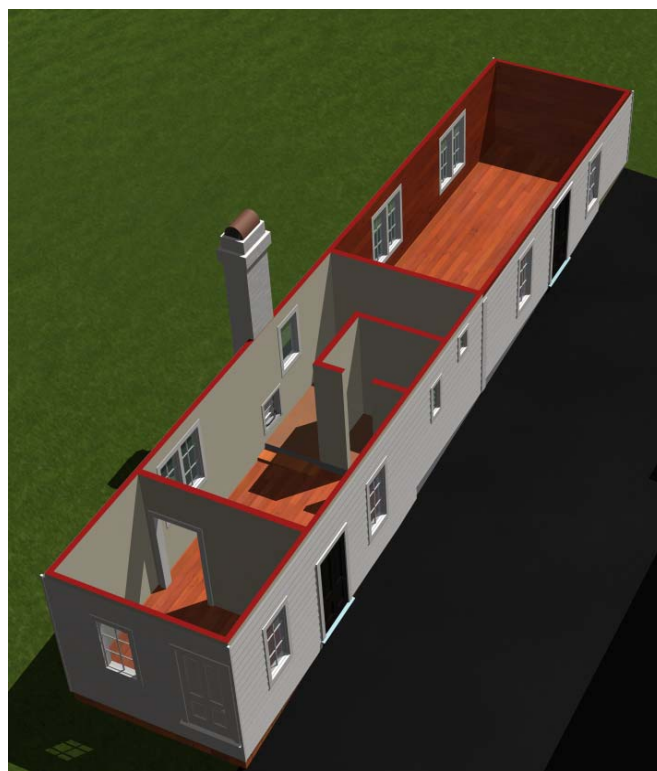
Figure 32. 3D model of Cottage during the final stage showing interior rooms

A 3D model of the cottage is presented in Figure 32. A profile of the cottage was drawn up and shows the main construction of the eastern original cottage. The information was based on the measurements of the various components prior to, during and after demolition (Figure 33).

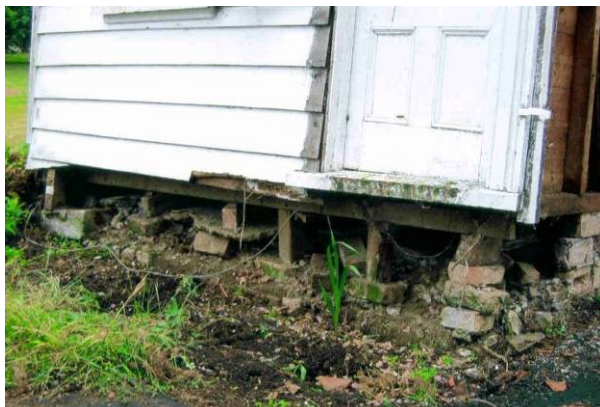
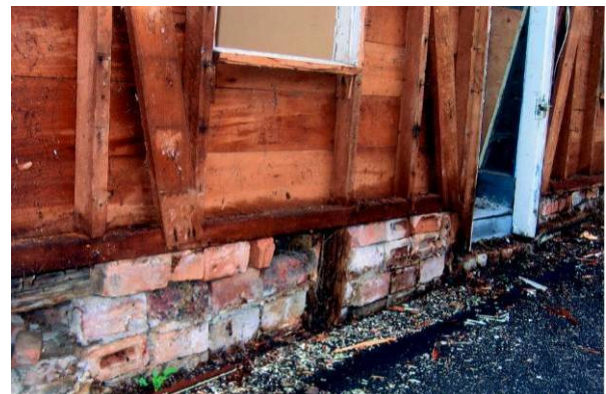
Figure 34. Base of cottage showing foundations (left: eastern end; right: north-east side)

The demolition of the eastern end of the cottage allowed for the different structural components of this oldest part of the structure to be recorded. Foundations were brick with timber bearers and walls studs framing additional courses of bricks were used to level the internal floor of the cottage (Figure 34).

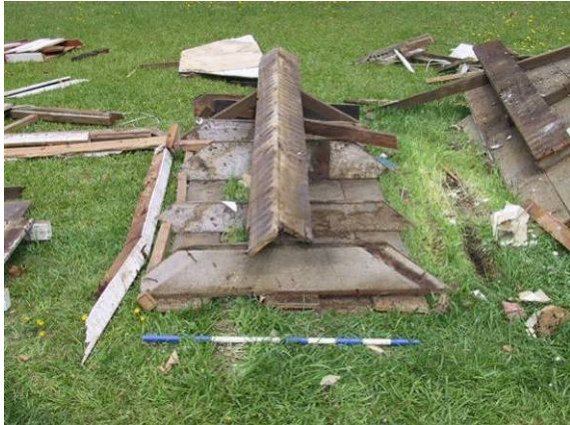
Figure 35. View of main ridge line of eastern end of cottage after demolition

The central ridge was made by bracing the two roof rafters together and it was capped with flat sawn ridge boards (Figure 35). Components of the ceiling showed a mixture of band and circular sawn kauri panels with tongue and groove side panels with regular cross bracing for the ceiling (Figure 36–Figure 38). Other components of the connection of the ceiling to the wall and bracing are shown in Figure 39 and Figure 40.

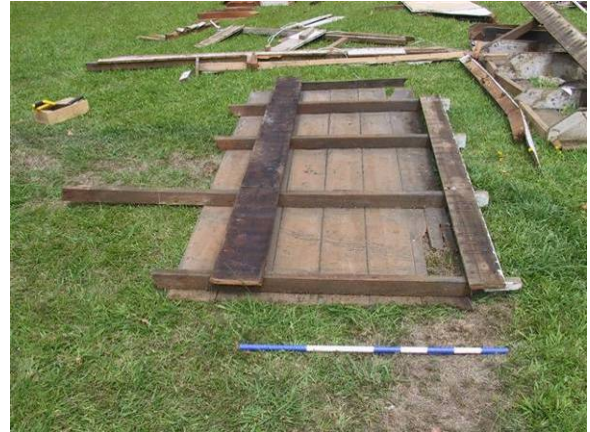
Figure 36. Ceiling of original cottage (topside)

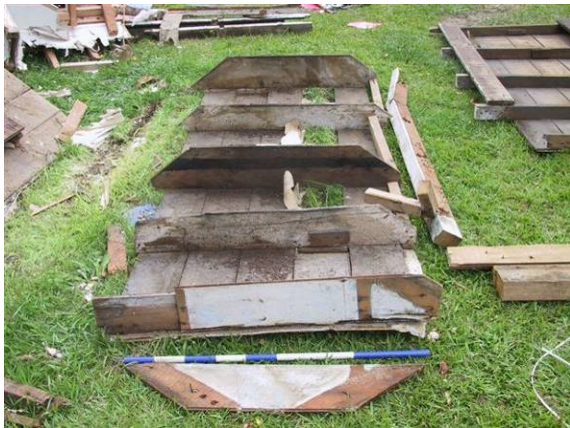
Figure 37. Reconstruction of ceiling elements and support of original cottage

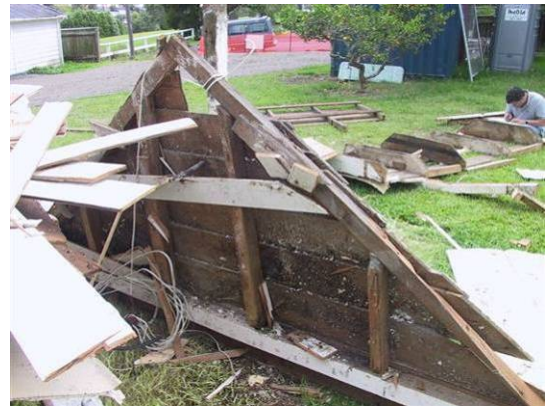
Figure 38. Interior of end-wall roof of cottage

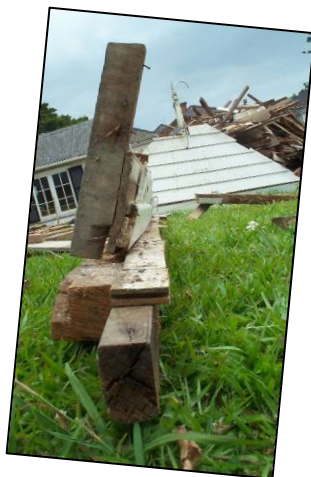
Figure 39. Connection of roof to wall studs in cottage

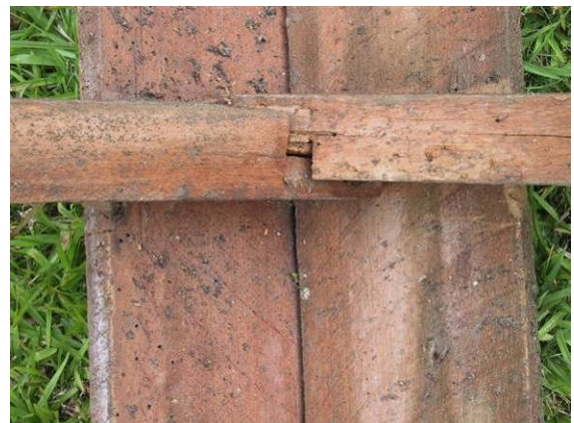
Figure 40. Ceiling bracing joint in cottage

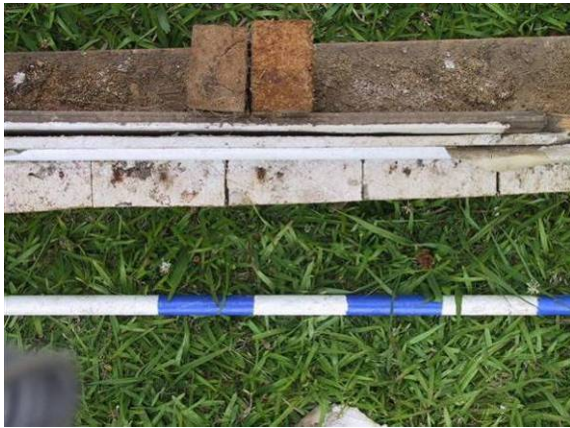
Figure 41. Join between wall and panelling in cottage

Other components of the cottage construction are detailed in Figure 41–Figure 45. The use of kauri throughout most of this original part of the cottage is of course not surprising, and illustrates the early preference for this material for building purposes. Other key elements are the mortise and tenon joint between the wall studs and the bottom plate (Figure 43). Close-up of the wall-sections illustrate that the walls were covered by a thin kauri sarking, over which gib had been added at some point. Covering that was the later wood panelling (Figure 44) framed at the base with kauri (Figure 46).
