139 ARNEY ROAD, REMUERA

Final Archaeological Report R11/2341,
NZHPT Authority No 2006/80

139 ARNEY ROAD (SITE R11/2341), REMUERA: FINAL ARCHAEOLOGICAL REPORT

In Fulfilment of NZHPT Authority No. 2006/80

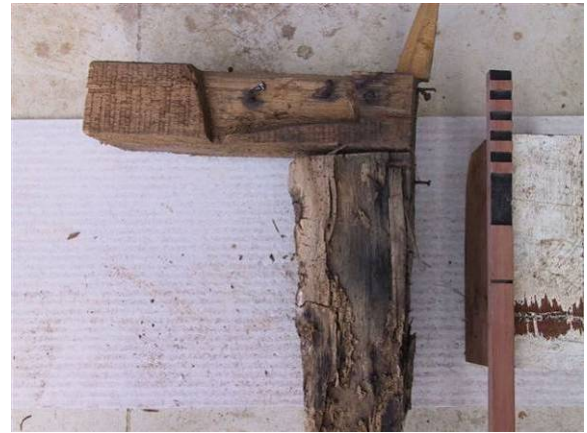
Figure 42. Bottom plate for wall and corner pile

Other components of the cottage construction are detailed in Figure 41–Figure 45. The use of kauri throughout most of this original part of the cottage is of course not surprising, and illustrates the early preference for this material for building purposes. Other key elements are the mortise and tenon joint between the wall studs and the bottom plate (Figure 43). Close-up of the wall-sections illustrate that the walls were covered by a thin kauri sarking, over which gib had been added at some point. Covering that was the later wood panelling (Figure 44) framed at the base with kauri (Figure 46).

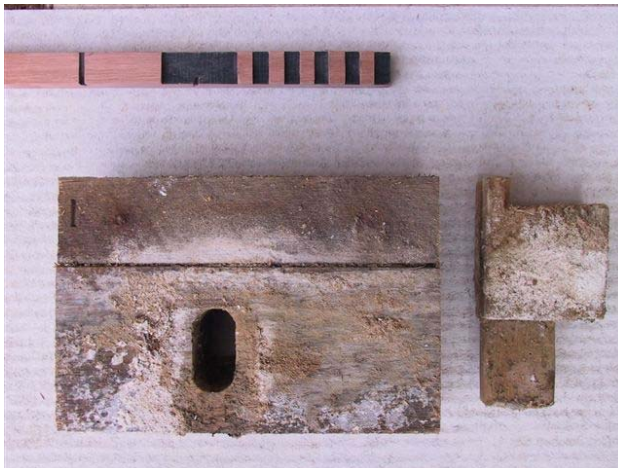
Figure 43. Bottom plate and stud

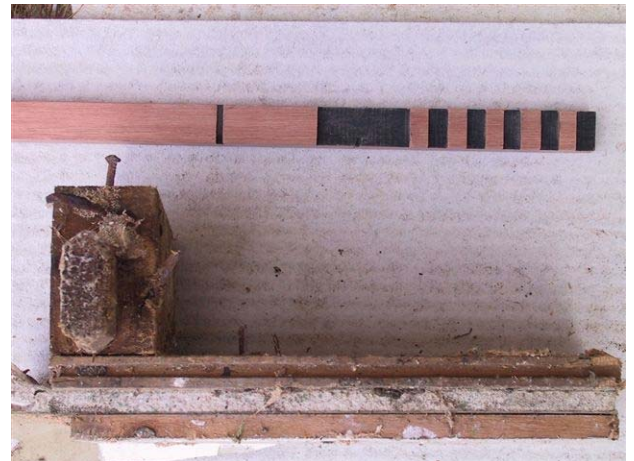
Figure 44. Cross-section showing wall and gib on wall stud in eastern end of cottage

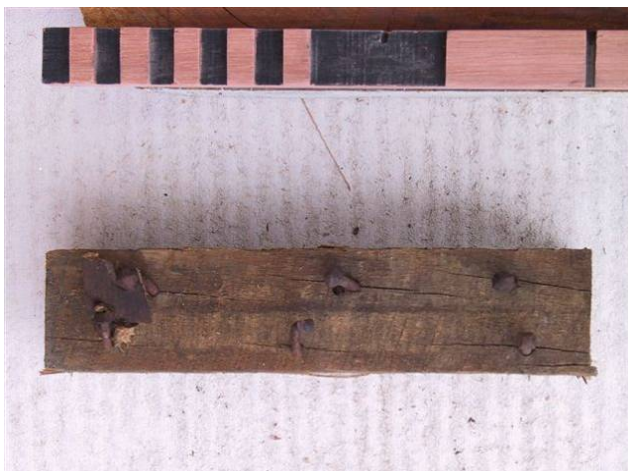
Figure 45. Bearer for wall panelling in cottage

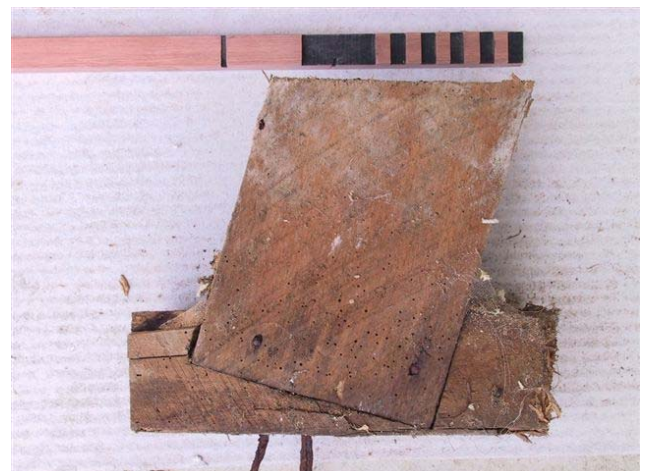
Figure 46. Bearing bracing pile

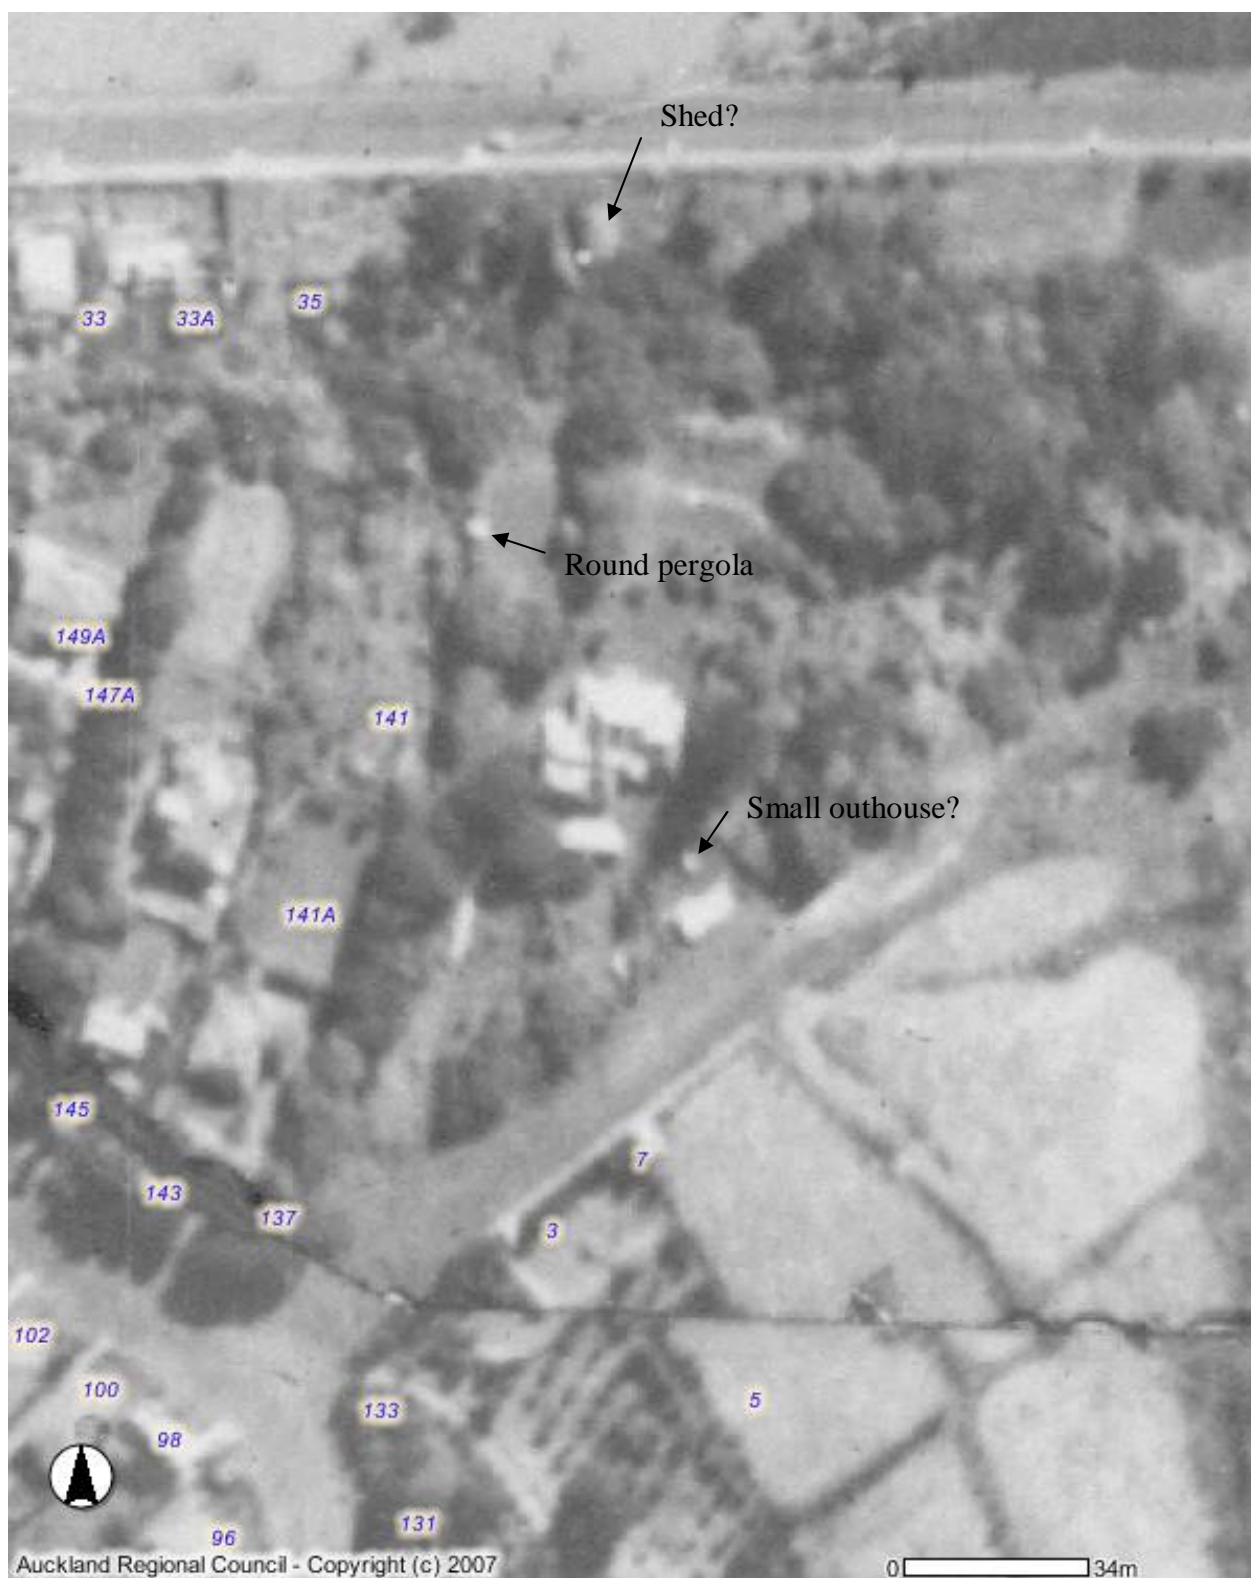
Figure 48. 1940 Aerial of the property (ARC Website) arrow showing smaller structures

The sequence of available aerial photographs from 1940, 1959 and 2001 (Figure 48-Figure 50) show some of the later changes to the property. In 1940, a small outhouse (?) may have been near the stables and there may also have been a small structure down by the road – perhaps a shed or boatshed. A round pergola on the western side (still present in 2007) was also identifiable. The terraces, though, were relatively clear, although the quality of the photograph does not make the tennis court very easy to identify.

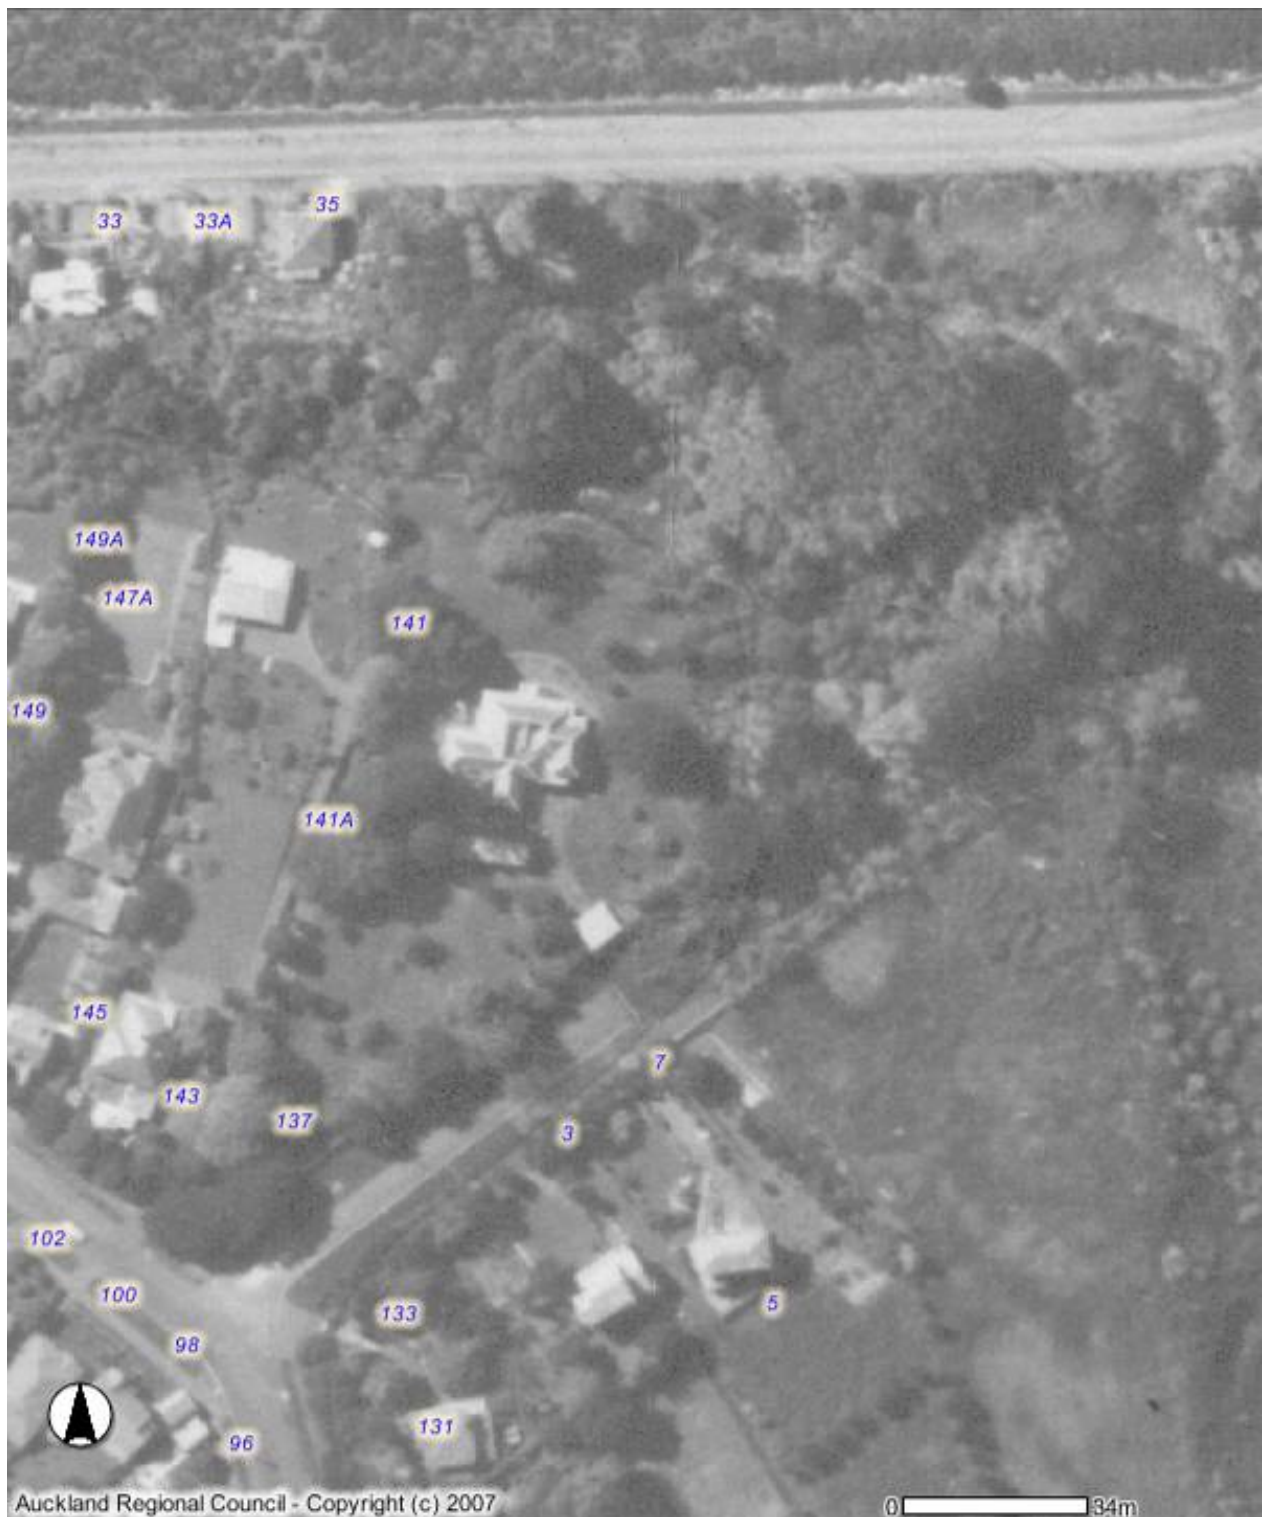
Figure 49. 1959 Aerial of the property (ARC Website)

By 1959 (Figure 49), the garage and brick pathway was in place but the lighting does not particularly highlight the terraces. The vegetation around the property was also starting to obscure the northern and eastern parts of the property and by 2001 (Figure 50) was quite dense. No sign of the possible structures identified in the 1940s aerial were visible with the exception of the round pergola at the western side of the property.

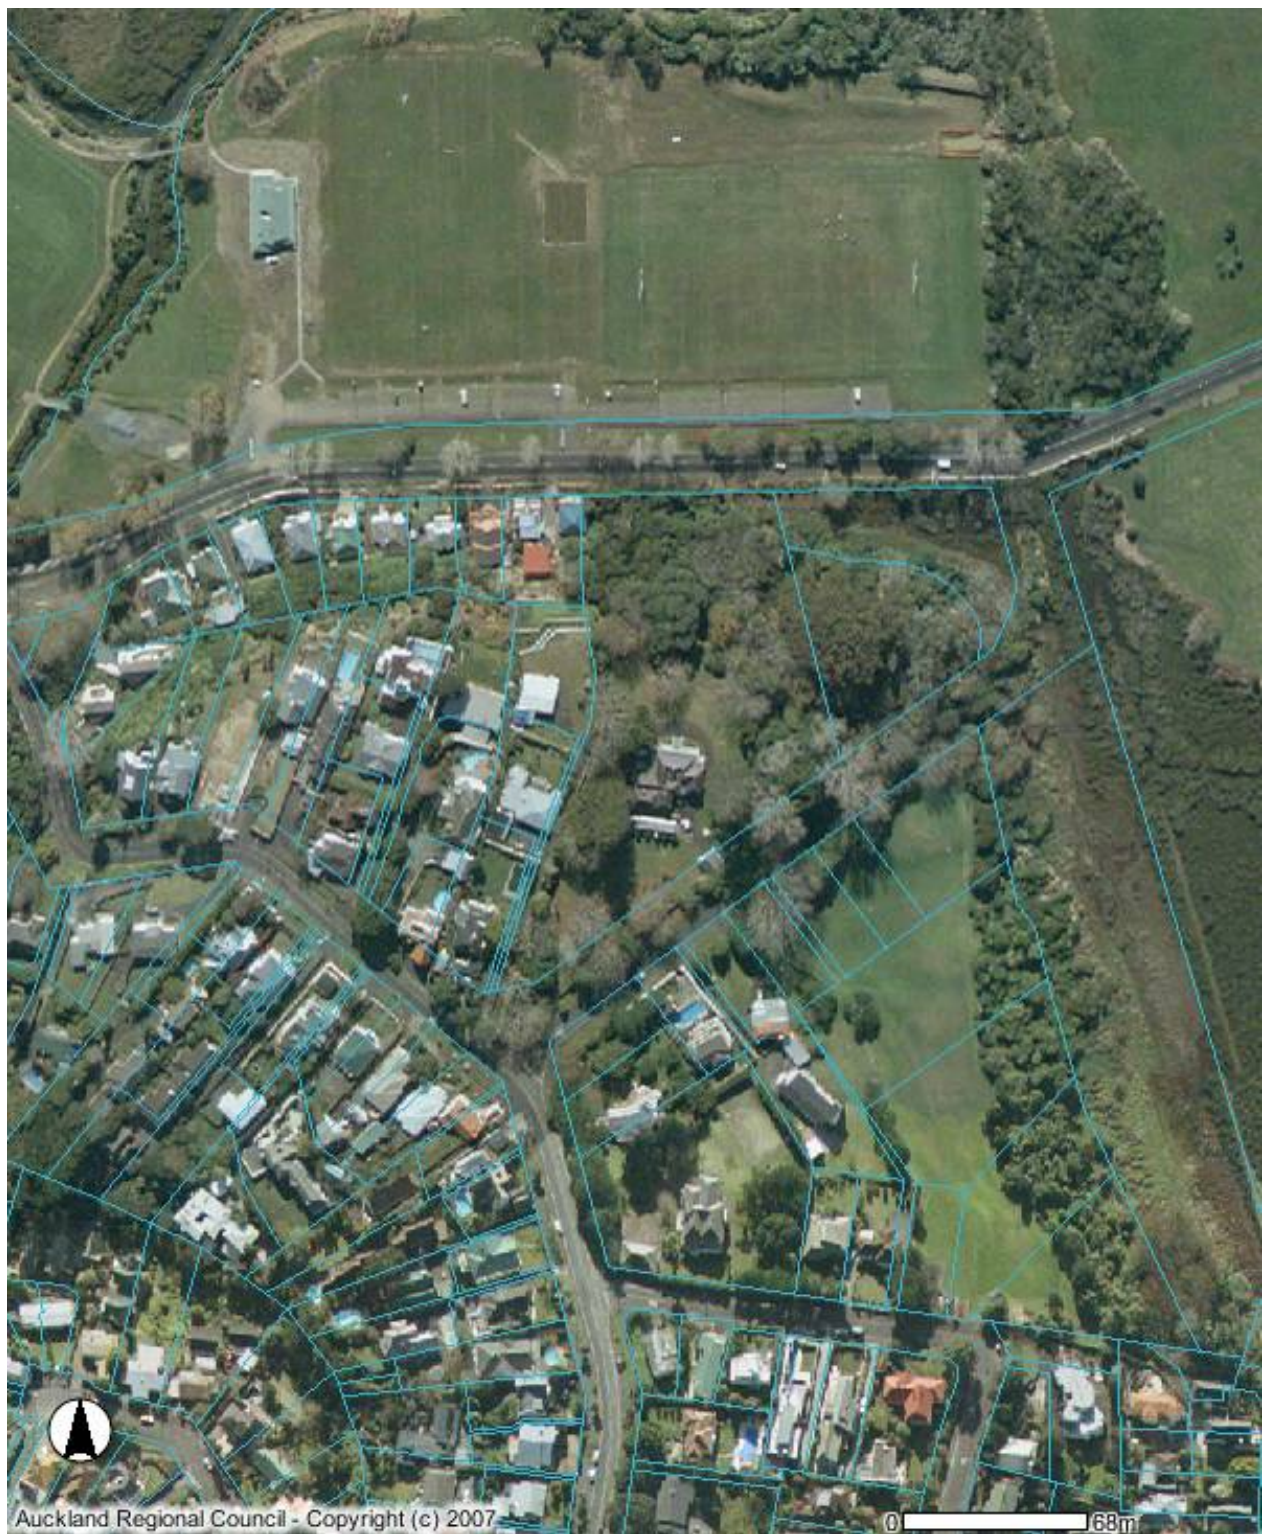
Figure 50. 2001 Aerial of the property (ARC Website)

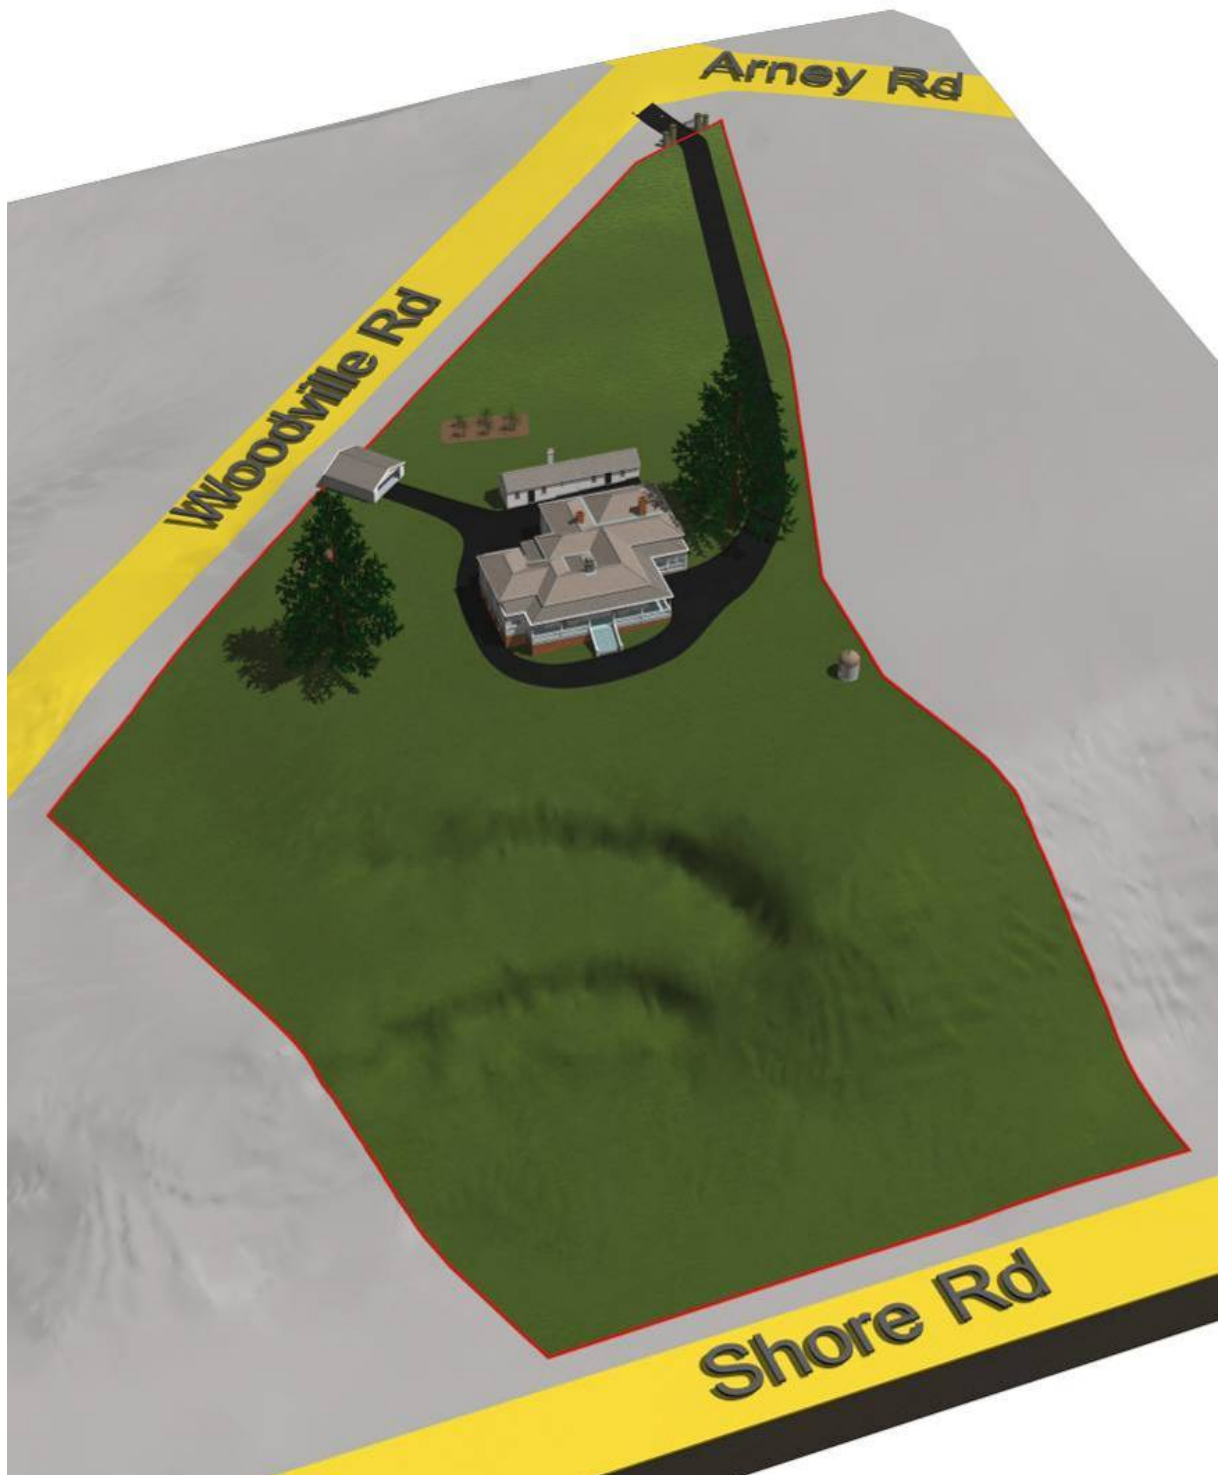
Figure 51. 3D Computer based model using LIDAR data showing reconstructed terraces

A 3D computer model of the property based on the LIDAR data was generated (Figure 51). Here it was possible to reconstruct the terraces to show how they might have looked prior to their gradual slumping. Close-up views of the model show the southern end of the property during its final phase (Figure 52) and elements such as the entrance gate (Figure 53).

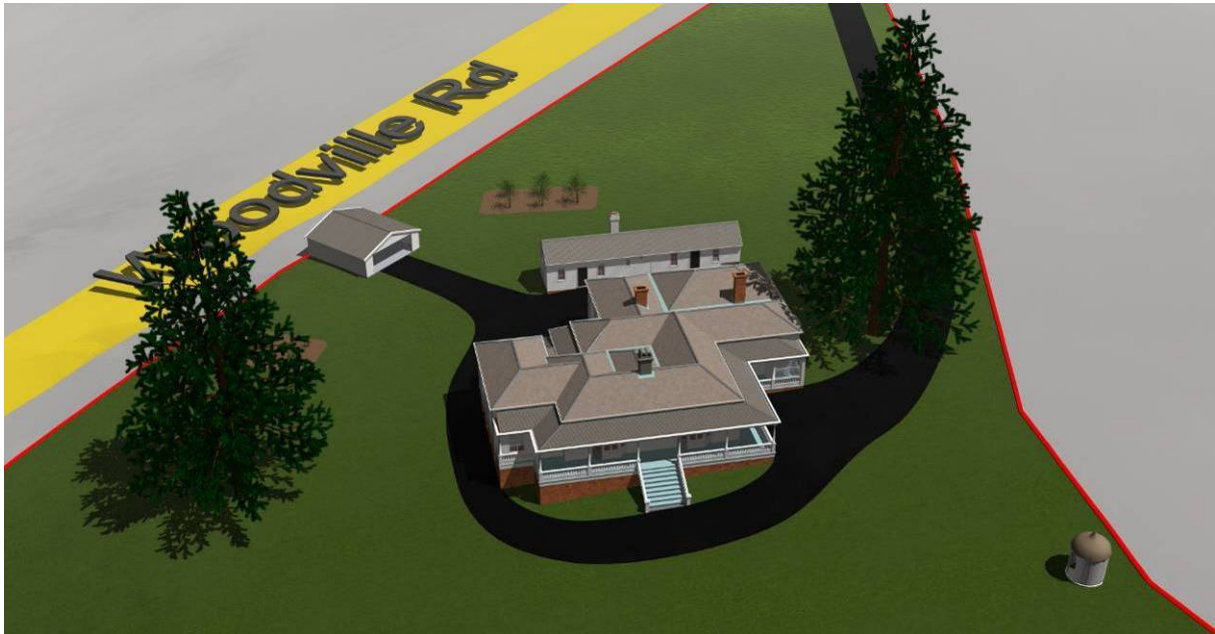
Figure 52. 3D Computer based model showing southern end of the property and major structures during the 1960s

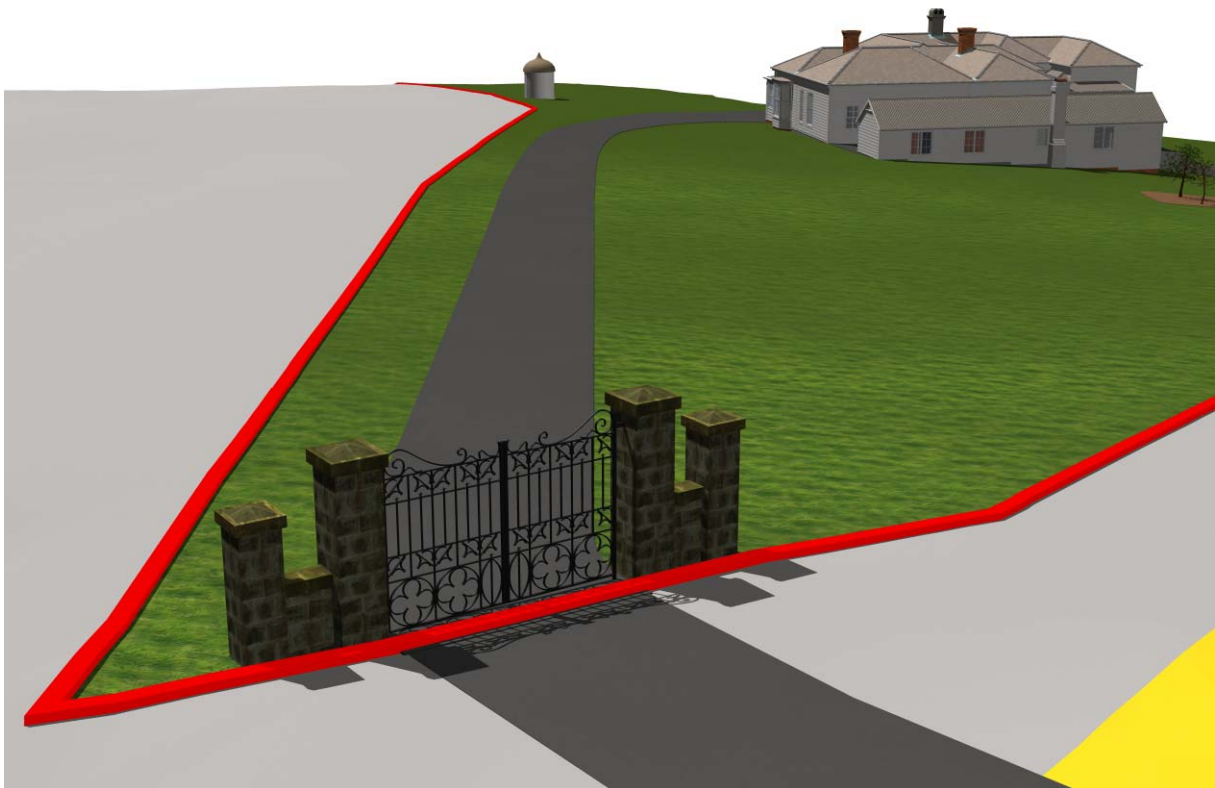
Figure 53. View of 3D constructed from SW corner of the property showing model of the gated entrance

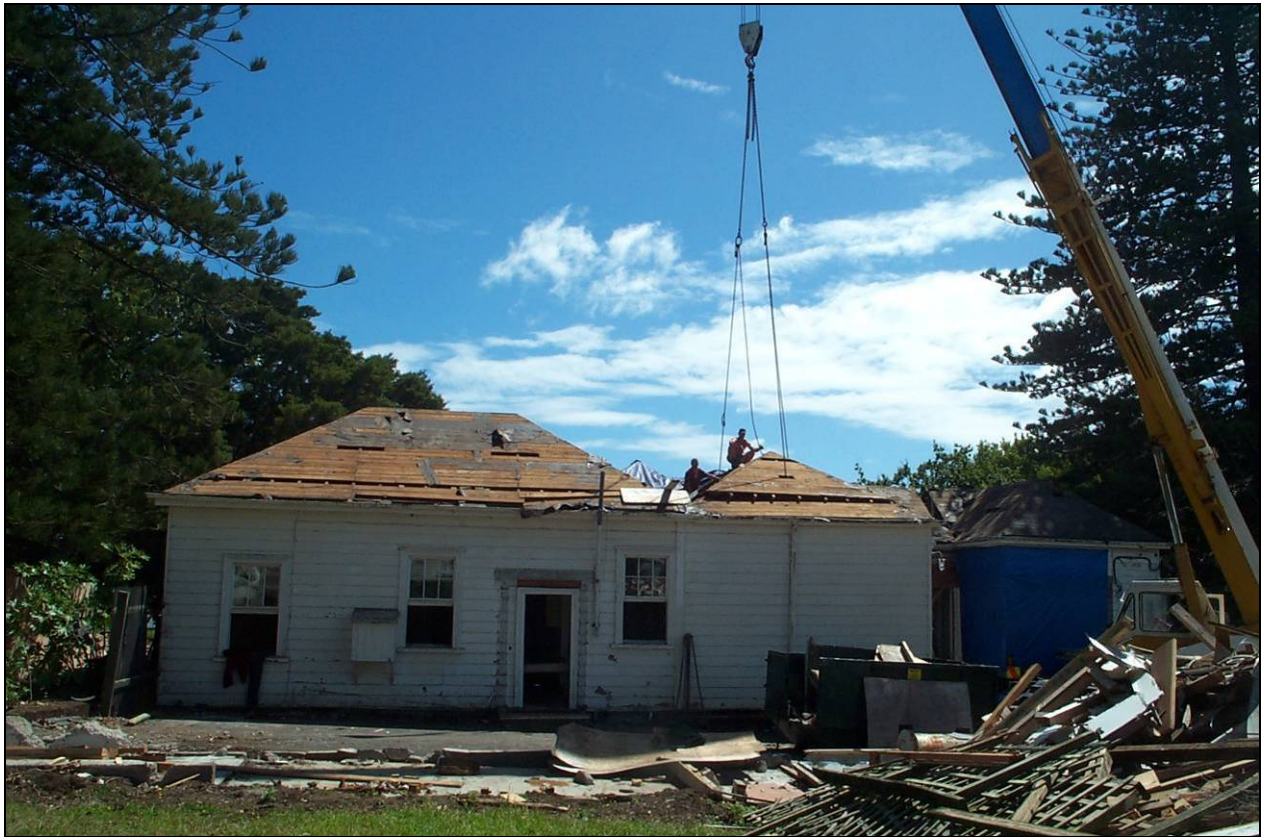
Figure 55. Dismantling of the main house

The main house was dismantled in February 2006. External structures such as decks and some of the later additions were demolished, but the bulk of the main house was cut into sections (Figure 55) and moved to the new location at South Head, Kaipara. The removal of the house (Figure 56) allowed additional recording of the main structures which was incorporated in the recording of the house described earlier.

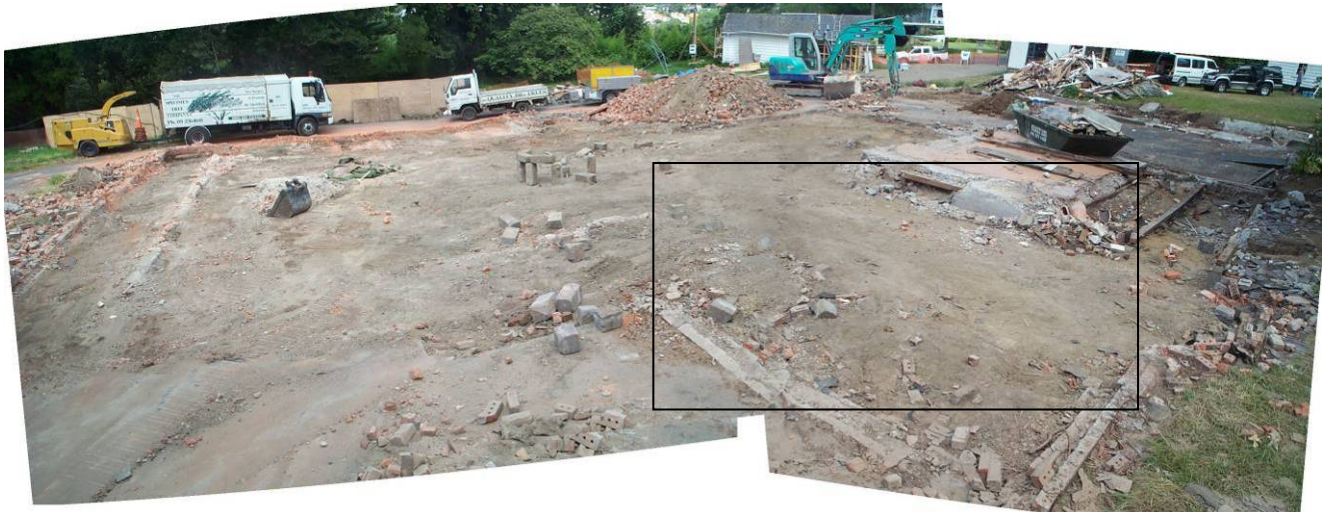
Figure 56. View of area of house after house removal

(Area of Figure 57 indicated)

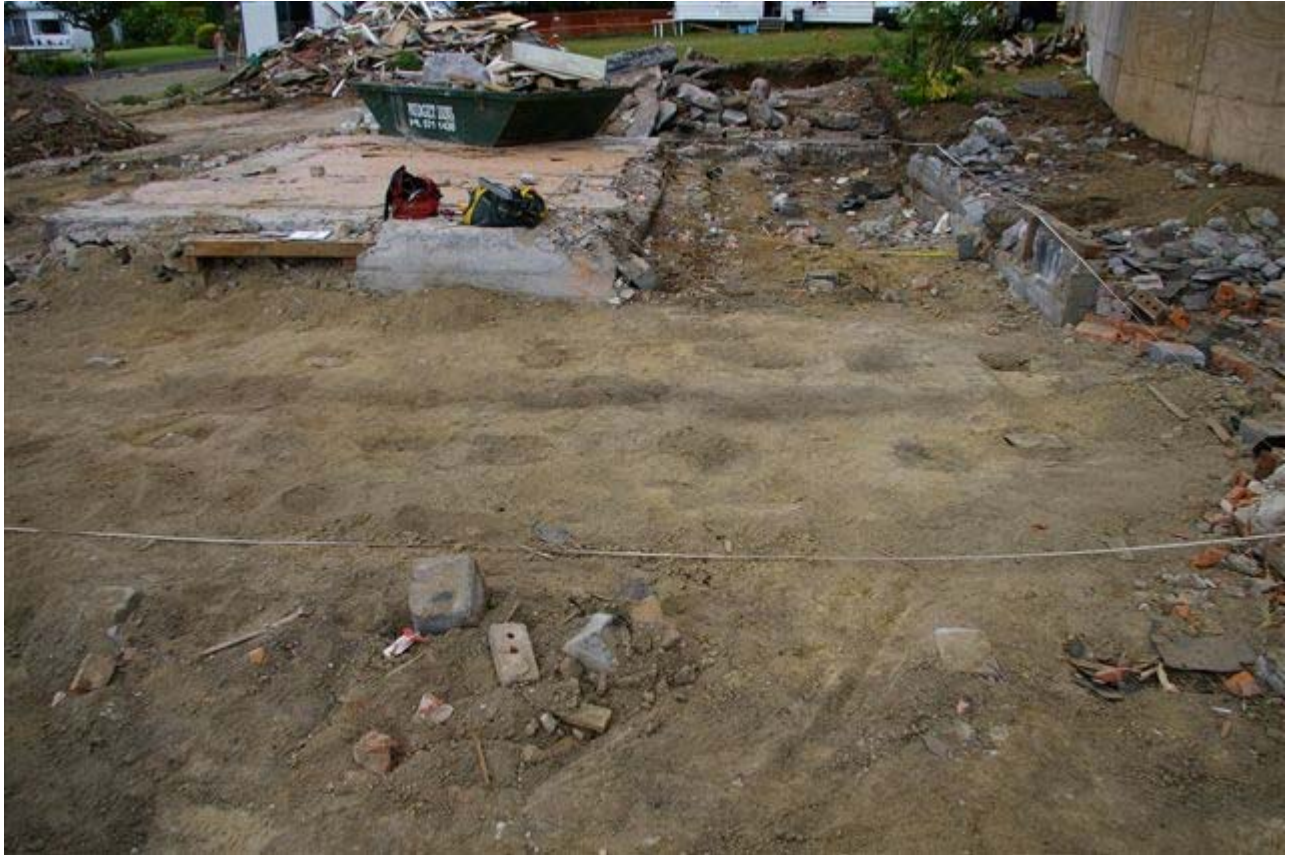
Figure 57. View of old pile shadows under room G14 (sitting room/parlour)

Overall, very little new information was gained from the investigations under the house, although recording of the piles and foundations was carried out. Remnant pile locations were visible, particularly near the kitchen (Figure 57) but in also places elsewhere (Figure 58). A sample of the bricks used in the foundations was recorded (Figure 59) but they were all un-diagnostic as regards to manufacturer. A range of sandstock and moulded bricks was present and the impression was that overall the bricks used in the piles and main foundations were earlier than those used in the verandah foundations (Figure 60). The information contributed to the 3D model.

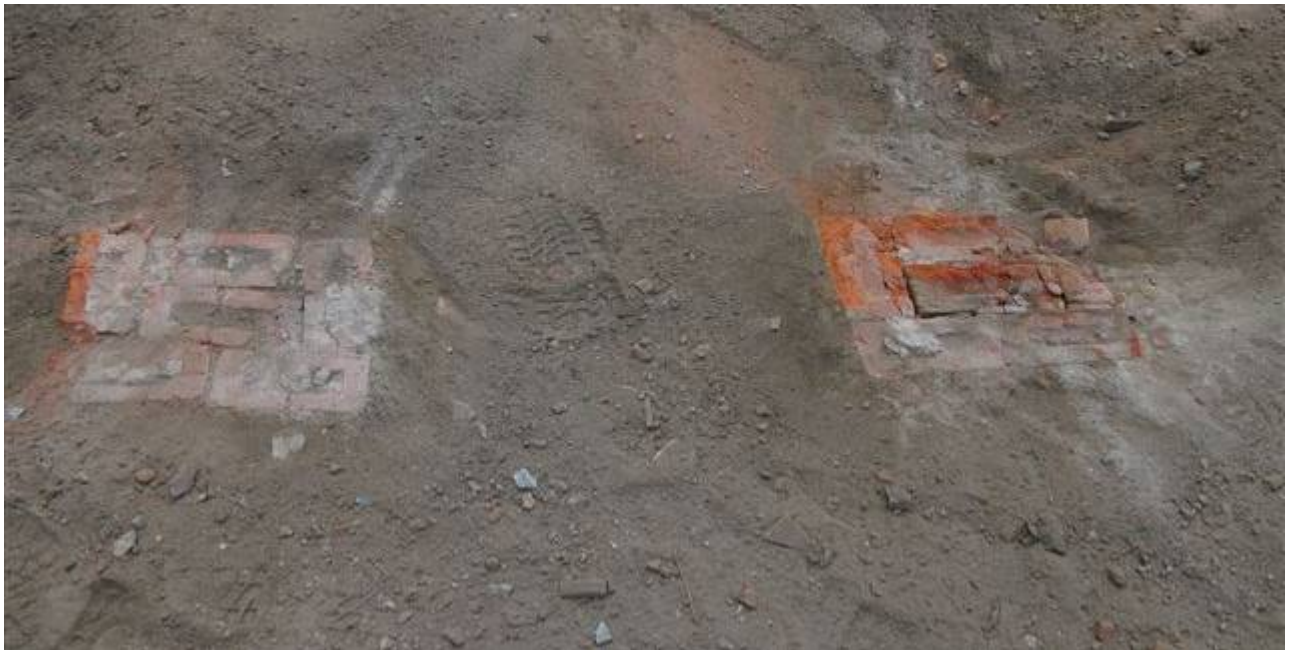
Figure 58. View of remnant brick piles under the main part of the house

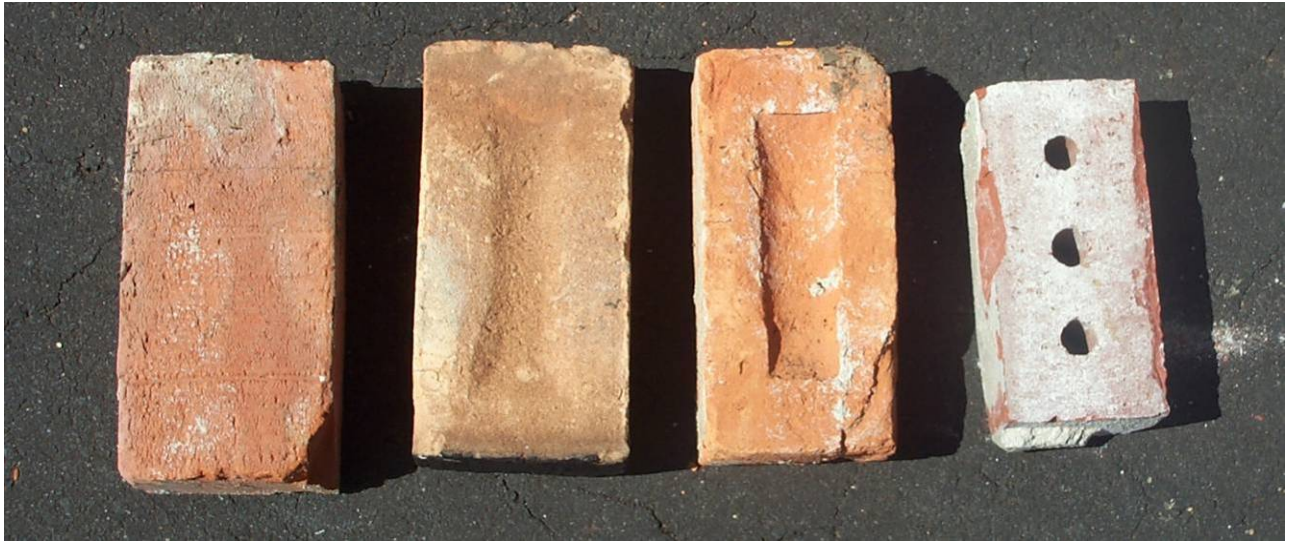
Figure 59. Range of bricks found in the house foundations

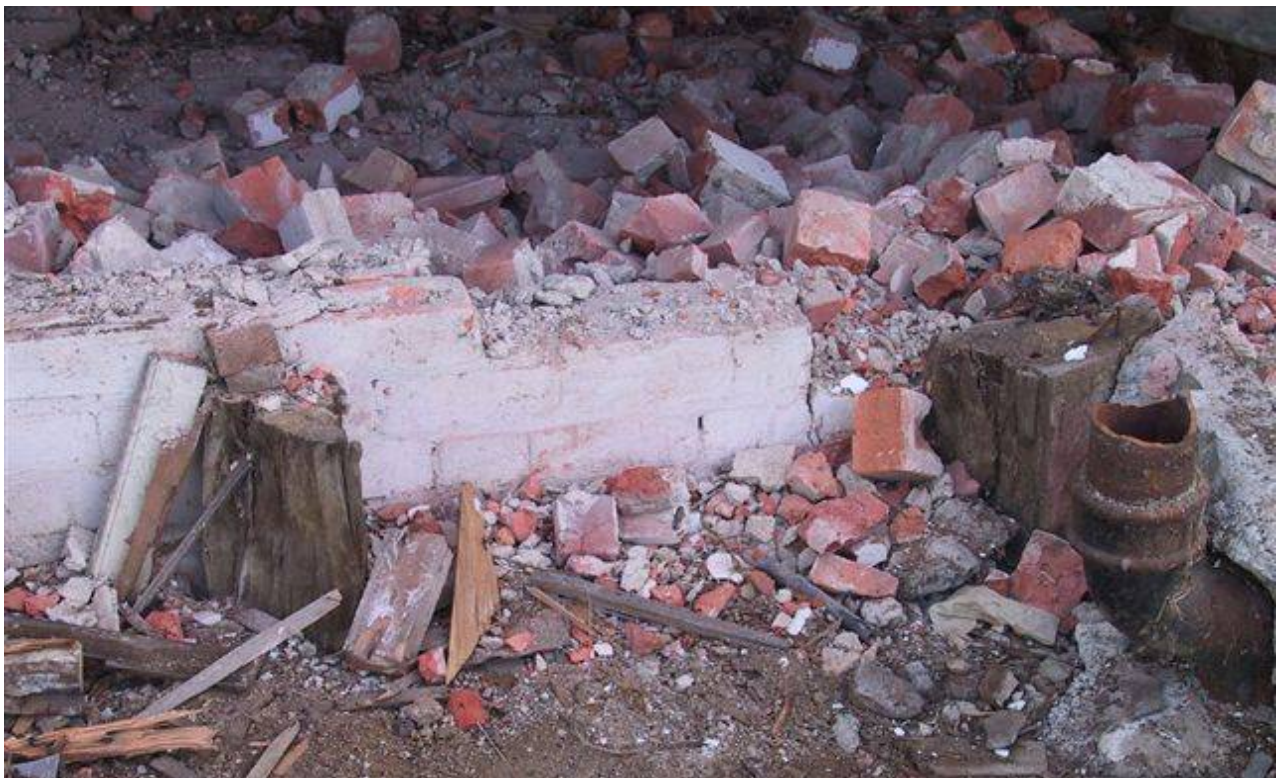
Figure 60. Wooden piles in southeast corner of the house outside later brick foundations

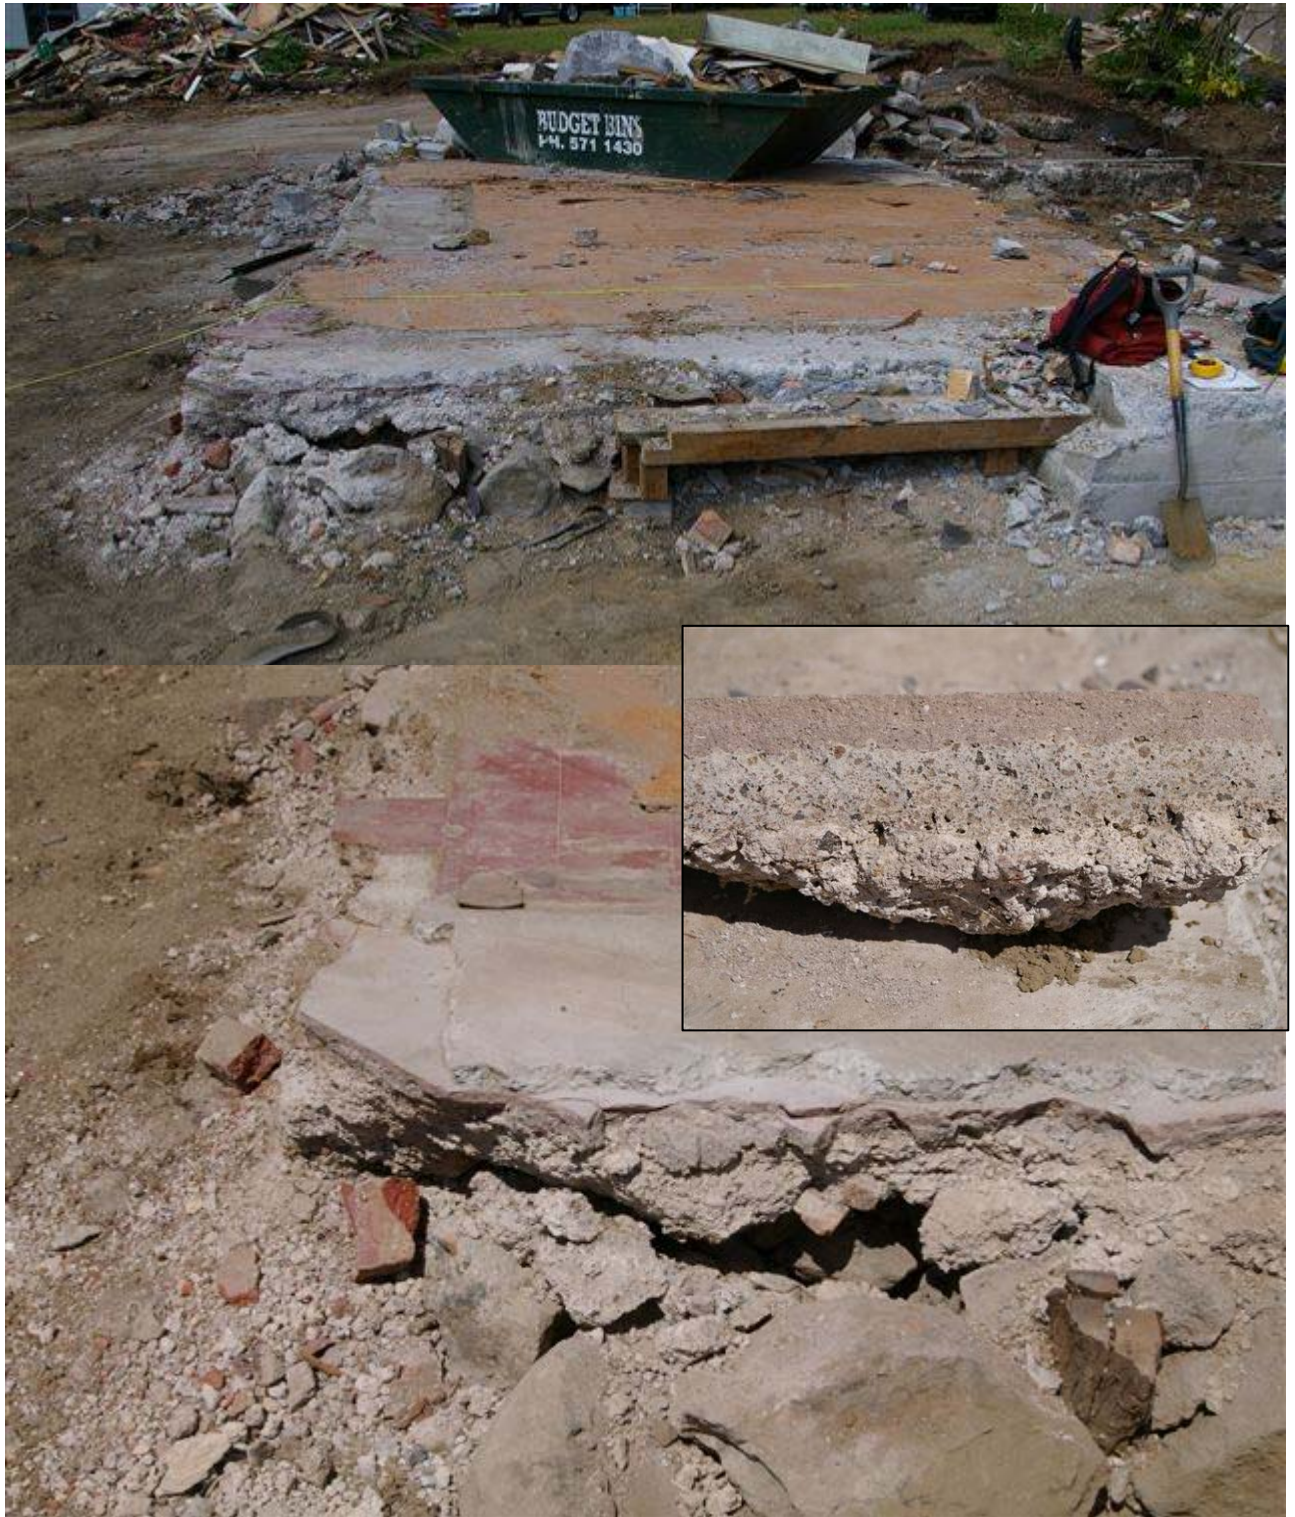
Figure 61. View of concrete pad from the kitchen area showing layers of early concrete and later tiling.

(Inset showing early concrete from base of pad)

The other area of interest was the concrete pad under the kitchen (Figure 61) which showed the layering of different types of concrete used in construction followed by different tiling used through its lifetime.

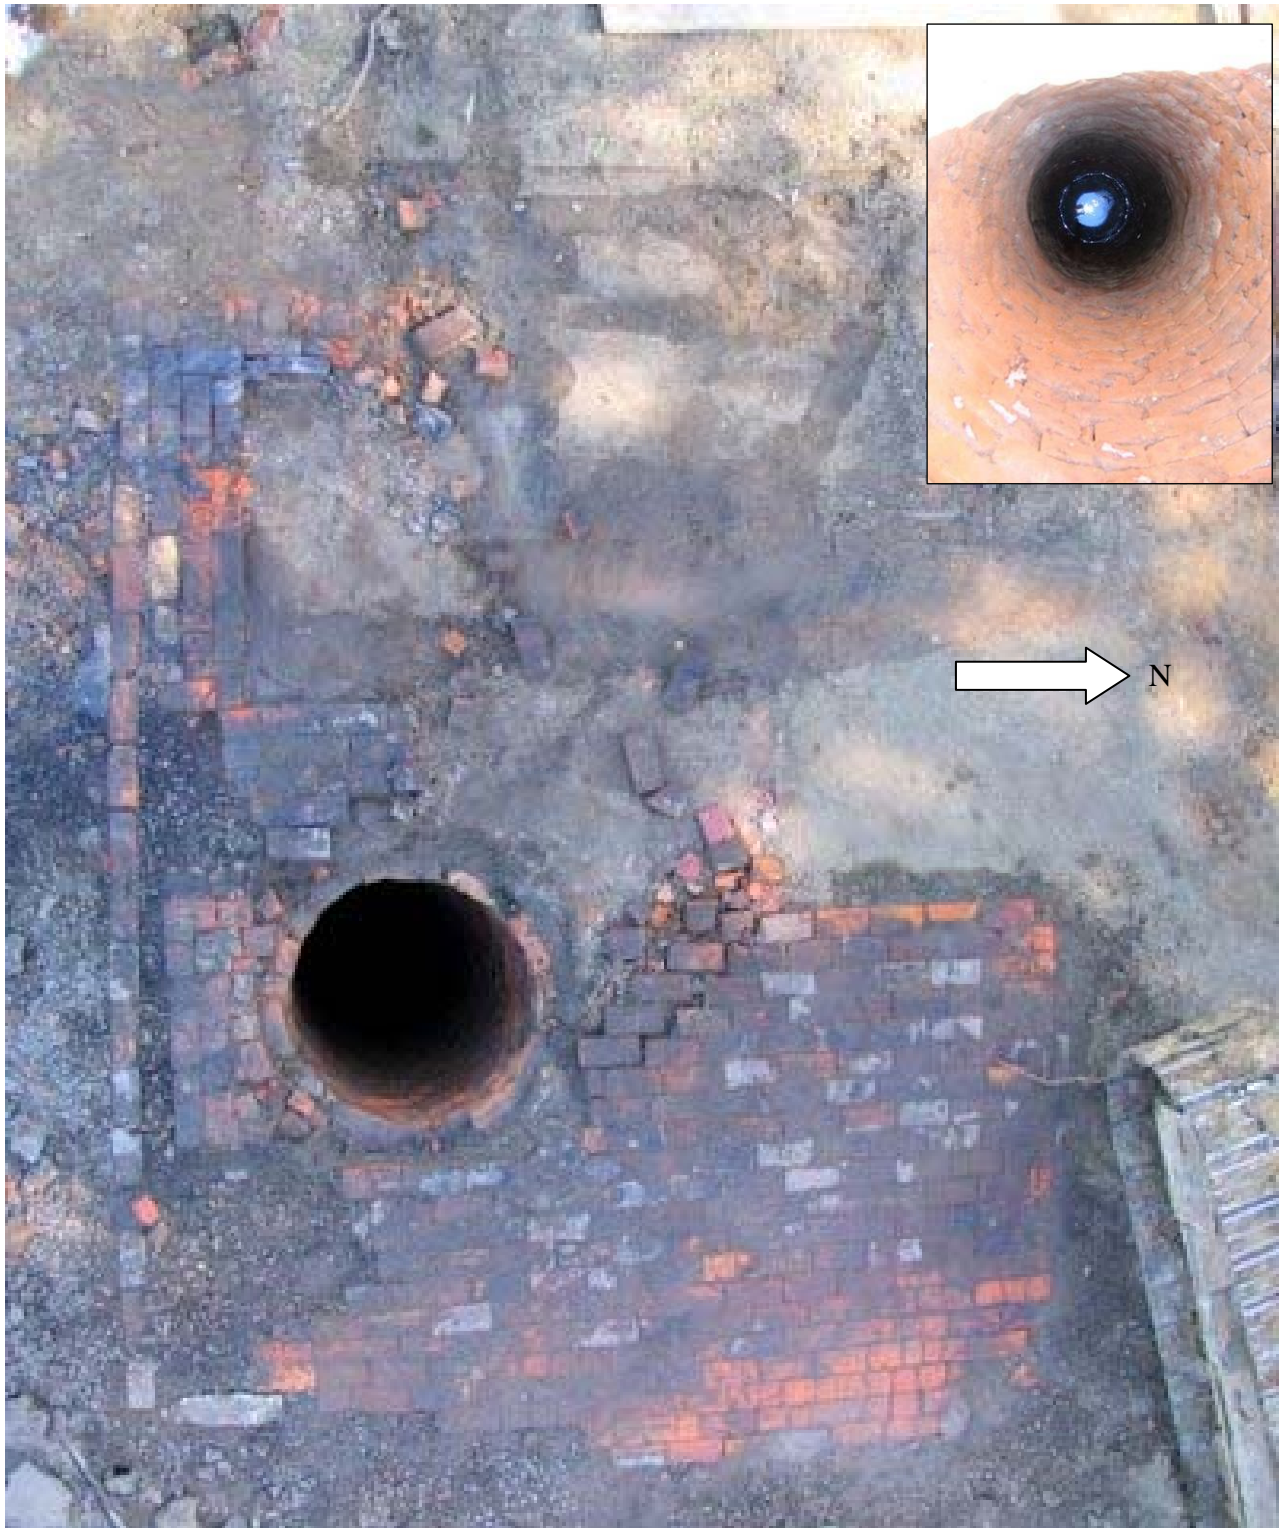
Figure 63. Plan view of brick lined well in brick paved area

A well located behind (south of) the original house was identified during monitoring of the building (Figure 4, Figure 63). The brick well was under the asphalt and around 1.2m in (external) diameter. The well was set in a brick paved area or courtyard around 3.7m wide and 4.5m long. The well had not been filled in but it was possible to recover a collection of bottles from the bottom (over 10m deep) for analysis.

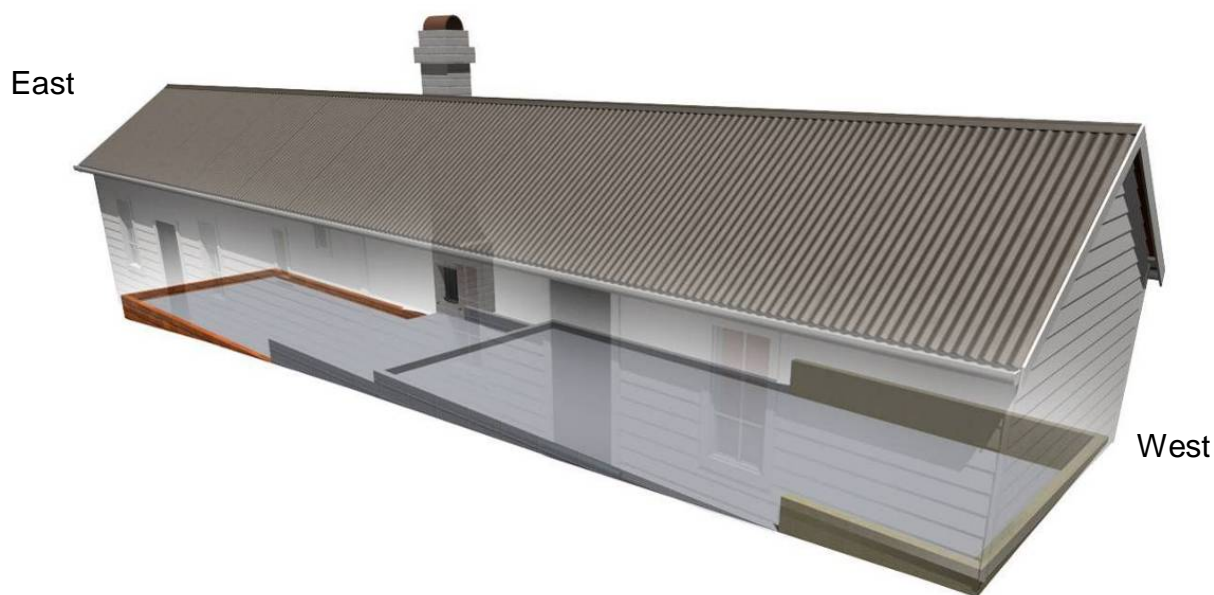
Figure 69. X-Ray view of cottage above showing original floor levels

Excavation of the cottage area revealed little new information regarding the occupation of the site beyond some limited structural details. The original floor levels were reconstructed and are shown in Figure 69. The earlier eastern floor was a thin plaster/concrete, while the western end is a dense more modern concrete.
