139 ARNEY ROAD, REMUERA

Final Archaeological Report R11/2341,
NZHPT Authority No 2006/80

139 ARNEY ROAD (SITE R11/2341), REMUERA: FINAL ARCHAEOLOGICAL REPORT

In Fulfilment of NZHPT Authority No. 2006/80

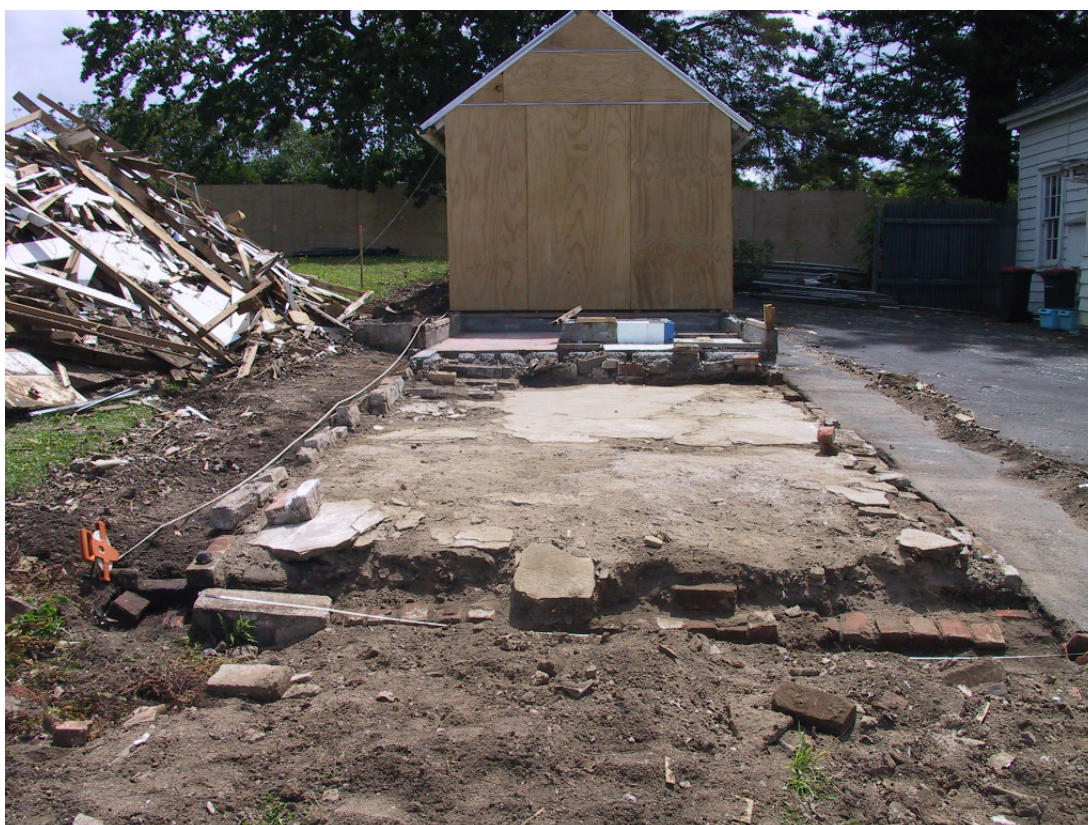
Figure 70. Excavation of eastern cottage foundations

The work on the cottage took place in two phases. The eastern (earlier) end was investigated after that half of cottage was demolished. The excavation (Figure 70, Figure 71) outlined the original brick foundations of the building and remains of the floor plate, totara piles and fragmentary plaster floor. Most interesting was the fill under the floor which contained fragmentary 19th century rubbish fill which included butchered sheep and cow bone. The material was relatively scattered and may have been dumped to level the ground.

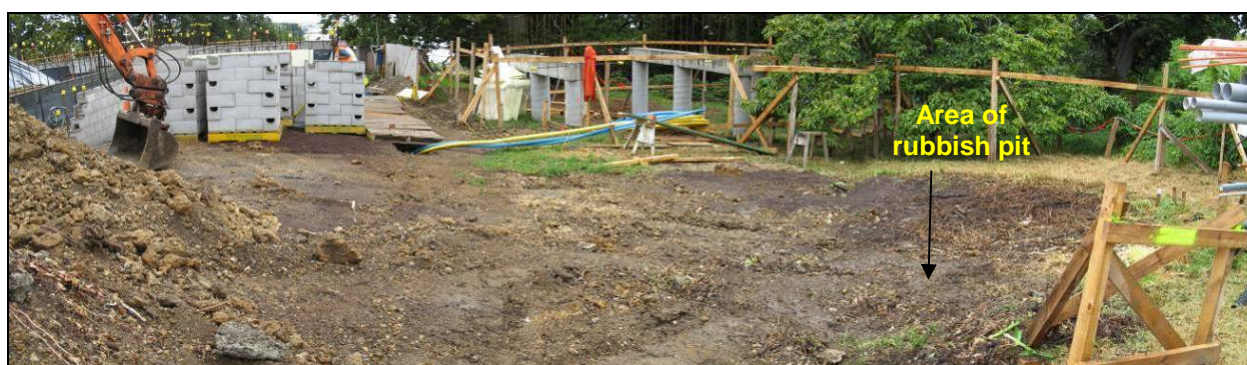
Figure 74. View of area monitored in 2007 north of garage (see Figure 4)

This area was not expected to be particularly productive but the work was carried out as a precaution given the proximity of the original house and the stables. The area was cleared (Figure 74) and trenches for the new building were dug. They revealed a soil profile of around 30cm of dark topsoil over the yellow clay natural base (Figure 75).

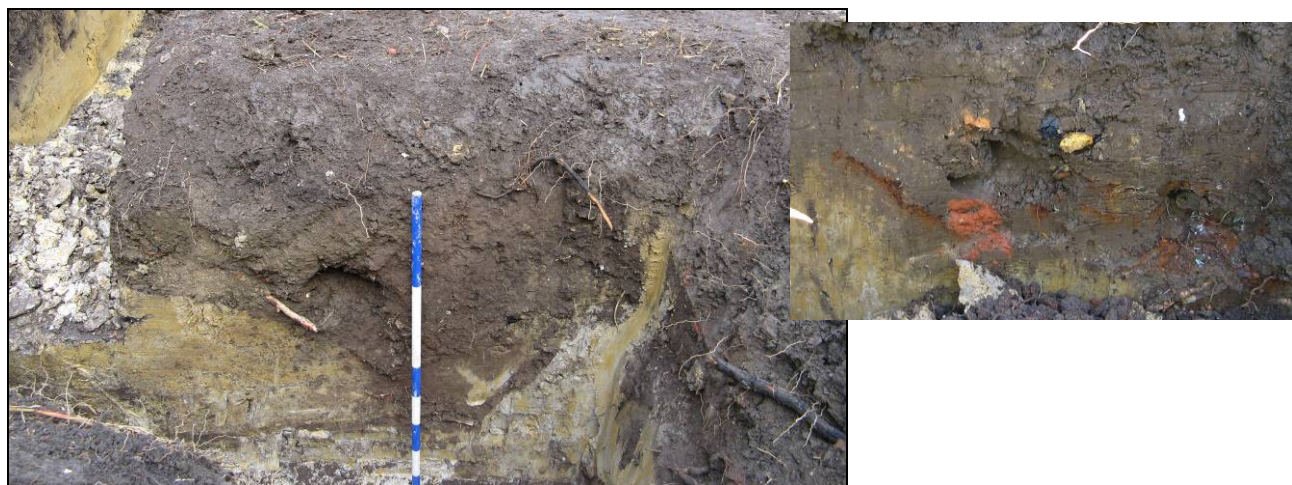
Figure 76. View of section of the rubbish pit showing brick and other fragments (inset)

One small rubbish pit was identified in the north-east corner trench with some crushed brick (Figure 4). The pit had a diameter of around 80cm. The artefacts were few and highly fragmented. They included a small number transfer-print ceramics and other ceramic items including fragments of a stoneware jar typical of late 19th/early 20th century sites (Figure 77). This pit may relate to rubbish pits identified by Foster (2005) during his initial assessment.

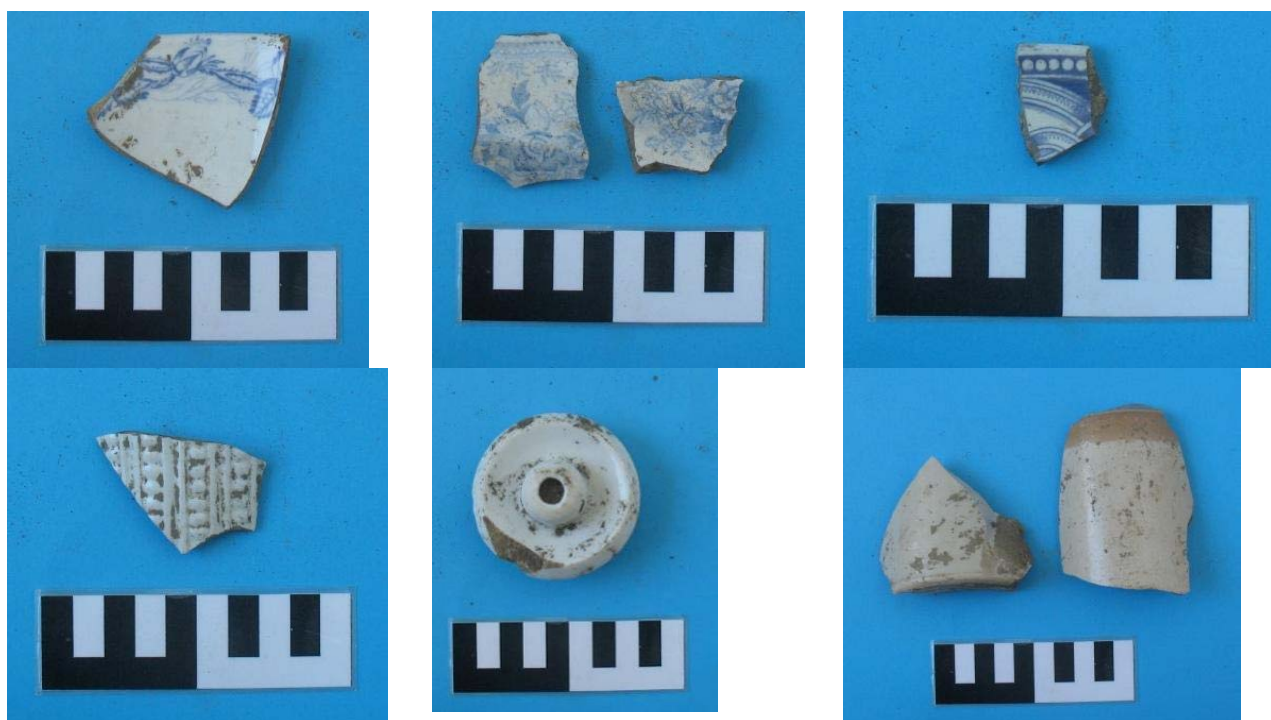
Figure 77. Artefacts from the rubbish pit

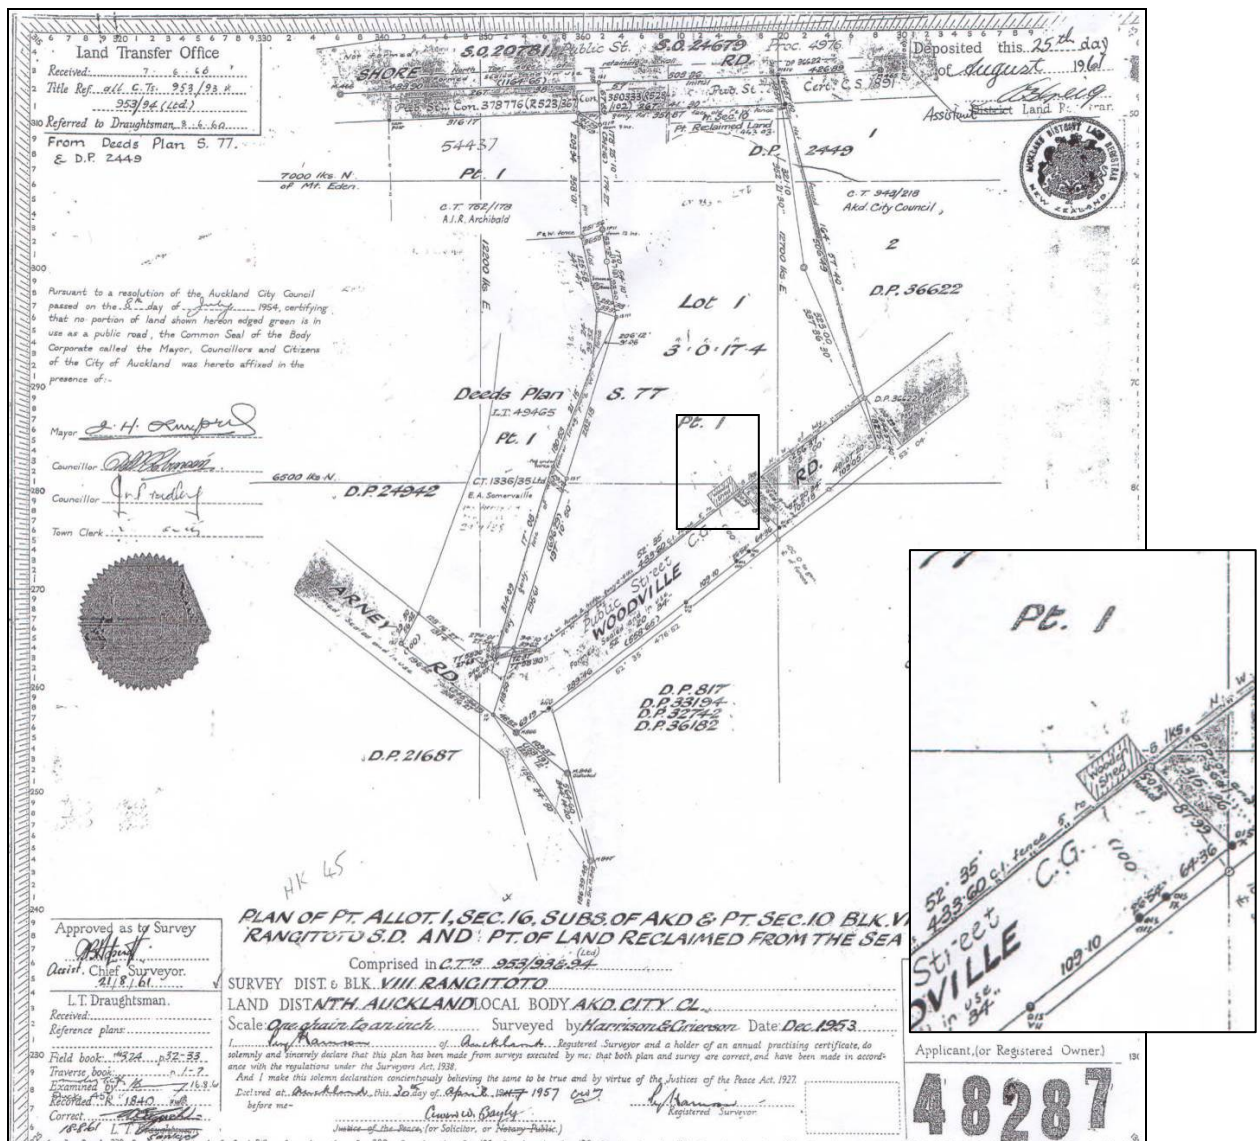
Figure 78. DP 48287 dated 1953 showing wooden shed

One of the major priority areas for the investigation was the area of the previous stables, thought to be the building marked on a 1953 plan as a shed (Figure 78). This had been demolished in 1952 and replaced with a garage. It had not earlier been possible to assess whether any remains of the stables were under the garage, but in November 2008, the garage was removed and it was possible to carry out investigations.

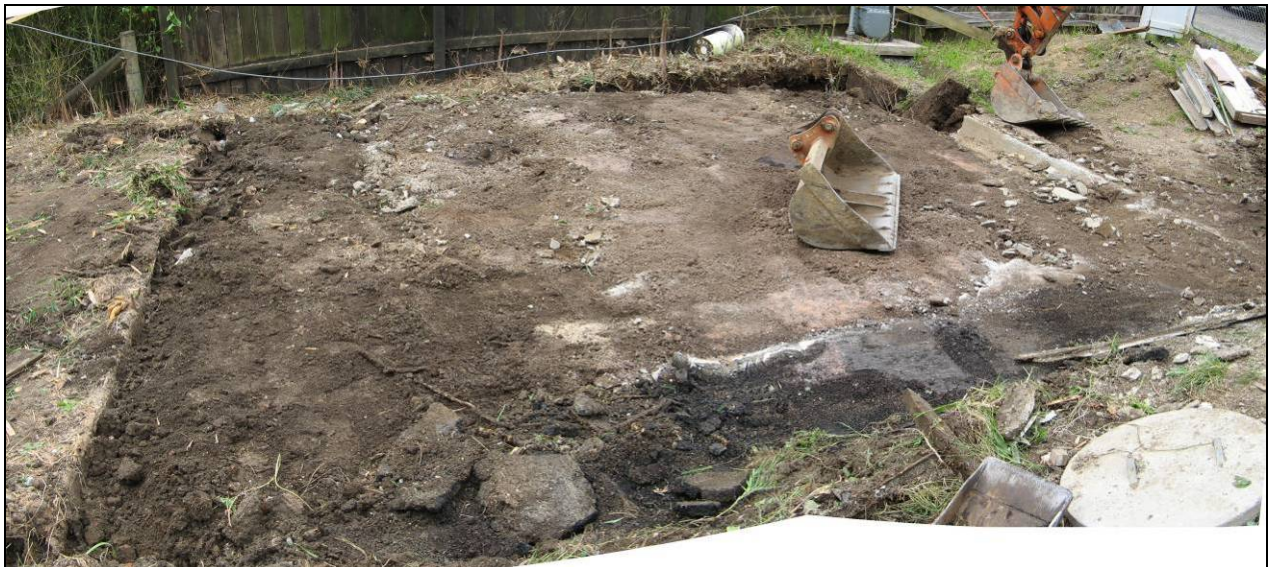
Figure 80. View of area of excavation after removal of concrete slab looking east

The area (Figure 79) was stripped with a mechanical excavator, removing the concrete floor (Figure 80) of the modern garage under archaeological supervision on 11 November 2008 and a number of features were exposed in the area of the former shed (Figure 81, Figure 82). The features consisted of a relatively modern concrete foundation delineating the wall area of a structure approximate 5m x 6m. Two lines of bricks in the clay, two bricks wide, were clearly visible marking the entrance into the garage, for wheel tracks. A large modern drain had damaged this and ran around the western and southern sides of the structure towards the roads.

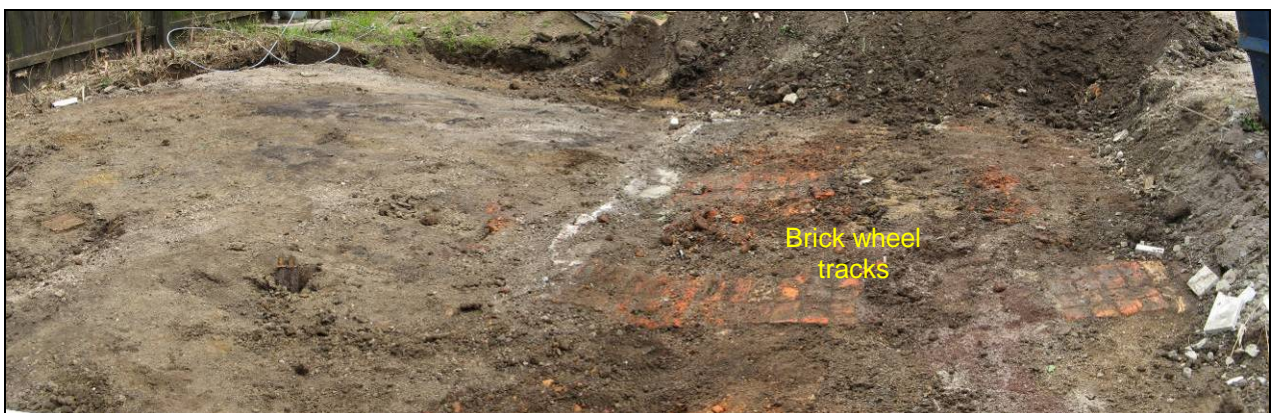
Figure 81. View of excavated area (looking south)

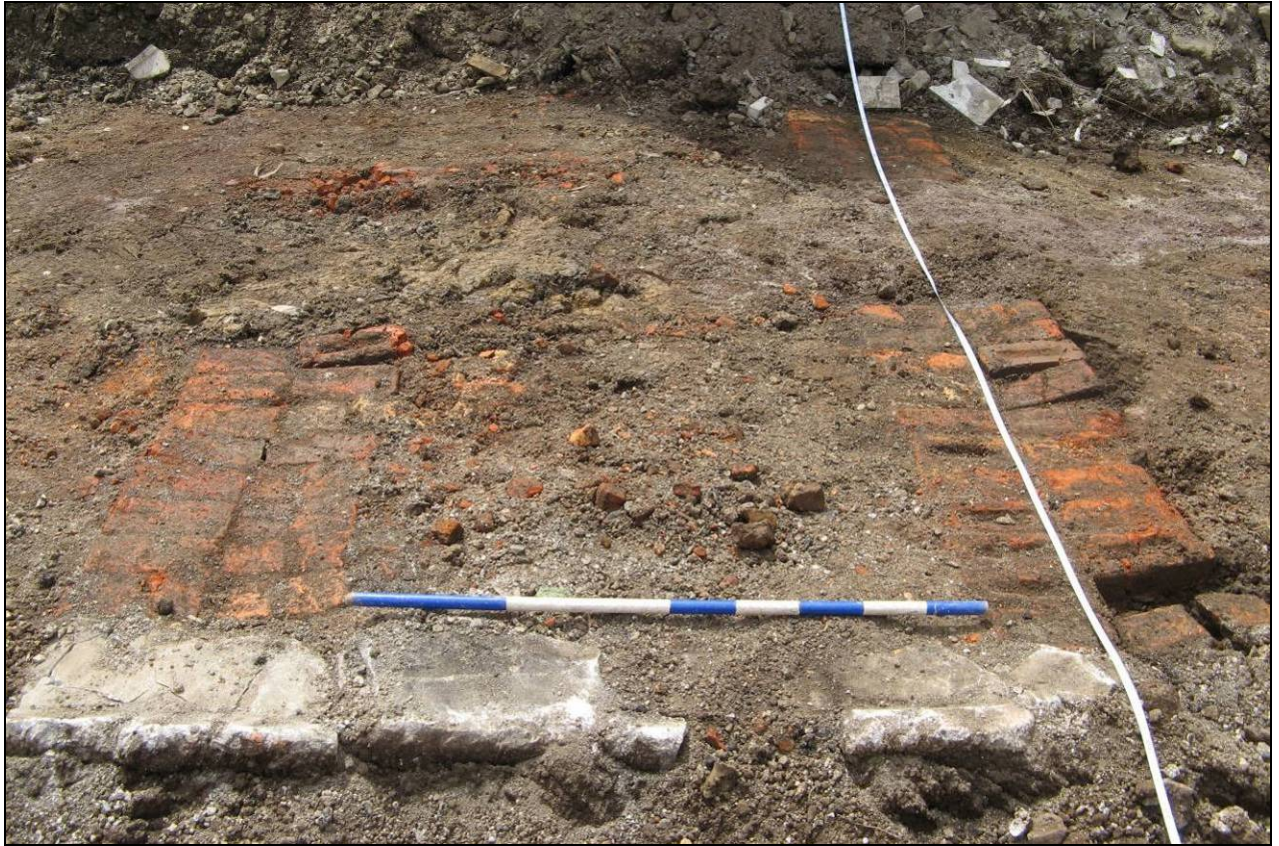
Figure 83. View of garage entrance showing brick wheel tracks

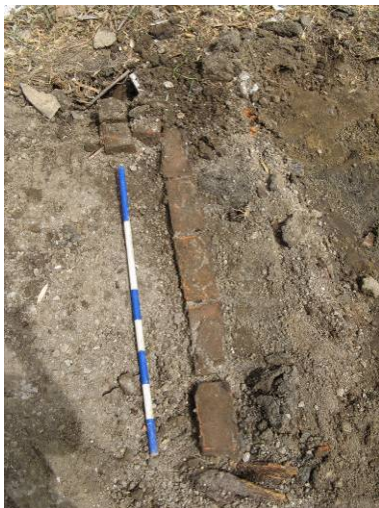
Figure 84. Brick foundation inside the garage area

In the inside of the concrete wall, a remnant line of bricks was identified, with a few postholes, a brick pile foundation? (Figure 84) and a nearby shadow of a similar pile. These fragmentary remains were not particularly diagnostic although the postholes may indeed relate to the original stables.

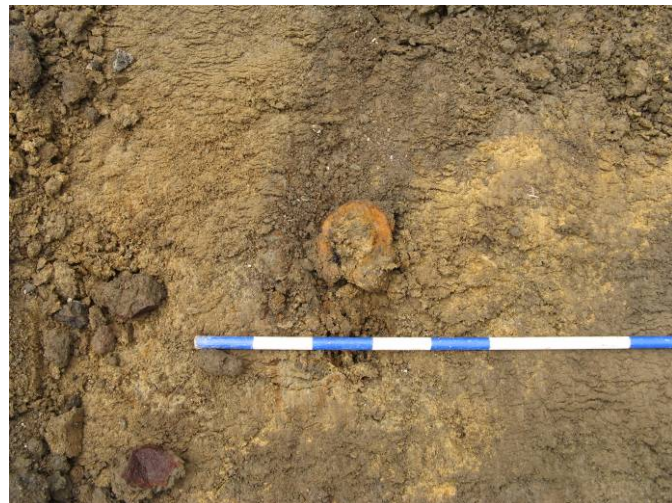
Figure 85. Horseshoe below garage

It is likely that the site was levelled in 1952 after the stables structure was removed and that this destroyed most of the features relating to the earlier structure. However, a single horseshoe (Figure 85) was recovered from the southeast part of the modern structure. Given the paucity of other artefacts, it is quite possible that it was placed deliberately when the modern garage was built to commemorate the earlier structure. This may have been a similar action to the placing of the wooden crucifix found under the main house in 2006 (and the placing of the angel figurine found at the Wynyard St excavations referred to earlier).

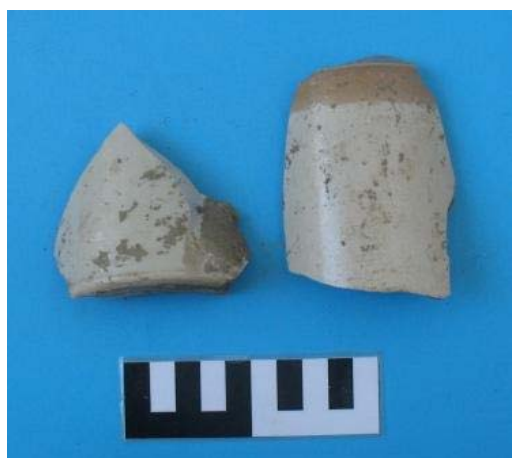
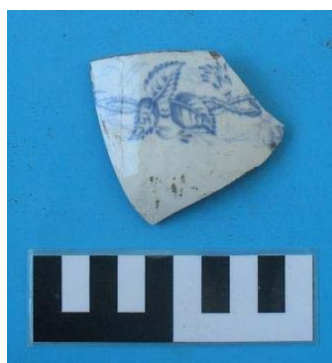
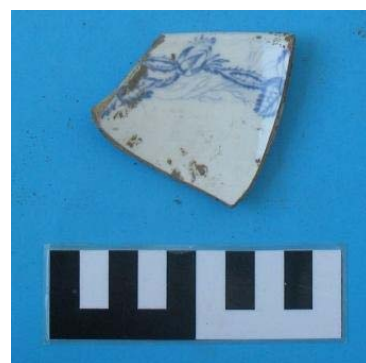
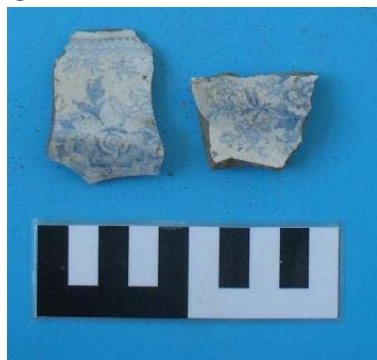
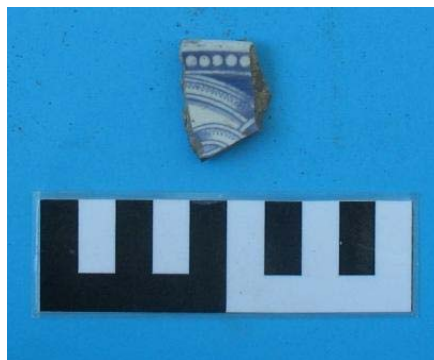
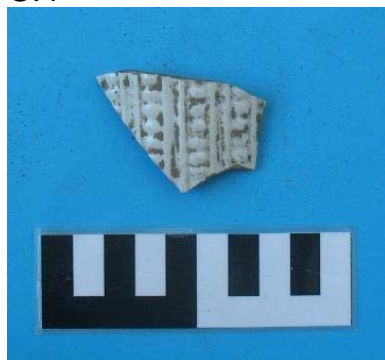
Figure 86. Ceramic artefacts from garage excavation

A few fragmentary artefacts (Table 4) were recovered in the nearby area but were not particularly diagnostic, although most probably from late 19th century to early 20th century (Figure 86). The insulator is probably later. They were scattered in the subsoil and indicated that the area had generally been turned over in the past.

ID	Material	Type	Colour/Decoration	Notes
G.1	Metal	Horseshoe		Highly corroded metal horseshoe
G.2	stoneware	jar	cream/tan	
G.3	ceramic	cup	blue transfer	
G.4	ceramic	plate	blue transfer	Asiatic Pheasant pattern
G.5	ceramic	plate	purple transfer	
G.6	ceramic	jug	white relief	
G.7	ceramic	insulator	white relief	None

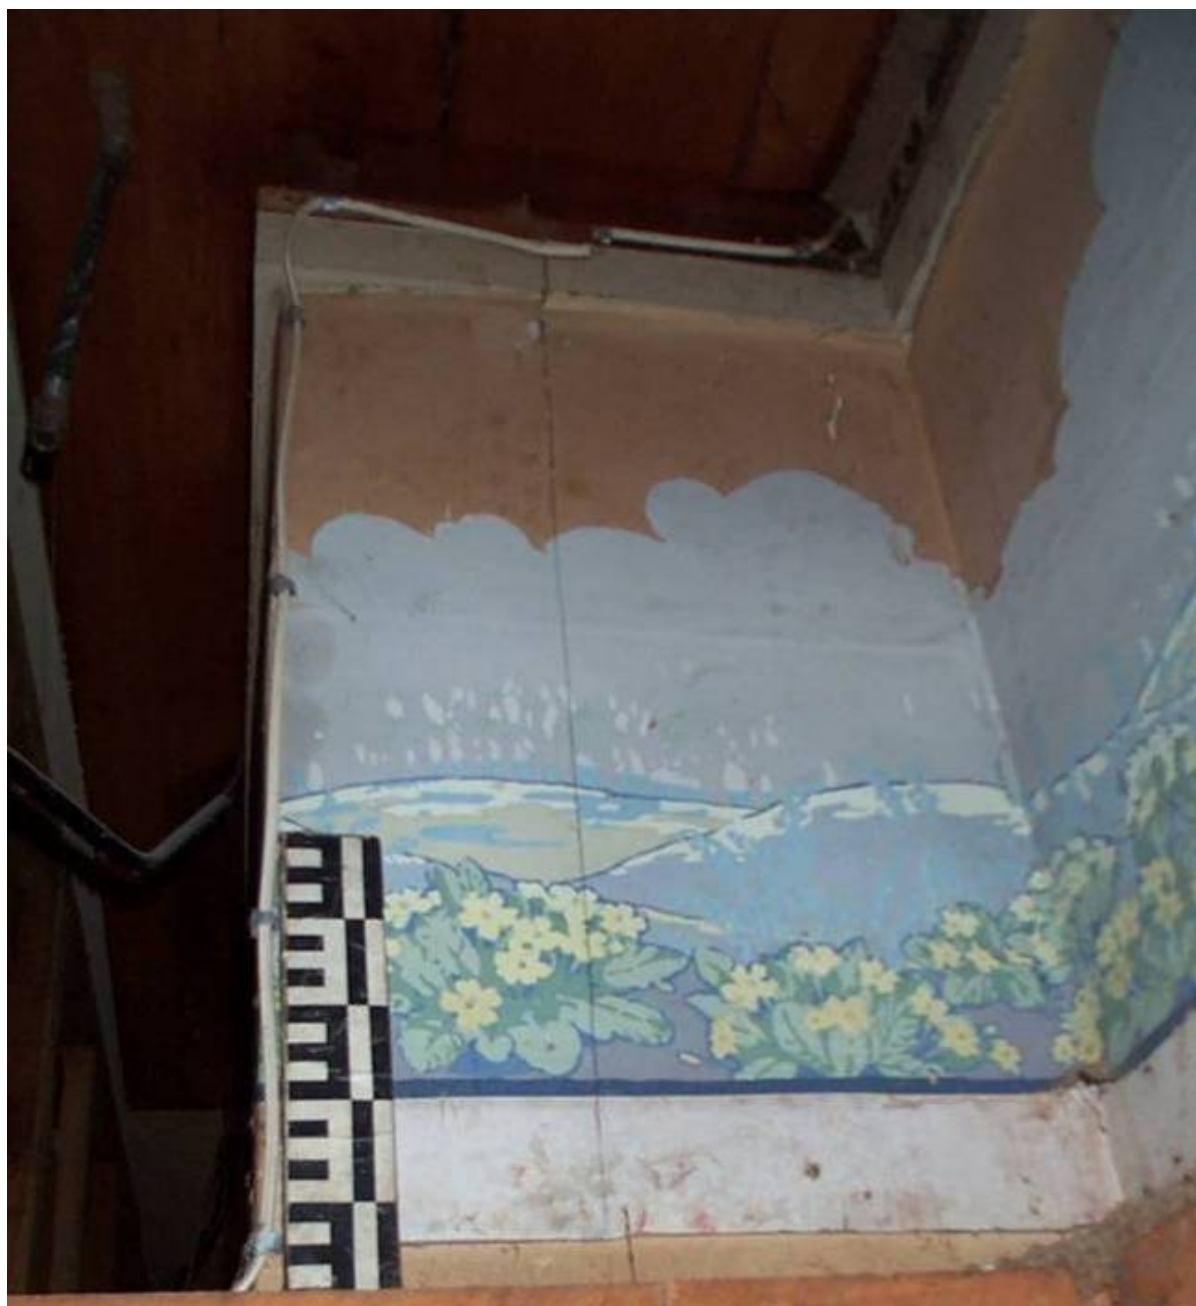
Motif or Style:	Scenic / flowers
Object Type:	Wallpaper frieze
Production technique:	Hand block-printed.
Creation Place & Date:	c. late 1890s – c.1910

Maker / Manufacturer:	Unknown
Maker's Mark:	Not visible
Measurement:	Measurements of sample retrieved: W. = 66 cm. Depth of frieze = 49 cm.
Collection:	Salmond Reed Architects.
Reference Number:	SRA76
Description:	<p>This cut-out scenic frieze is influenced by the Arts and Crafts style of the late nineteenth century. It consists of stylised cloud-like tree forms and a typical English country scene featuring primroses in the foreground. The tree crowns form the upper edge of the frieze while a dark blue horizontal stripe forms its base. The entire design has been applied on to a slightly textured neutral ground in white and varying shades of grey, blue, green, and yellow distemper. It has been pasted, at the upper edge, onto a brown paper which has a vertically streaked finish. Below the frieze is a plain cream paper.</p> <p>The sample forms part of a sandwich consisting of at least two underlying papers, the lowest with a scrim backing. Below the scenic layer a plain machine printed paper is visible. It has a simple pattern of tiny iridescent cross like forms (see SRA77). The oldest paper/s which may date to the construction of the house, cannot be accessed without the attention of a conservator.</p>

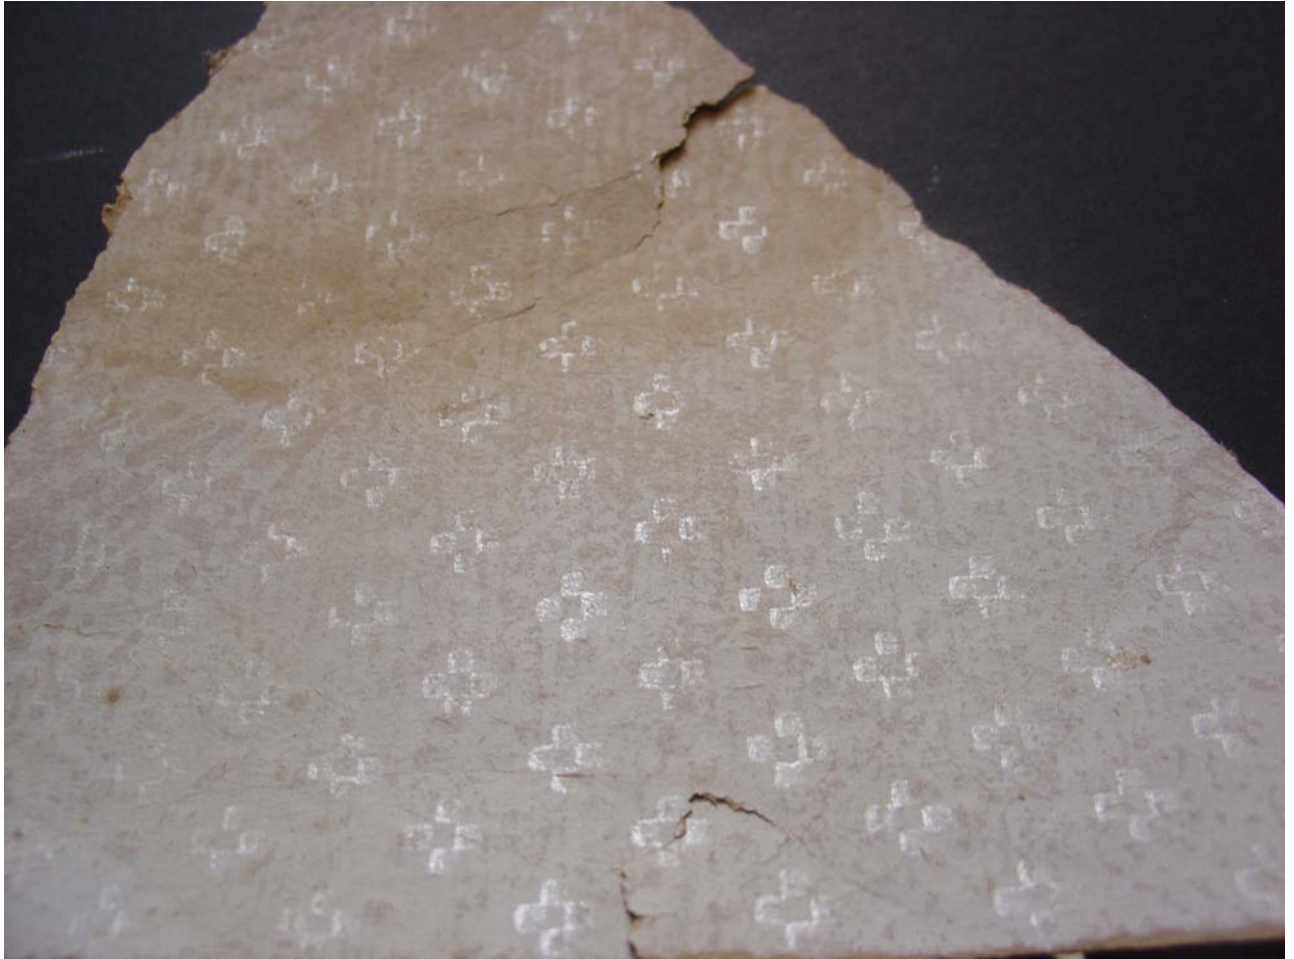
Detail of paper found beneath SRA76

Motif or Style:	Diaper / trellis pattern
Object Type:	Wallpaper
Production technique:	Machine printed
Creation Place & Date:	c.1880s -1890s
Maker / Manufacturer:	Unknown
Maker's Mark:	Not visible
Measurement:	15cm. x 14cm.
Collection:	Salmond Reed Architects.
Reference Number:	SRA77
