FLOOD MITIGATION SCHEME KAEO, NORTHLAND

FINAL ARCHAEOLOGICAL MONITORING AND EXCAVATION REPORT (SITES P04/760 & P04/761)

Report prepared for Northland Regional Council Under NZHPT Authority No. 2012/520

April 2015

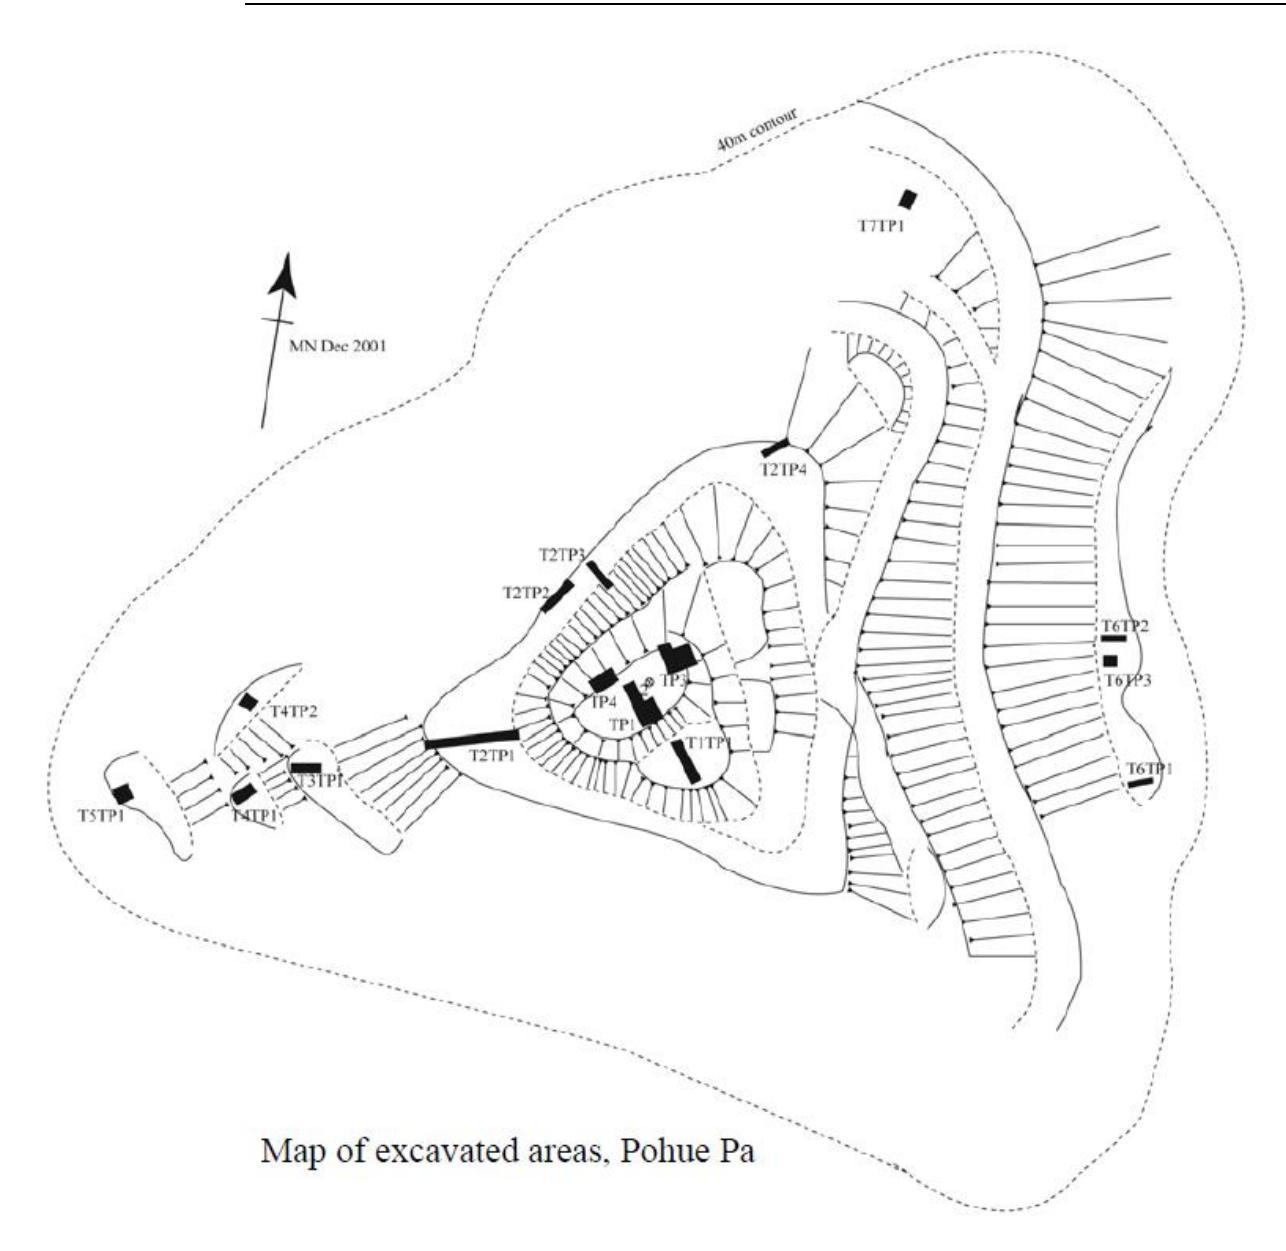
Figure 17. Plan of test pits and trenches excavated on Pohue Pa by Stuart Bedford un 2001-02 for the NZHPT

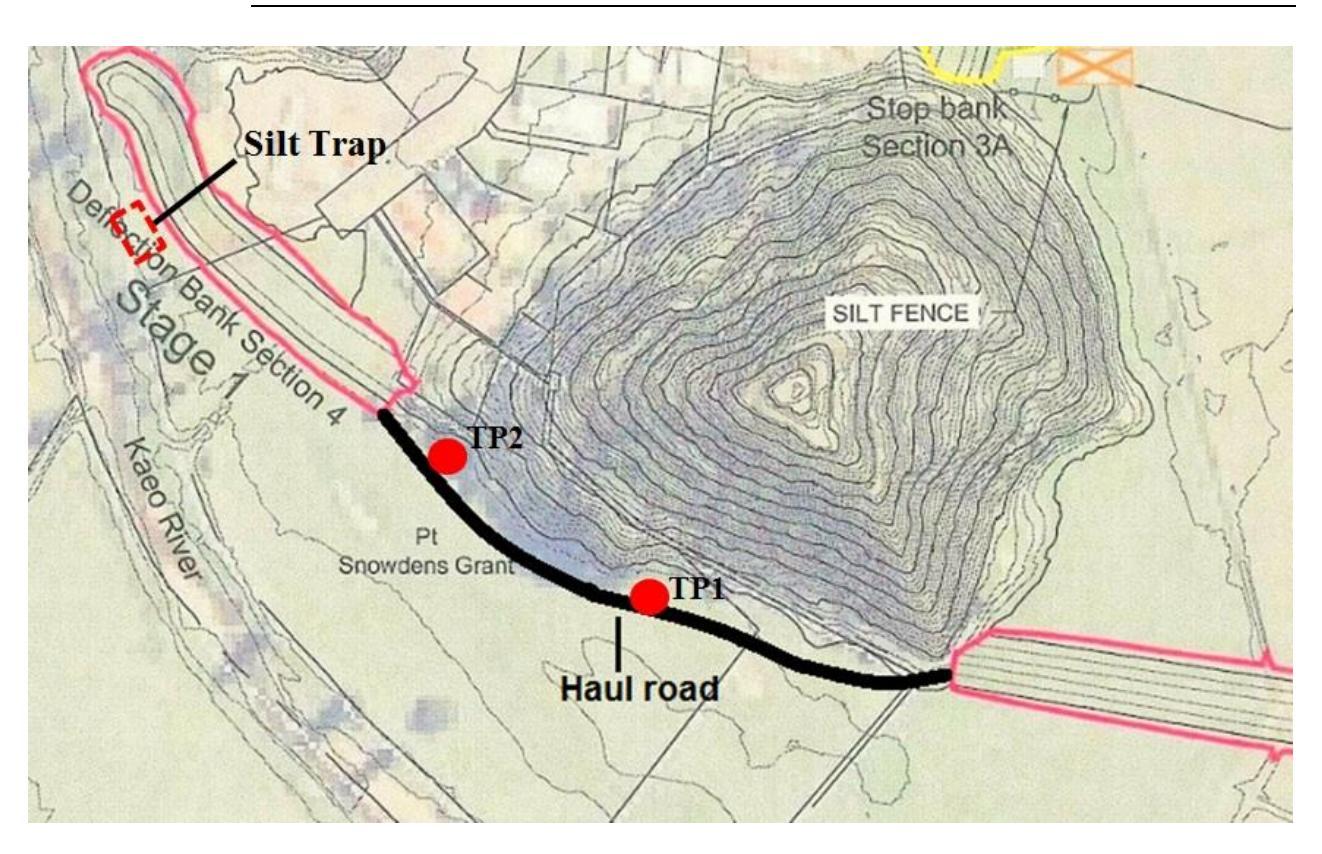
Figure 25. The route of the haul road, western stopbank section (deflection bank); the silt trap and location of the two test pits to the south of Pohue Pa

A silt trap 7m in length x 5m wide and 0.87m deep was excavated to the west of Pohue Pa close to the northern banks of the Kaeo River (Figure 25). The stratigraphy observed in all trench edges consisted of thin yellowish mid-brown silty loam topsoil under turf that was 0.09m thick, which sealed yellowish brown alluvium that extended to the limit of excavation. No archaeological deposits or features were observed in the silt trap excavation and, as was to be expected so close to the river channel, the stratigraphic sequence was dominated by alluvium deposited during flood events.

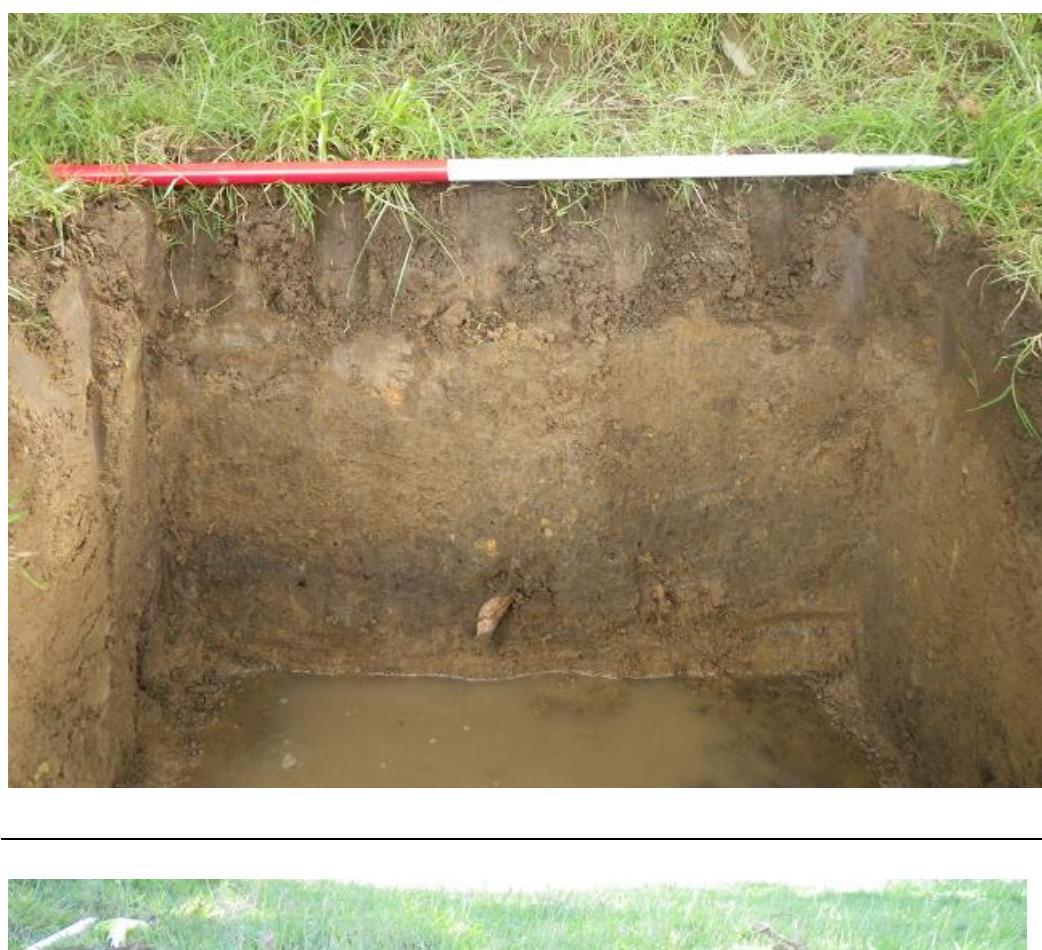
Figure 27. West facing section of Test Pit 2. Scale: 1m

No archaeological deposits or features were observed in Test Pit 2 and the stratigraphic sequence was dominated by either alluvial or colluvial deposition (Figure 27).

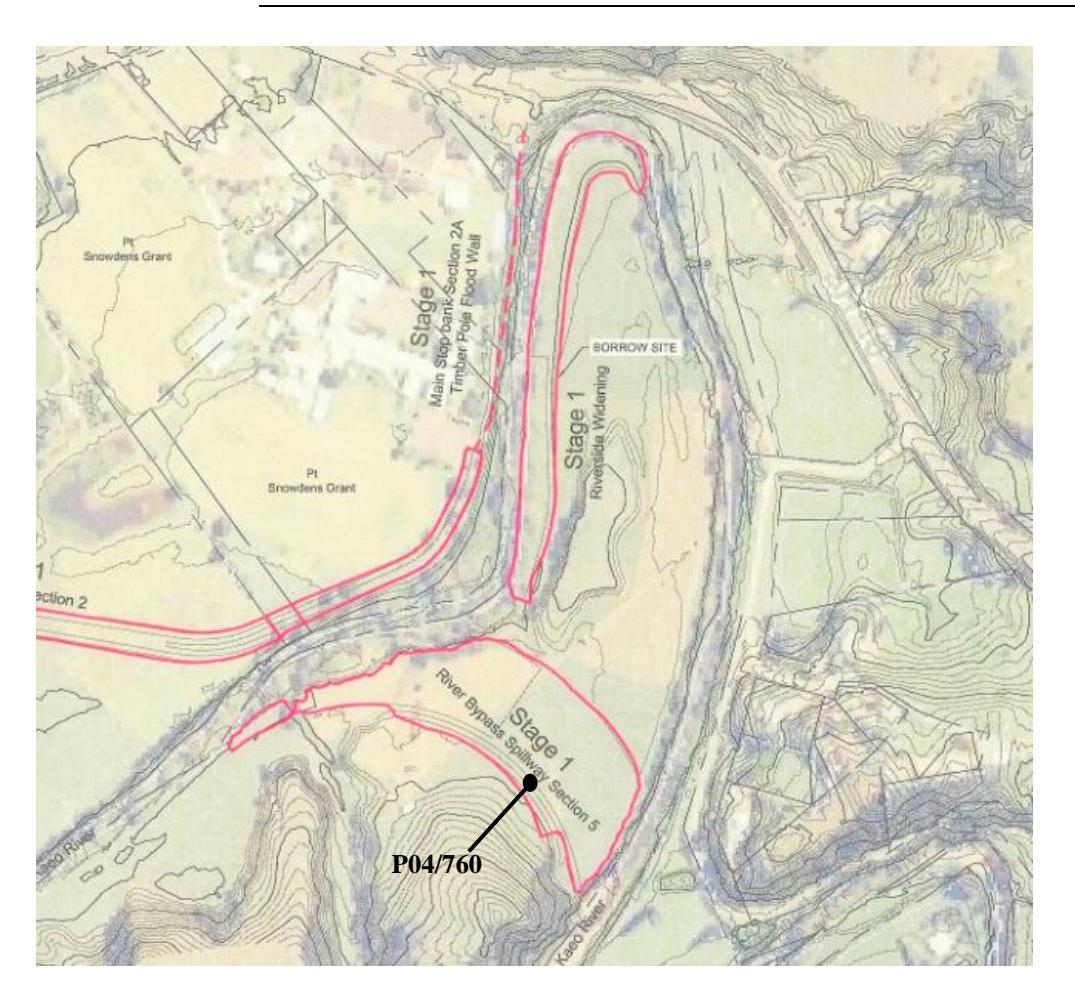
Figure 31. The River Bypass Spillway and Stopbank Borrow site works areas, with location of P04/760 indicated

The borrow site was located on the western side of a north facing meander loop of the Kaeo River and the area excavated to provide fill material for the stopbanks was approximately 350m x 30m (Figure 31 and Figure 34). The stratigraphy in this area consisted of a very thin greyish brown silty topsoil overlying either alluvial or colluvial silts that composed the subsoil across the area (Figure 34). No archaeological features or deposits were observed within the borrow site works area.

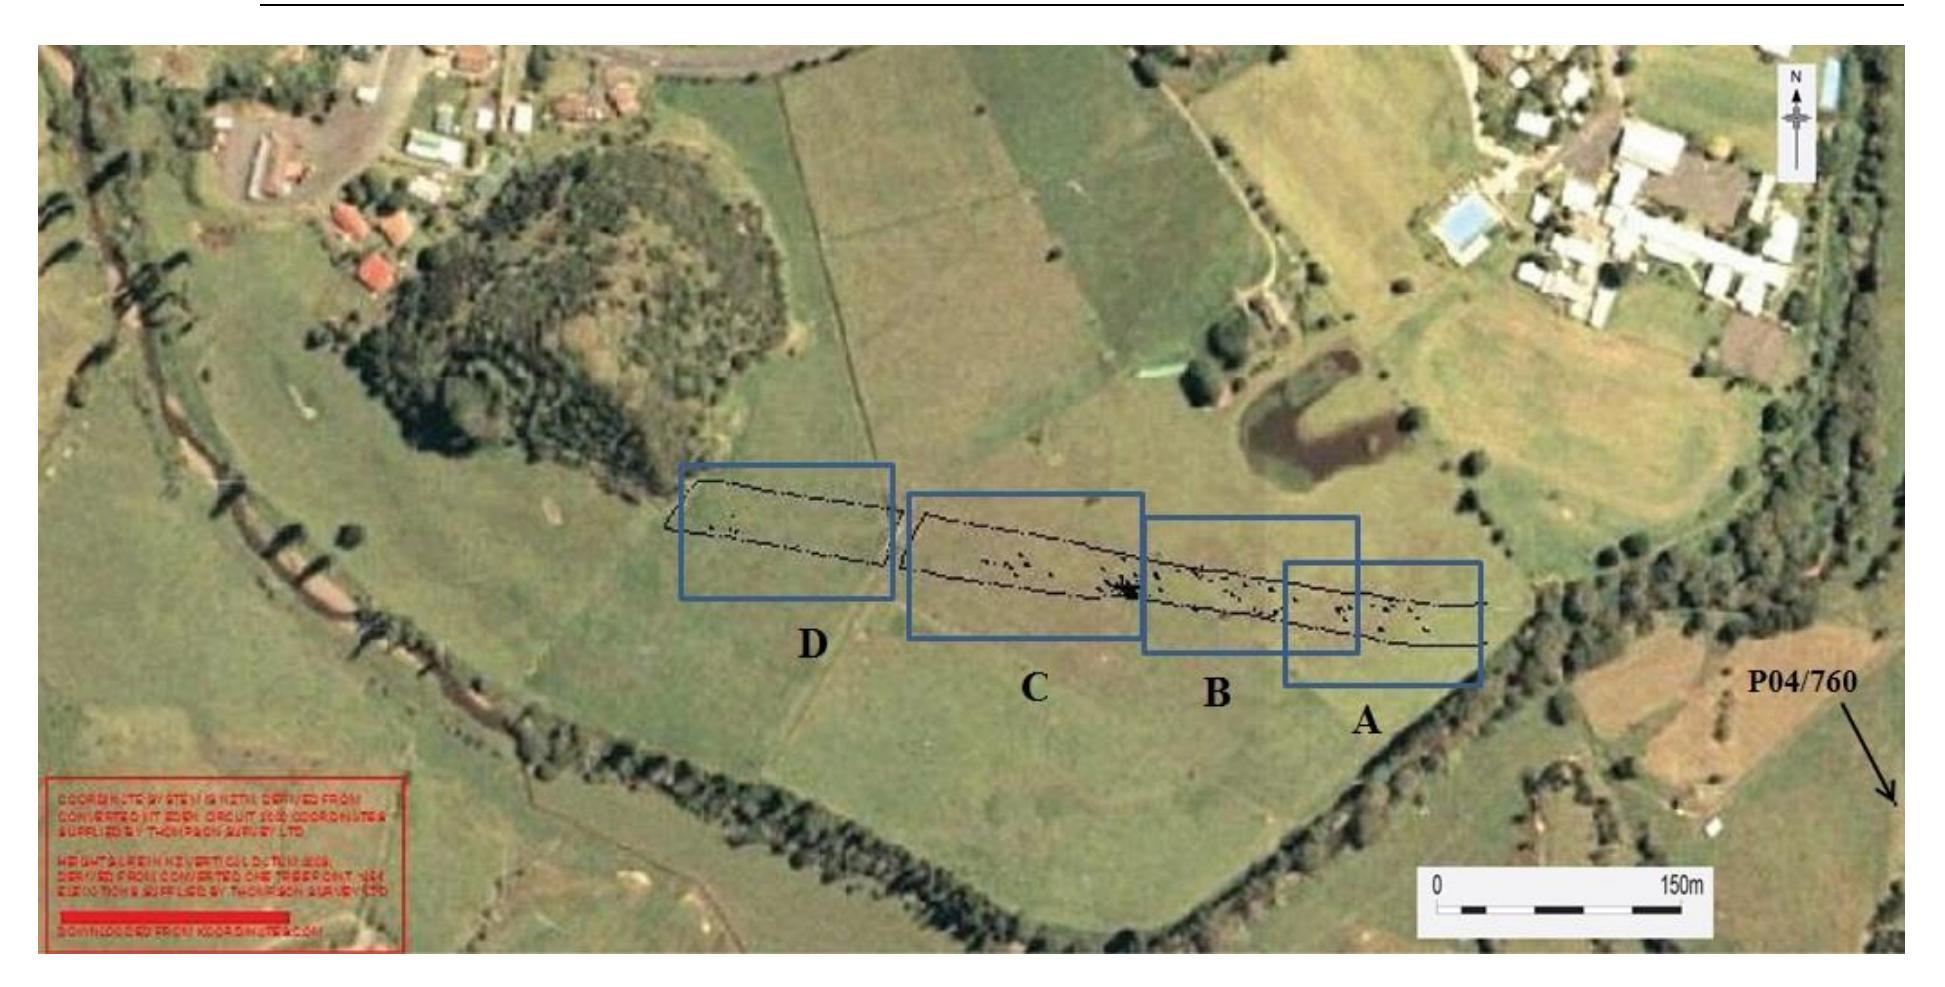
Figure 38. Plan of excavated extent of site P04/761 with aerial overlay; the location of site P04/760 is indicated by the arrow. Details of Sections A-D are presented in Figures 39-42

The results of the excavation and recording of site P04/761 are set out below. Plans and section diagrams are included as Figure 38–Figure 44 and Figure 49–Figure 50), and a list of context descriptions can be found in Appendix 1.

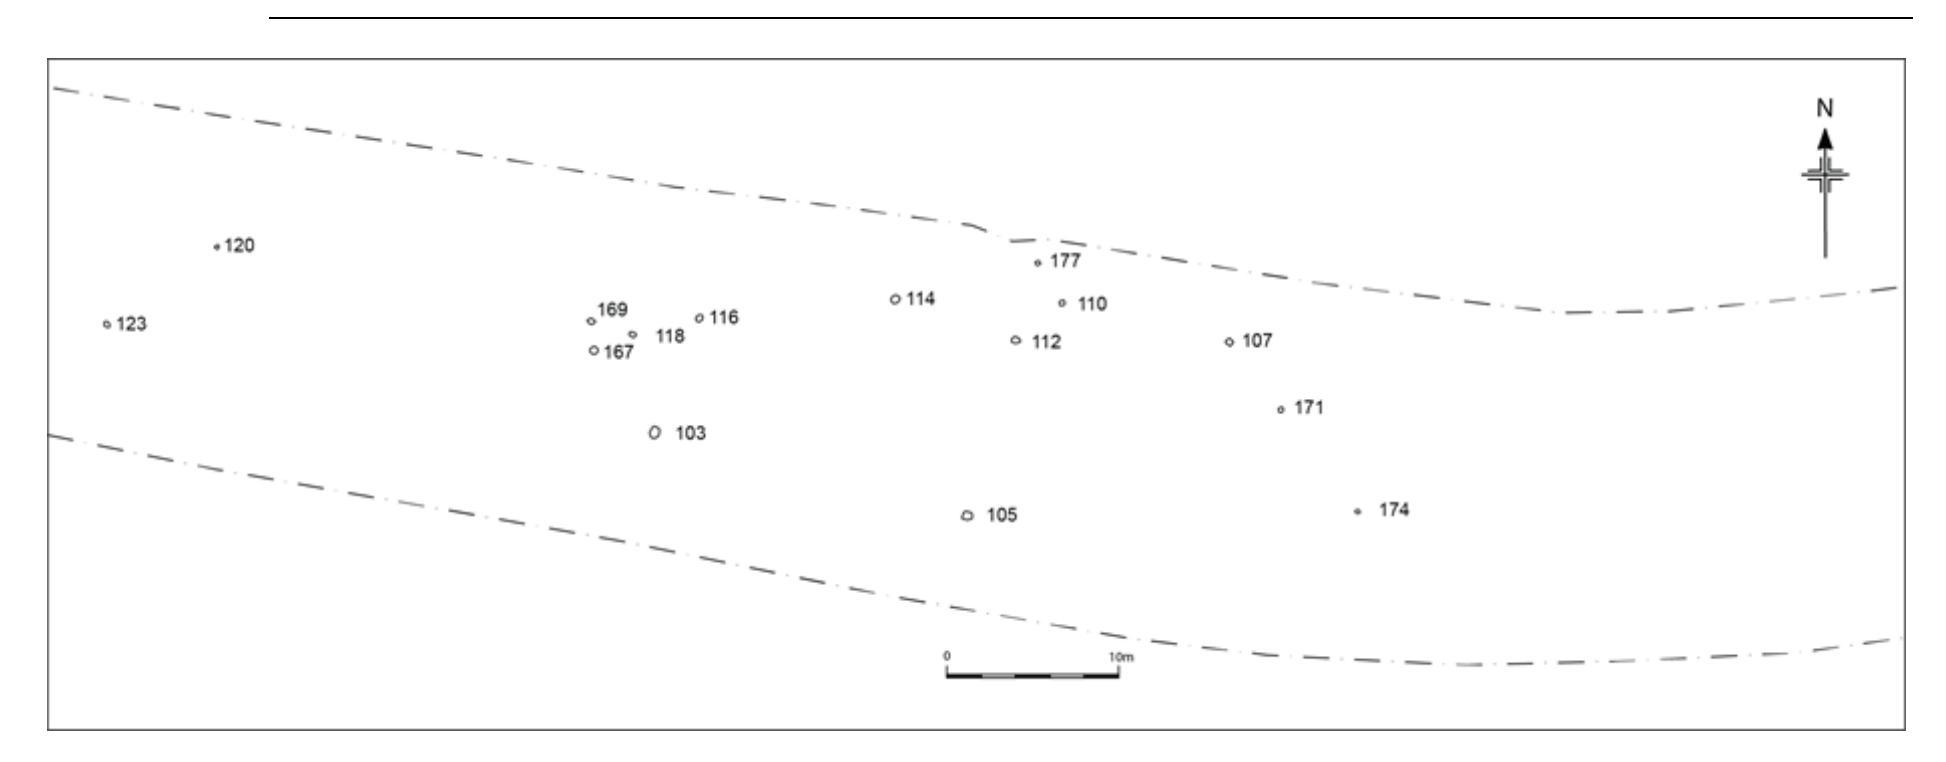
Figure 39. Plan of archaeological features comprising eastern extent of site P04/761, Section A in Figure 38

Excavation	Hangi
Results, continued	Thirty-two earth ovens were recorded during the excavation of site P04/761 (Figure 39 and Figure 60; Appendix 1). All of the features were observed cutting the natural alluvium (context 102) and had been vertically truncated (severely in some areas) by the historic ploughing, and sealed by plough soil (context 101). The hangi were present across the excavation area with two concentrations observed to the west of the pit complex and at the eastern end of site P04/761 (Figure 39 and Figure 41). Many of the oven features had been severely truncated by the historic ploughing with only the bases of many of the features surviving and as such, only those features that seemed to be more intact were selected for excavation in half section (Figure 59).
	Of the 32 hangi features observed only six had any real depth surviving. Hangi [218] was both the largest and the deepest of the hangi (Figure 55). This feature was sub-rectangular to irregular in shape, aligned east-west and measured 0.99m x 0.85m x 0.10m deep (Figure 39 and Figure 59). In contrast hangi [116] (a sub-circular feature aligned southwest-northeast) was just 0.41m x 0.33m and only surviving to a depth of 0.04m (Figure 59).

Nineteen postholes were observed on either northwest or northeast alignments located in the eastern and central areas of site P04/761 (Figure 39, Figure 40 and Figure 61). The central northwestern posthole alignment consisted of postholes [135] (corner post), [138], [141], [144], [147], [150], [153], [156], [159] and [162] while the northeastern alignment in the central area contained postholes [135] (corner post), [120], [123], [126] and [129] (Figure 39). The eastern area alignments were not as definitive as the central ones due to the mechanical excavator strip being variable over much of the area with large parts of the eastern excavation not being of sufficient depth to expose the natural alluvium (context 102). Three postholes in that area ([107], [171] and [174]) appear to be on a northwestern alignment and possibly suggest a further field to the south of that indicated by the central alignments. Finally, postholes [110] and [177], while being the same morphologically, cannot be assigned to any particular alignment (Figure 39).

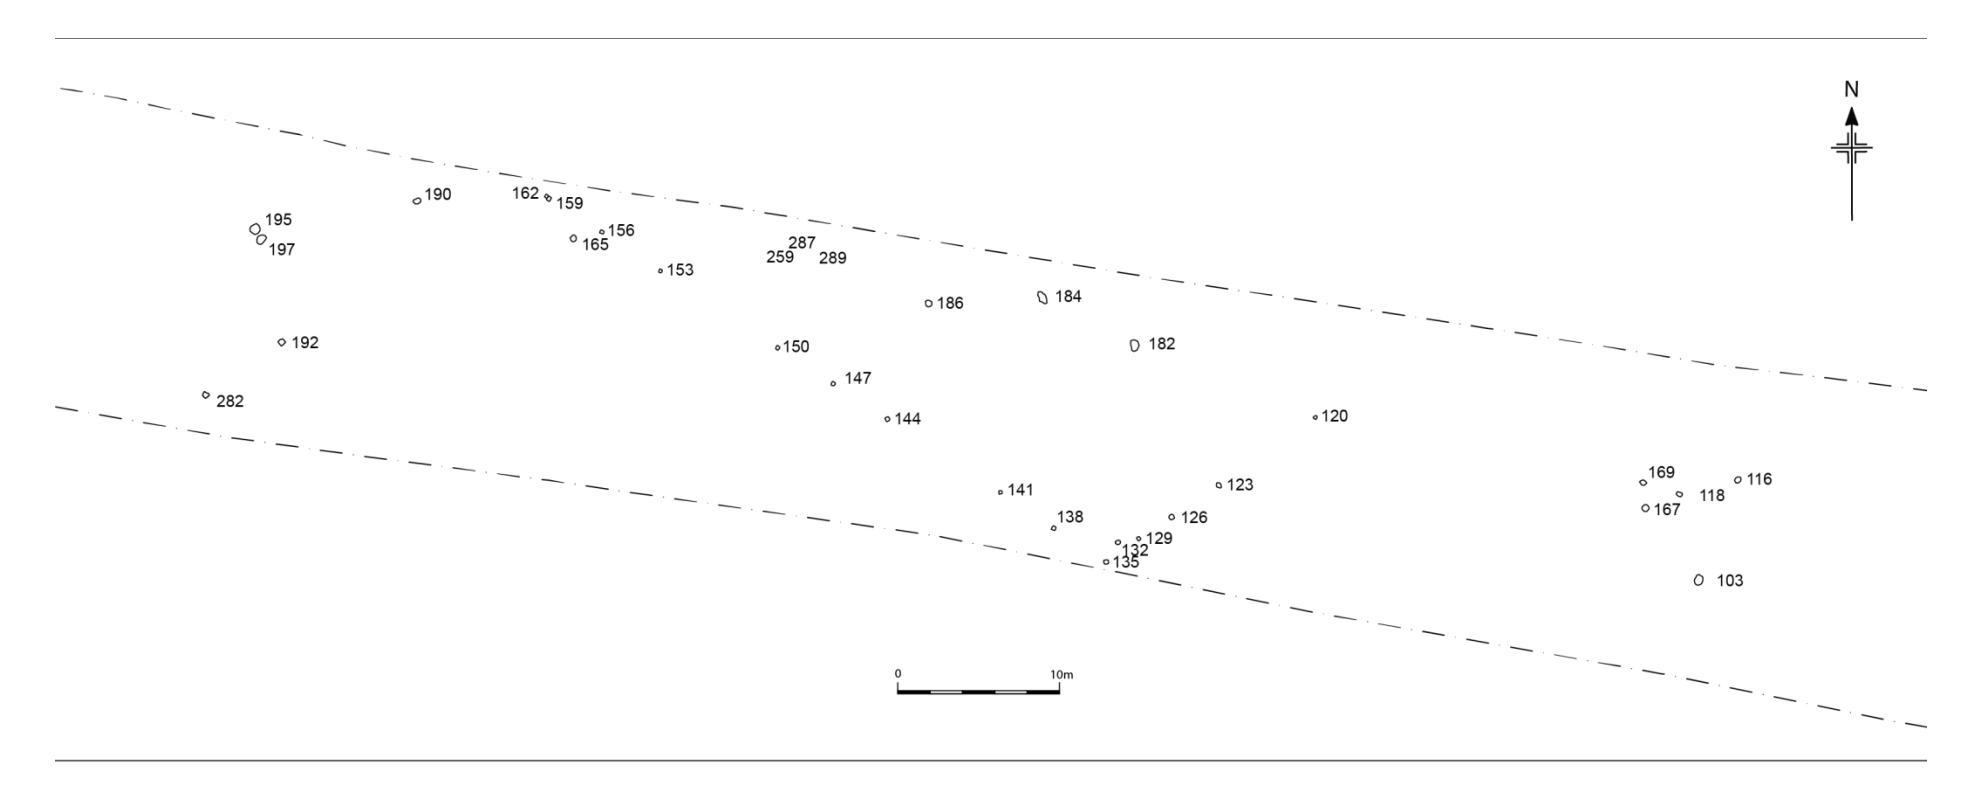
Figure 40. Plan of archaeological features comprising the central eastern extent of site P04/761. Section B in Figure 38

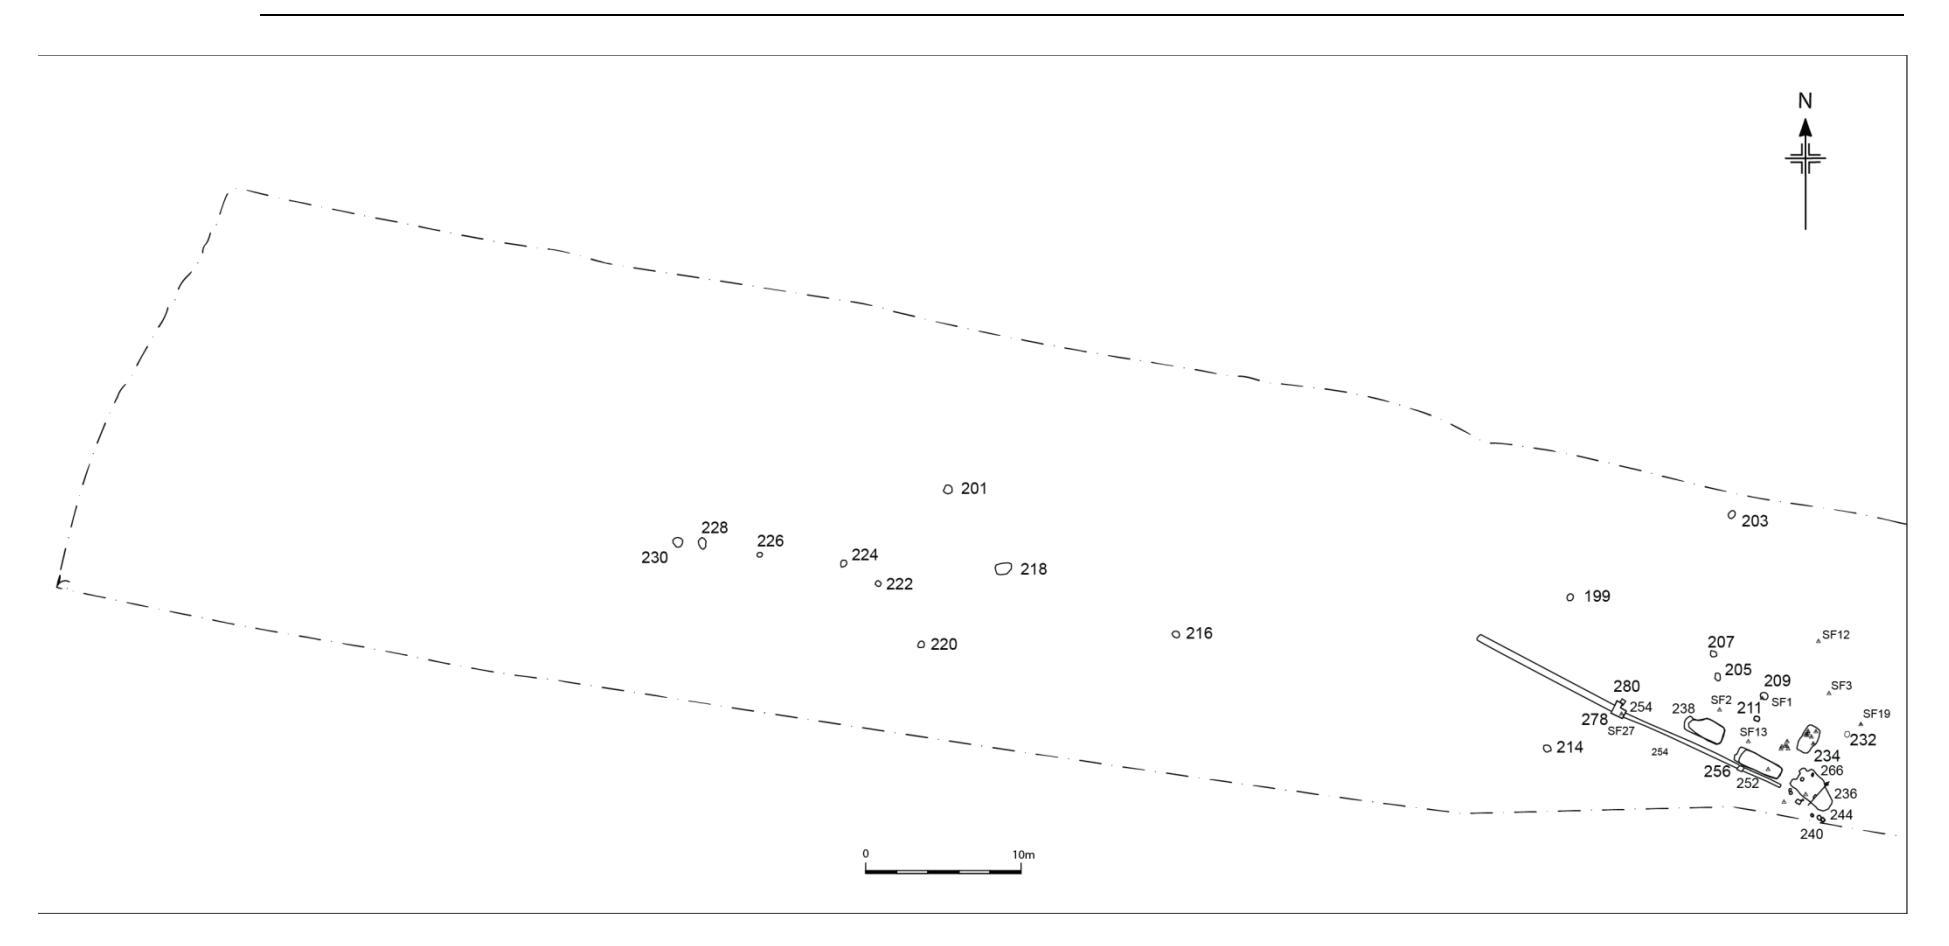
Figure 41. Plan of archaeological features comprising central extent of site P04/761. Section C in Figure 38

Feature [234] was a rectangular pit cut into the natural alluvium (102), aligned northeast-southwest, and measured 2.06m x 1.13m and 0.46m in depth (Figure 41, Figure 43–Figure 46). The pit was cut with steeply sloping (spade cut) smooth sides on its eastern edge and vertically on its western side and had a flattish base (Figure 44–Figure 46). The pit was filled by a single fill (context 235) consisting of moderately compacted mottled grey, brown, yellow alluvial silt with topsoil intermixed, that contained moderate inclusions of heat fractured rock and occasional charcoal. The nature of the fill suggests the pit was rapidly backfilled in a single event. No internal features were present within the pit structure. Seven obsidian flakes were recovered from the pit fill (236).

Storage pit [252] was a rectangular pit cut into alluvium (102) with smooth vertical sides with a gentle (45°) break to a flat base (Figure 41, Figure 43, Figure 44 and Figure 53–Figure 54). The pit appeared to have been excavated utilising a spade rather than a ko. The feature was aligned west-northwest–east-southeast and measured 3.56m x 1.09m and was 0.44m in depth. The pit contained one fill (context 253) that consisted of alluvium with intermixed bands of topsoil that contained occasional inclusions of charcoal and very occasional heat fractured volcanic oven stone fragments (Figure 53). One obsidian flake and two wrought iron nails were retrieved from this context, suggesting that the pit was in use during the contact or early European period.

Feature [278] was only partially observed in section during excavation of a drain (context 254) and a posthole (context 280) (Figure 41, Figure 44). The cut on the feature's southern edge (where it was observed to cut the drain) was smooth and vertical leading to a flat base at a depth of 0.54m (Figure 44 and Figure 55). The pit contained a single fill (context 279) that consisted of intermixed topsoil and alluvium representing a single episode of backfilling. No artefactual evidence was recovered from the pit fill.

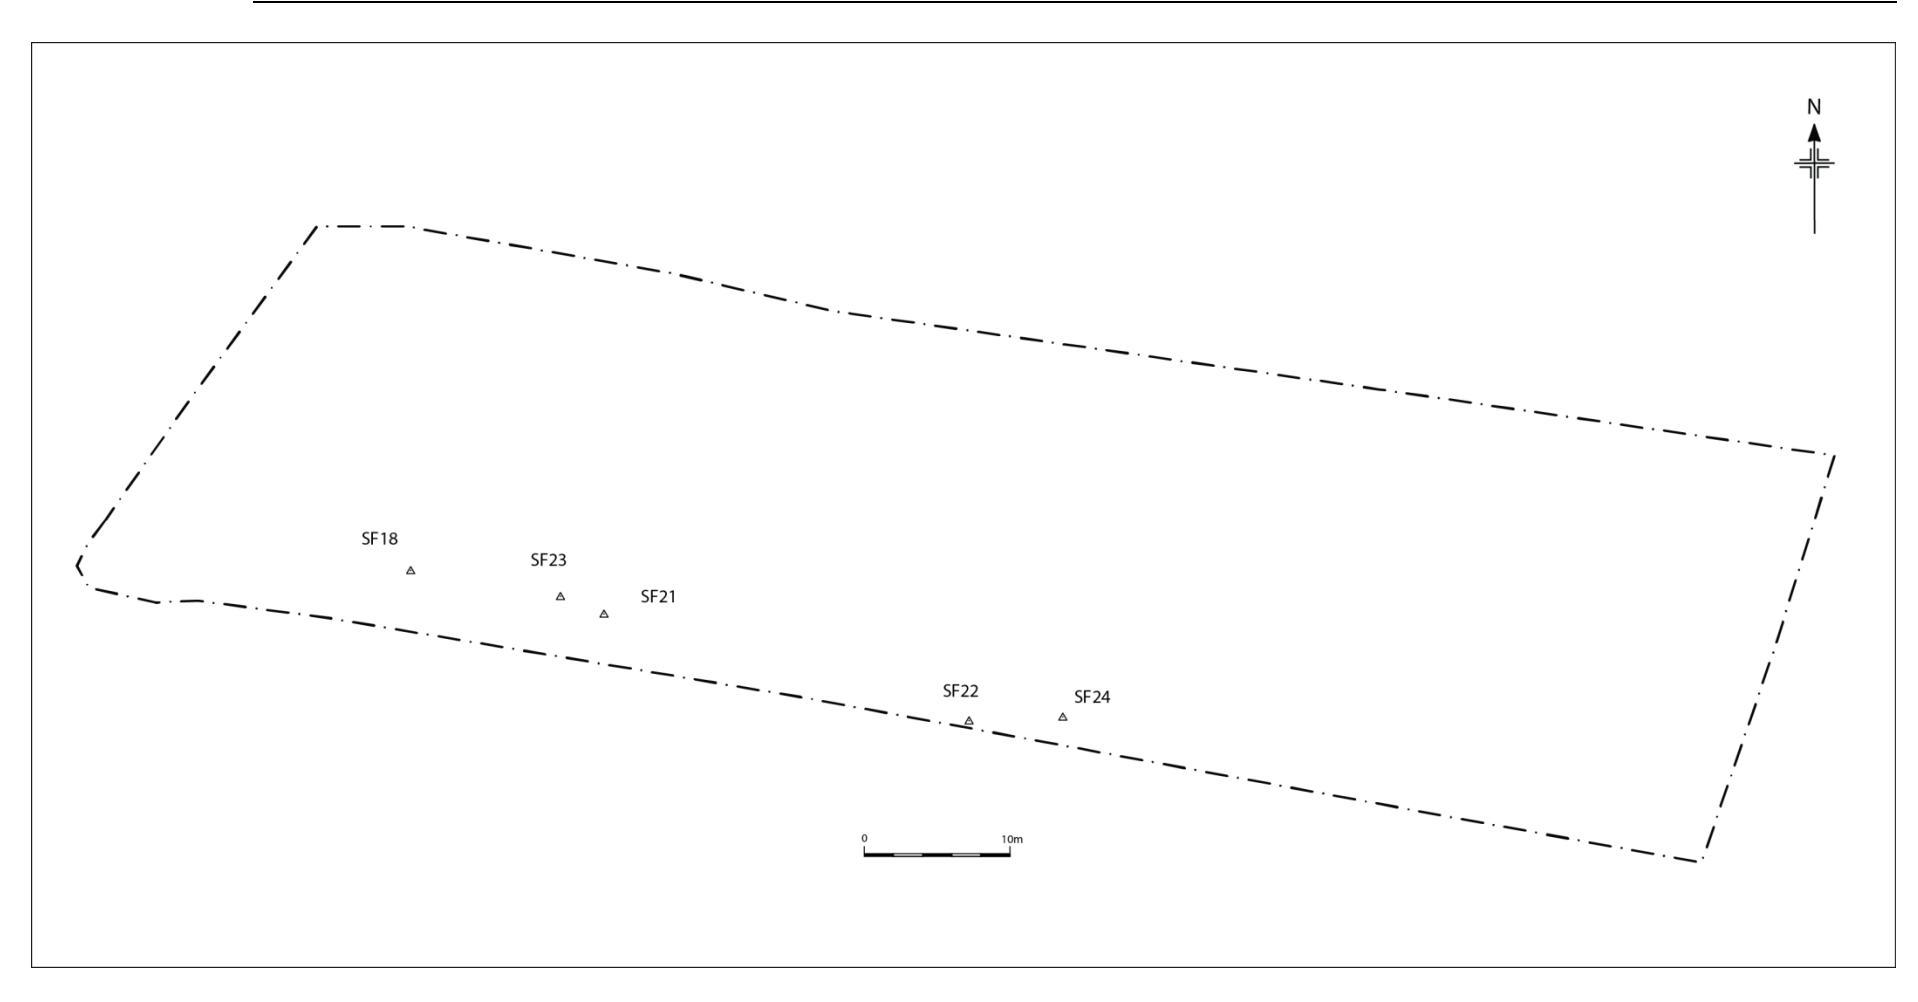
Figure 42. Plan of the location of small finds retrieved from the western extent of site P04/761. Section D in Figure 38

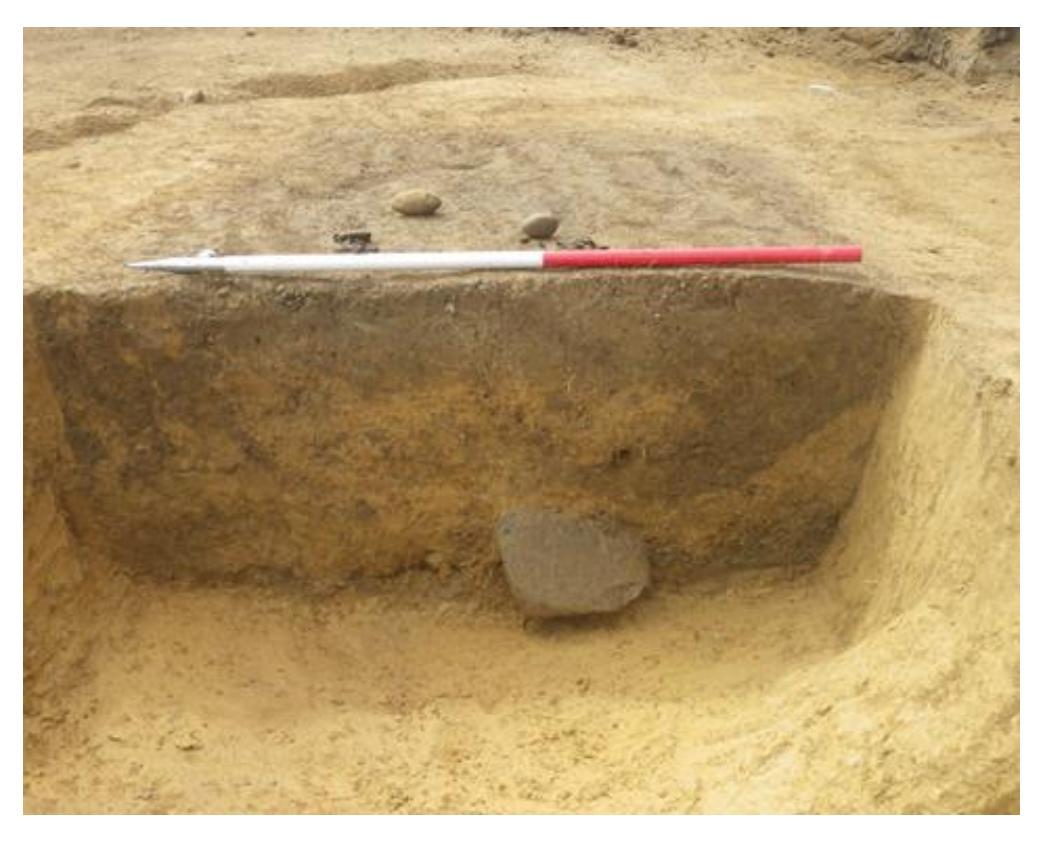
Figure 48. Southeast facing post excavation plan shot of pit [236]. Scale: 2x1m

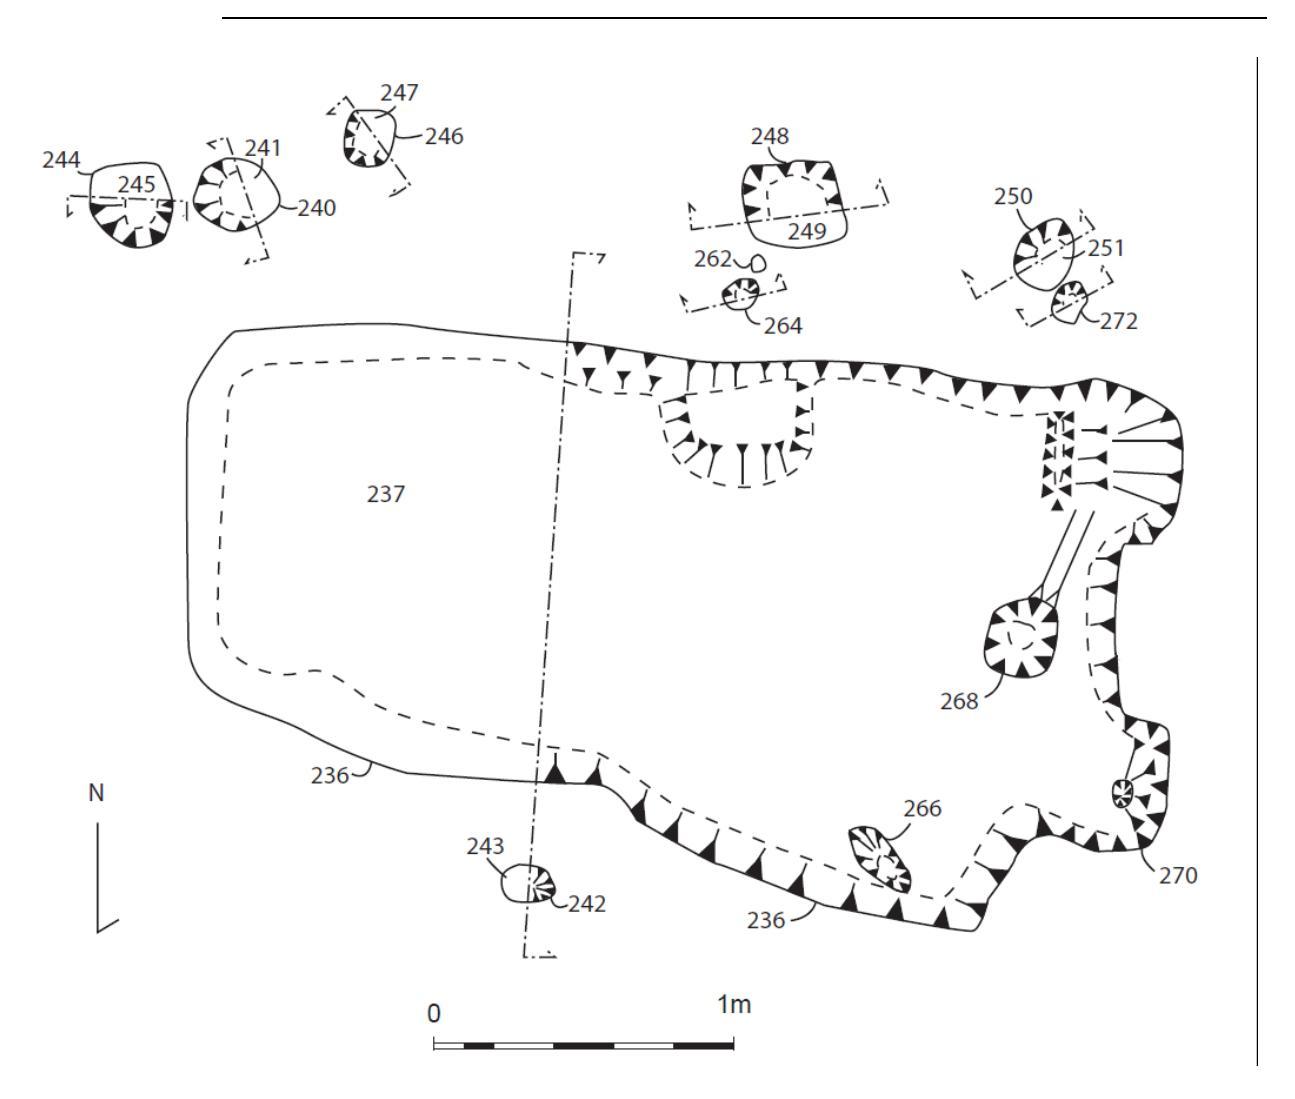
Figure 49. Post excavation plan of pit [236] and postholes [240], [242], [244], [246], [250] and stakeholes [262] and [272]. NB. Posthole [248] is a later 19th century posthole likely to be related to a European field boundary

aligned northwest–southeast and measured 3.34m x 1.82m and was 0.60m in depth (Figure 41, Figure 43, Figure 38Figure 44 and Figure 47–Figure 49). The pit contained two fills (contexts 237 and 274: Figure 44) with the primary fill (context 274) consisting of a firmly compacted intermixed topsoil and alluvium (single event backfill) with occasional inclusions consisting of heat fractured oven stones, river cobbles and charcoal. A hoanga (grindstone) was retrieved from context 274 close to the base of the pit (Figure 47). The upper fill (context 237) was compacted greyish brown silt with yellow mottles that consisted of the 19th century plough soil intermixed with alluvium natural and represents the infilling of a depression formed as a result of the settling of the initial deliberate backfilling of the pit. Artefacts retrieved from the upper pit fill consisted of a single heavily corroded wrought iron nail, a single small sherd of ceramic (willow ware) and a single struck obsidian flake.

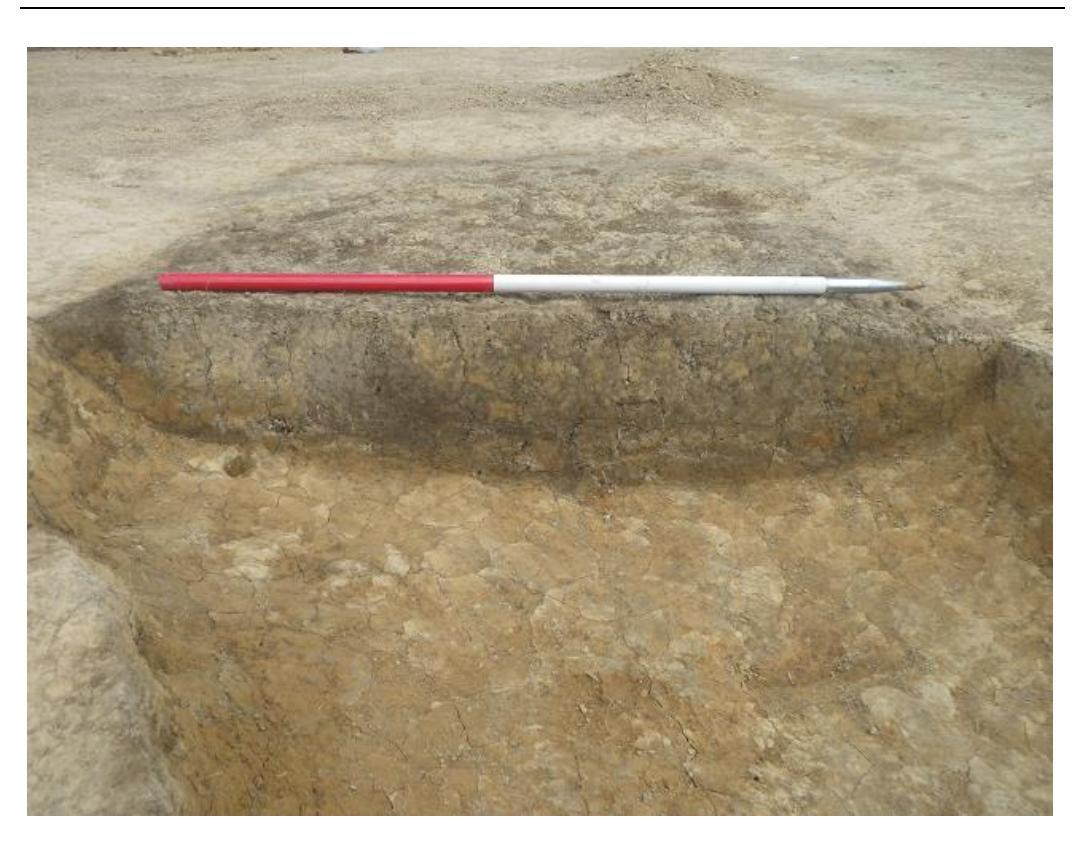
Figure 51. Westnorthwest facing section of pit [238]. Scale: 1m

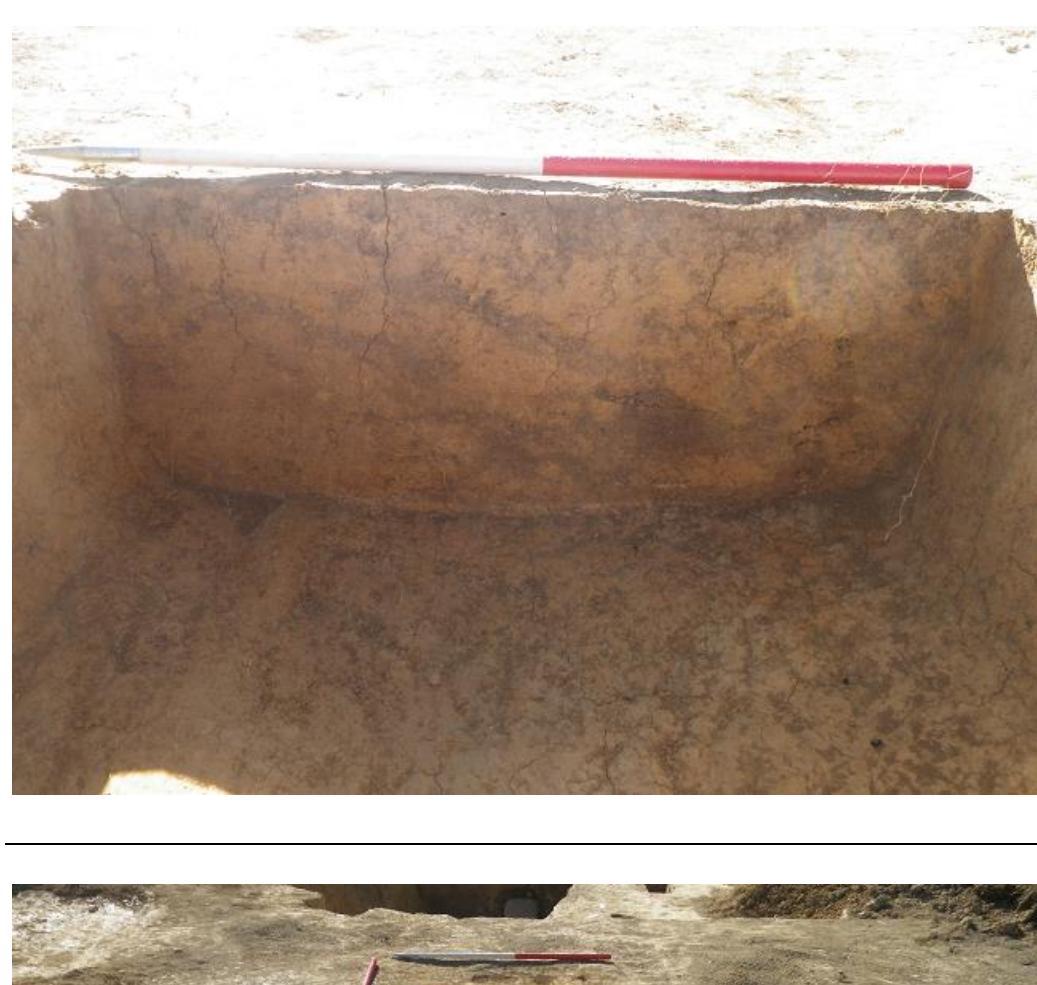
Figure 53. Westnorthwest facing shot of pit [252]. Scale: 1m

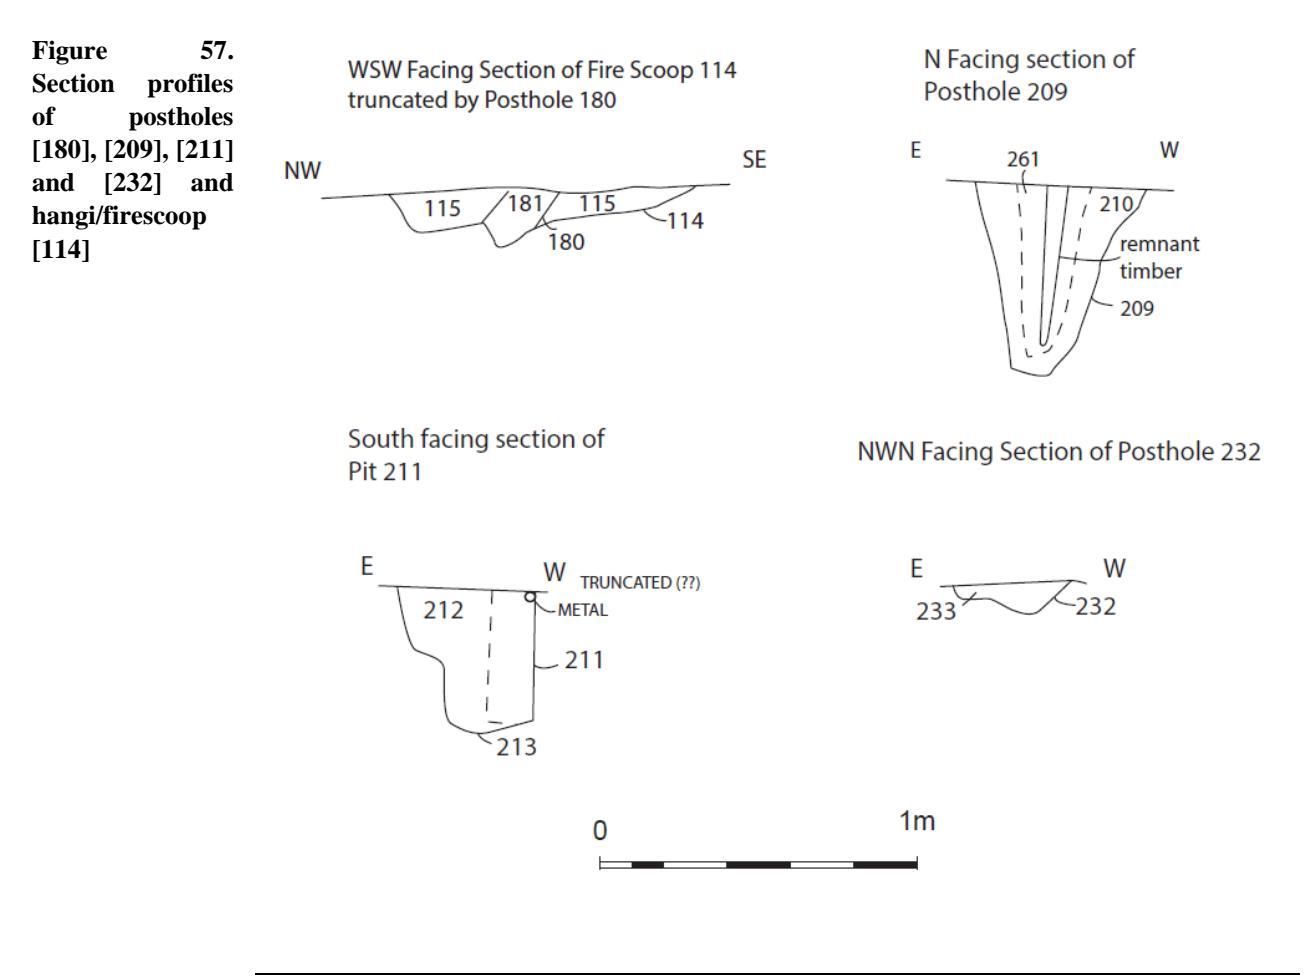
Figure 58. Northnorthwest facing section of posthole [209] with the remnants of a puriri post visible in mid-section. Scale: 0.3m

Posthole [209] was the largest of this group, and was oval in plan, measuring 0.55m x 0.45m and despite vertical truncation of the area, was still 0.51m deep (Figure 57 and Figure 58). The posthole was filled with yellowish light brown sandy silt (context 210) containing occasional charcoal inclusions. A post pipe (context 261) within the backfill of the posthole measured 0.15m x 0.12m x 0.51m deep and still held the degraded remains of a puriri post (Figure 57 and Figure 58). Posthole [211] was also excavated in half section and was 0.43m x 0.34m in size and was 0.46m deep (Figure 57). The feature was backfilled with a sandy silt deposit that contained occasional charcoal inclusions (context 212) and appeared identical to that observed in posthole [209]. Within the backfill a post pipe (context 213) was present as a soft, dark brown silty sand within context 212 and measured 0.15m x 0.15m x 0.43m deep (Figure 57). Due to the size and depth of postholes [209] and [211] (particularly when the vertical truncation is also considered), together with their location in close proximity to a number of storage pits, it is considered likely that both postholes represent the location of single post supported pātaka (food storehouses). It is also possible that the isolated posthole [256], which was observed cutting the infilled drain (context 254), in view of its size and shape in plan (0.38m x 0.31m) represents another example of a single post pātaka (Figure 43).
