FLOOD MITIGATION SCHEME KAEO, NORTHLAND

FINAL ARCHAEOLOGICAL MONITORING AND EXCAVATION REPORT (SITES P04/760 & P04/761)

Report prepared for Northland Regional Council Under NZHPT Authority No. 2012/520

April 2015

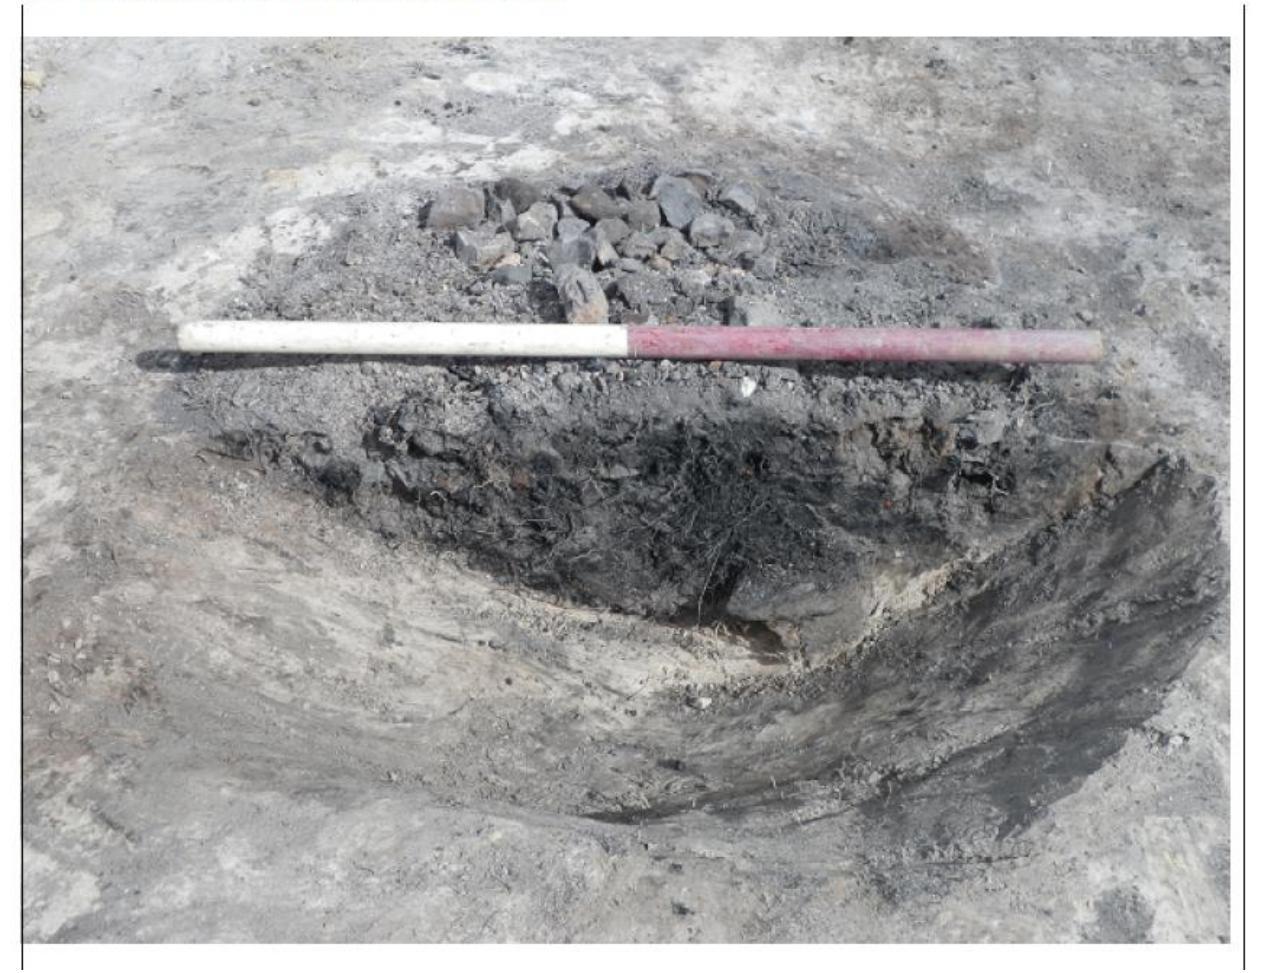
Northwest facing section of hangi 285 comprising site P04/760. Scale: 0.5m

Site P04/760 The firescoop/hangi (context 285) was sub-circular in plan and had 45° sides with a concave base, was aligned east-northeast-west-southwest and was 0.58m x 0.54m and 0.15m deep (Figure 31–Figure 33). The feature was filled with firmly compacted greyish black ash rich silt that contained frequent inclusions of charcoal and moderate inclusions of heat fractured rocks (Figure 33). A charcoal sample was taken from the fill for analysis and radiocarbon dating.

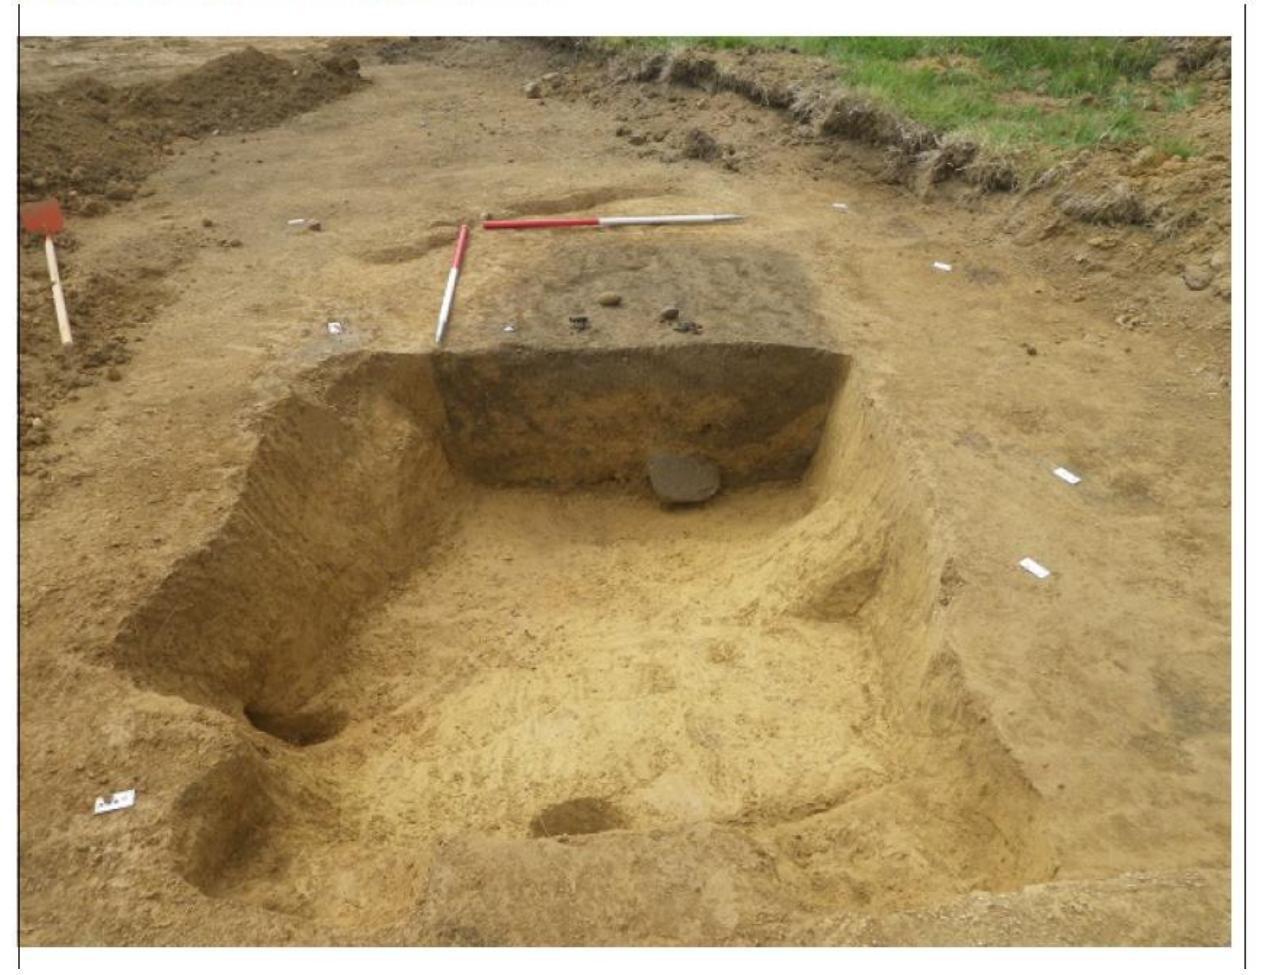
Post excavation shot of storage pit 236 with grinding stone visible in base of primary fill at centre right of section. Scale: $2 \times 1m$

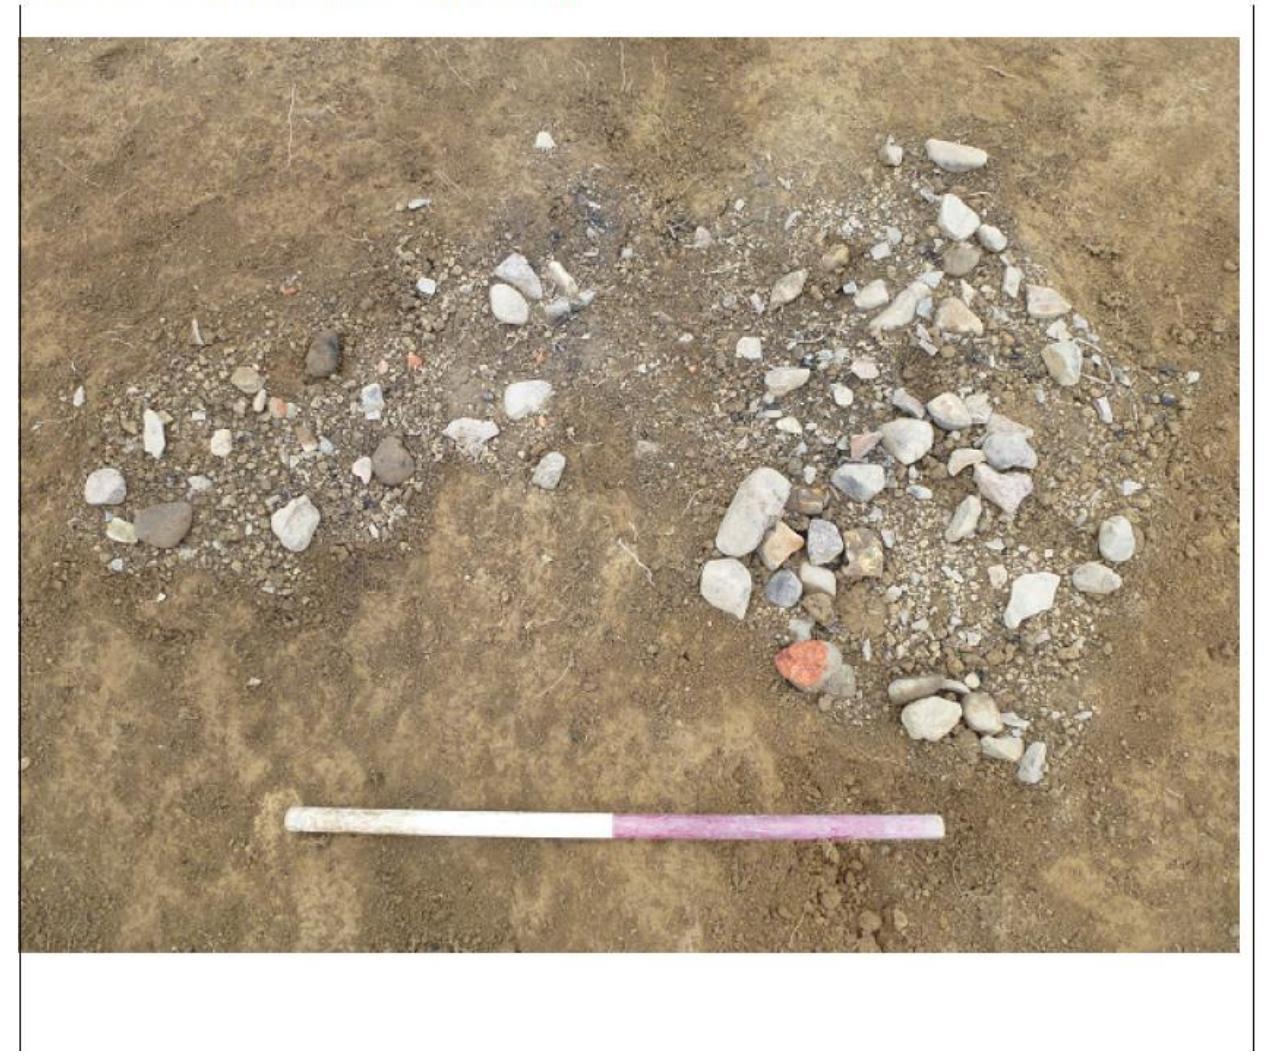
Pre-excavation shot of intercutting oven features within central area of site P04/761. Scale: 0.5m

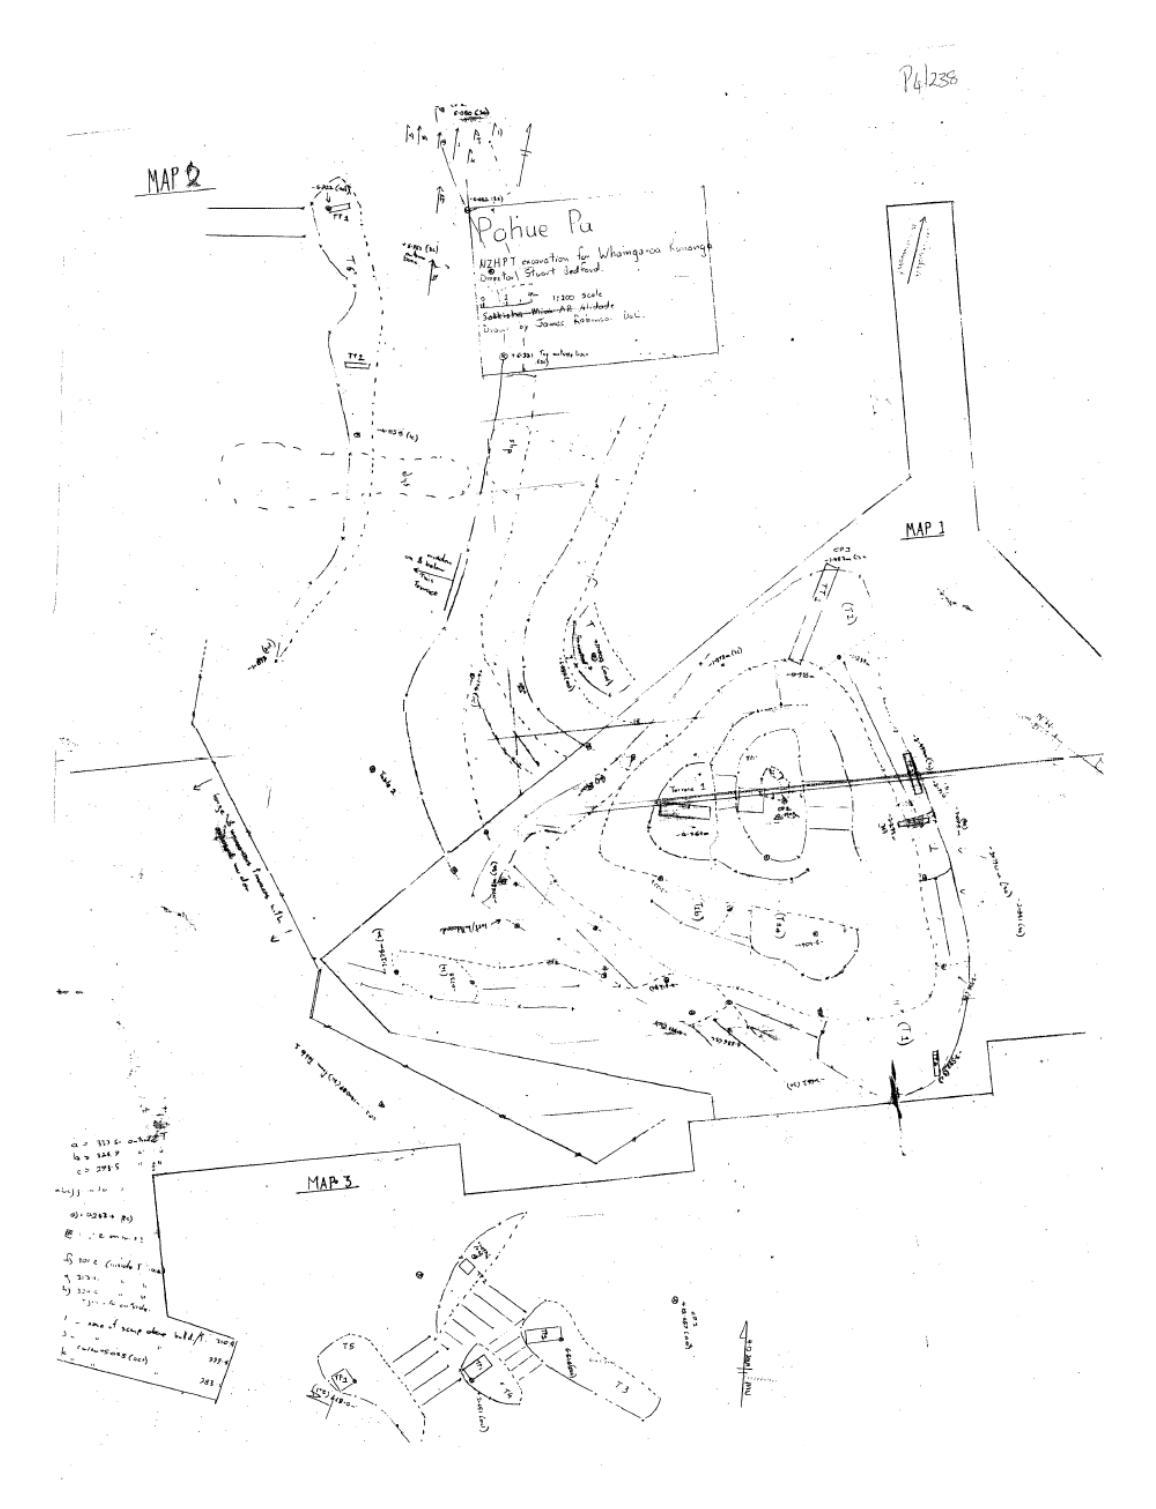
Sketch plan of the 2001 and 2002 test pitting and trial trenching undertaken by Stuart Bedford for NZHPT and Te Runanga O Whaingaroa
